CONDITION REPORT

Report No:  
2017295914  
DATE  
08/09/2026

| Manufacturer | SUZUKI | Registration Number | MC60VLGP |
| Model | SWIFT 1.2 GL 5-DR [2024-ON] | Register Number | |

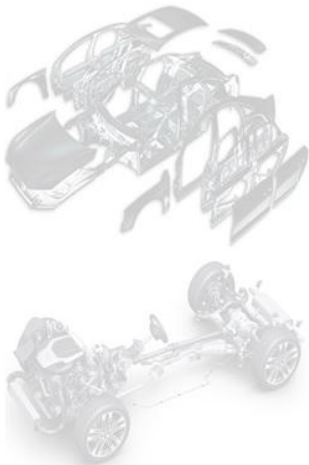
| Damage | Repair Way |
|---|---|
| Front Bumper Paintwork • Scratched | Repair |
| Sill Panel Left Paintwork • Scratched | Repair |

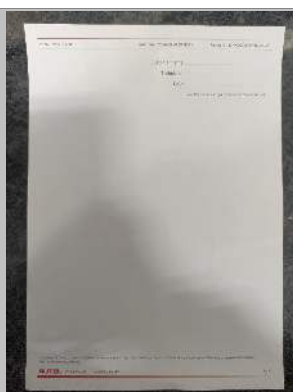
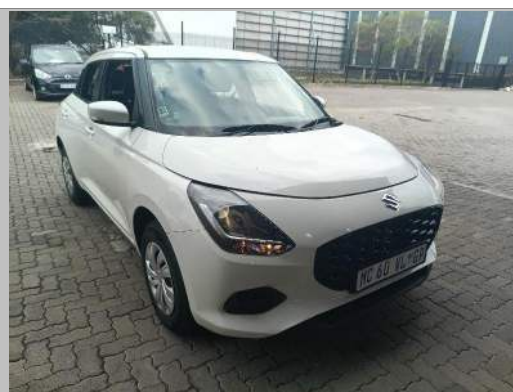
Diagnostics report

| No | System | Code | Description | Status |
|---|---|---|---|---|
| 1 | ABS | C1161-07 | PUMP MOTOR CIRCUIT | |

During the diagnostic the following error messages were detected: (See also attached Diagnostic Report. For more information regarding the Fault Codes (DTC) and the recommended rectifications please contact the workshops of the vehicle manufacture).

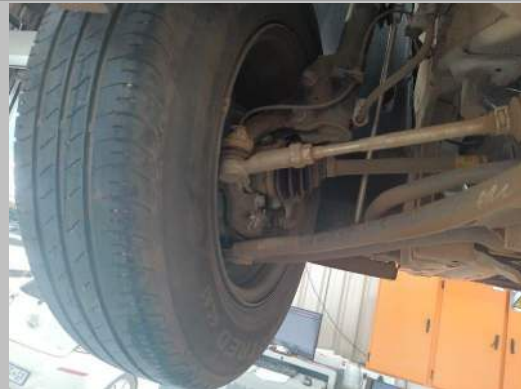
LF TYRE TREAD

| | Size | Load/Speed Index | Manufacture | Model | Type* | Production Date | Tread Depth (mm) |
|---|---|---|---|---|---|---|---|
| Front Left | 165/80R14 | 85T | MRF | Ecotred | V | 4224 | 5 mm |

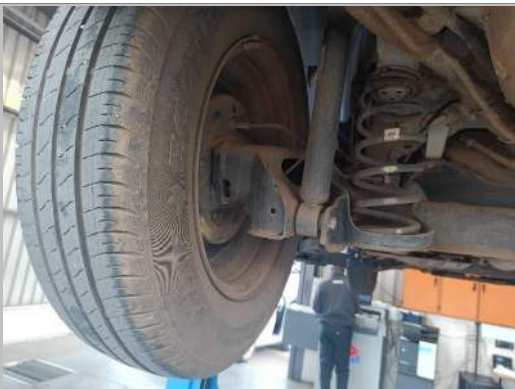
LR TYRE TREAD

| | Size | Load/Speed Index | Manufacture | Model | Type* | Production Date | Tread Depth (mm) |
|---|---|---|---|---|---|---|---|
| Rear Left | 165/80R14 | 85T | MRF | Ecotred | V | 4224 | 5 mm |

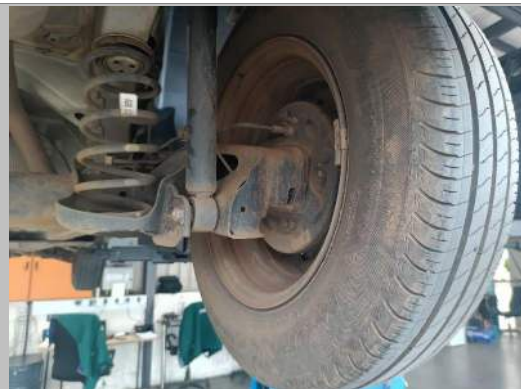
RR TYRE TREAD

| | Size | Load/Speed Index | Manufacture | Model | Type* | Production Date | Tread Depth (mm) |
|---|---|---|---|---|---|---|---|
| Rear Right | 165/80R14 | 85T | MRF | Ecotred | V | 4227 | 5 mm |

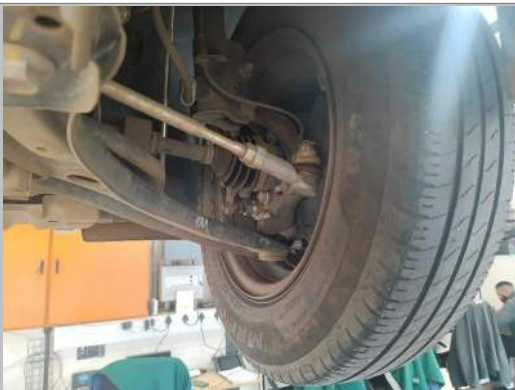
RF TYRE TREAD

| | Size | Load/Speed Index | Manufacture | Model | Type* | Production Date | Tread Depth (mm) |
|---|---|---|---|---|---|---|---|
| Front Right | 165/80R14 | 85T | MRF | Ecotred | V | 4324 | 5 mm |

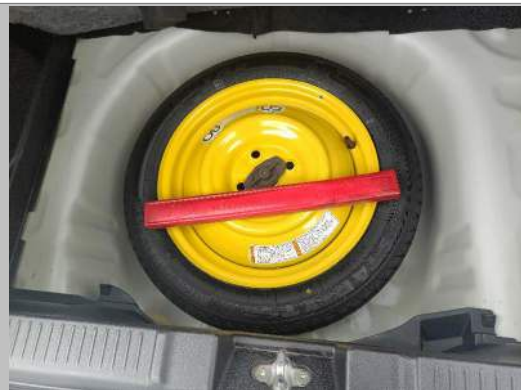
Sparewheel

| | Size | Load/Speed Index | Manufacture | Model | Type* | Production Date | Tread Depth (mm) |
|---|---|---|---|---|---|---|---|
| Spare | T135/70R15 | 99M | Jk tyre | Temporary | V | 0000 | 6 mm |
