CONDITION REPORT

Report No:  
2016975241  
DATE  
11/08/2025

| Manufacturer | SUZUKI | Registration Number | MF69KGGP |
| Model | SWIFT 1.2 GL+ 5-DR CVT [2024-ON] | Register Number | |

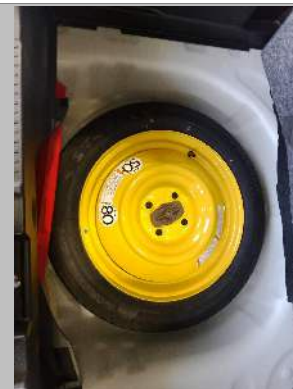
Spare wheel

| | Size | Load/Speed Index | Manufacture | Model | Type* | Production Date | Tread Depth (mm) |
|---|---|---|---|---|---|---|---|
| Spare | T135/70R15 | 99M | Jk tyre | Star-xt | V | 4824 | 4 mm |

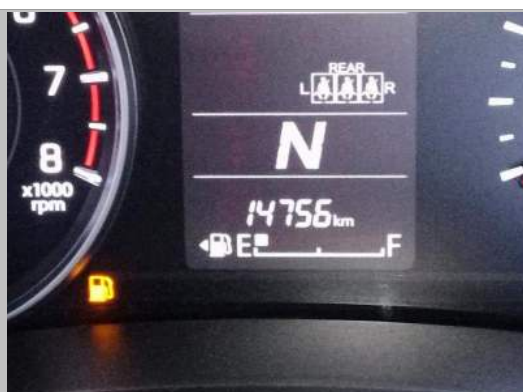
ODOMETER

| Km Reading | 14,756 KM | Fuel | PETROL |

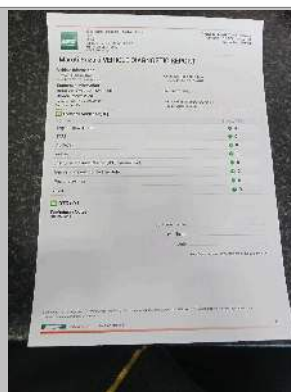
Diagnostic report

During the diagnostic no active error messages were detected. (See also attached Diagnostic Report. For more information regarding the Fault Codes (DTC) and the recommended rectifications please contact the workshops of the vehicle manufacture).

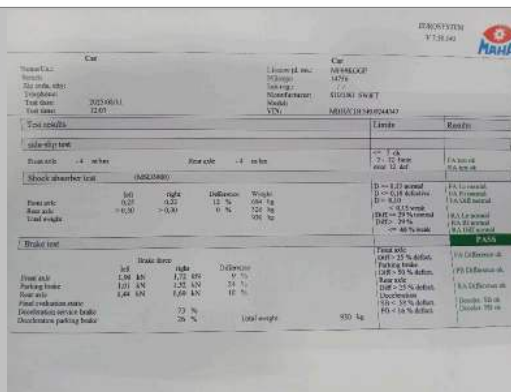
Shock and brake report

| | Left | Right | | |
|---|---|---|---|---|
| Front | 1.9 | 1.7 | - | |
| Rear | 1.4 | 1.6 | - | |
| Emergency / Parking | 1 | 1.3 | - | |

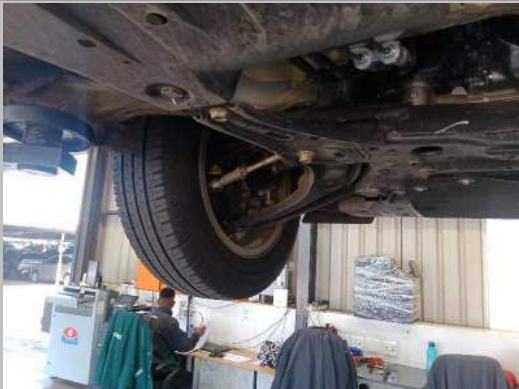
LF TYRE TREAD

| | Size | Load/Speed Index | Manufacture | Model | Type* | Production Date | Tread Depth (mm) |
|---|---|---|---|---|---|---|---|
| Front Left | 185/65R15 | 88H | Bridgestone | Ecopia | V | 4124 | 4 mm |

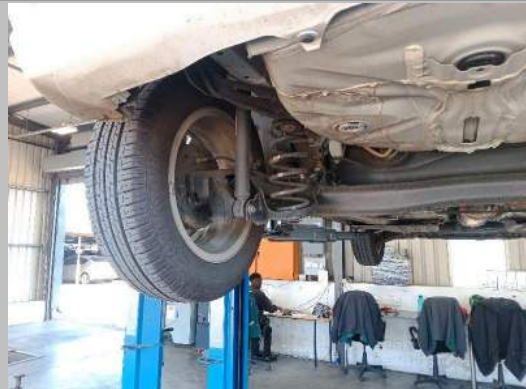
LR TYRE TREAD

| | Size | Load/Speed Index | Manufacture | Model | Type* | Production Date | Tread Depth (mm) |
|---|---|---|---|---|---|---|---|
| Rear Left | 185/65R15 | 88H | Bridgestone | Ecopia | V | 4024 | 4 mm |

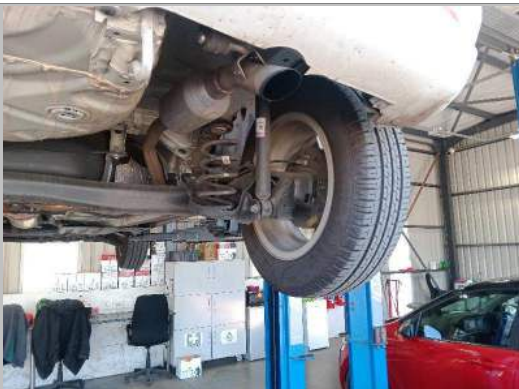
RR TYRE TREAD

| | Size | Load/Speed Index | Manufacture | Model | Type* | Production Date | Tread Depth (mm) |
|---|---|---|---|---|---|---|---|
| Rear Right | 185/65R15 | 88H | Bridgestone | Ecopia | V | 4024 | 4 mm |

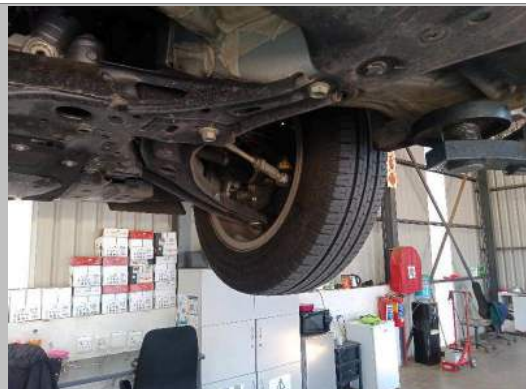
RF TYRE TREAD

| | Size | Load/Speed Index | Manufacture | Model | Type* | Production Date | Tread Depth (mm) |
|---|---|---|---|---|---|---|---|
| Front Right | 185/65R15 | 88H | Bridgestone | Ecopia | V | 4024 | 4 mm |

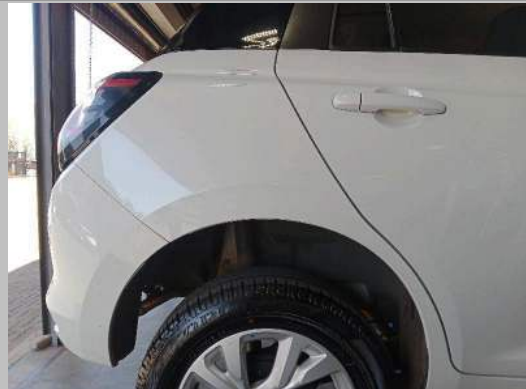
| Damage | Repair Way |
|---|---|
| Rear Fender Right Paintwork • Scratched | Repair |

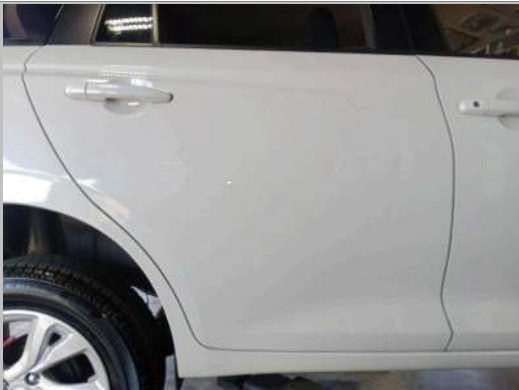
| Damage | Repair Way |
|---|---|
| Door Rear Right Paintwork • Scratched | Repair |

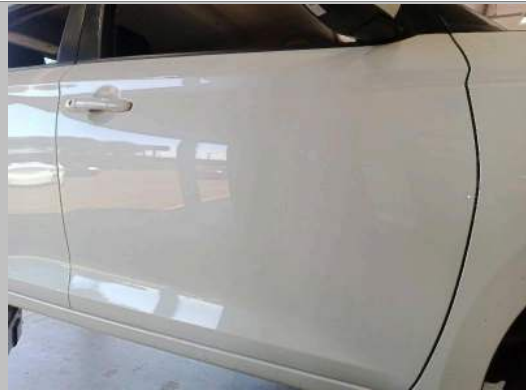
| Damage | Repair Way |
|---|---|
| Door Front Right Paintwork • Scratched | Repair |

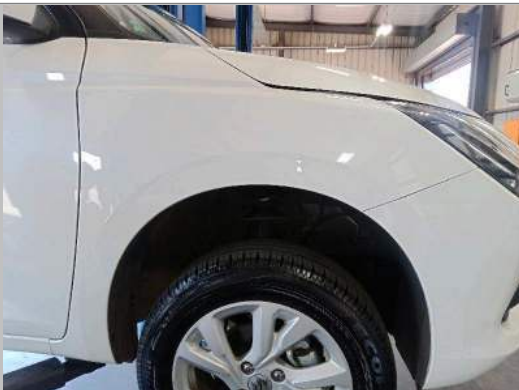
| Damage | Repair Way |
|---|---|
| Front Fender Right Paintwork • Scratched | Repair |

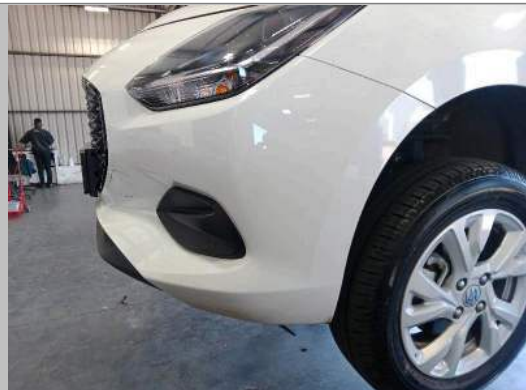
| Damage | Repair Way |
|---|---|
| Front Bumper Paintwork • Scratched | Repair |

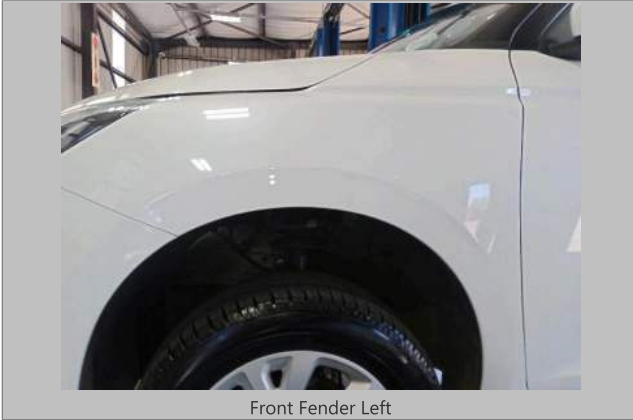
| Damage | Repair Way |
|---|---|
| Front Fender Left Paintwork • Scratched | Repair |
