CONDITION REPORT

Report No: 2016336665

Vehicle Type	PASSENGER VEHICLE	Registered Owner	MFC AUCTION HOUSE
Manufacturer	TOYOTA	Registration Number	DZW088L
Model	AVANZA	Register Number	
VIN	MHKM5EA2N0K002884	Date Of First Licensing	
Engine Number		Last COR	
Doors	5	License Expiry Date	31/08/2020
Color	GOLDEN	Power / Displacement	
Year Model		Paint Finish	M - METALLIC
Km Reading	315,590 KM	Fuel	PETROL
Cab / Body Type	STATION WAGON	Transmission	MANUAL

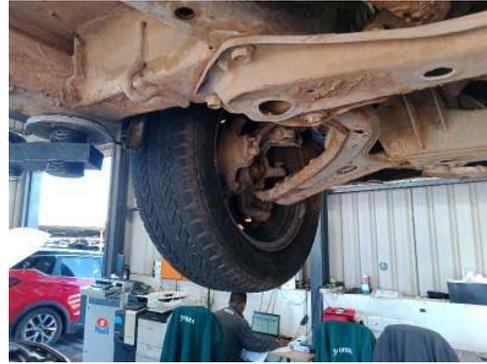
LF TYRE TREAD

Size	Load/Speed Index	Manufacture	Model	Type*	Production Date	Tread Depth (mm)
Front Left	185/60R14	82H	Dunlop	Sp sport	V	3118	2 mm
Front Right	185/70R14	88H	Symmetry	Sy101	V	4821	4 mm
Rear Left	185/70R14	88H	Ardent	Tour rx1	V	3221	0 mm
Rear Right	185/70R14	88H	Royal black	Royal passen	V	4619	0 mm

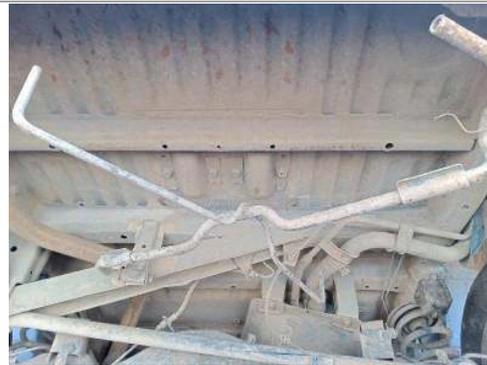
No spare wheel

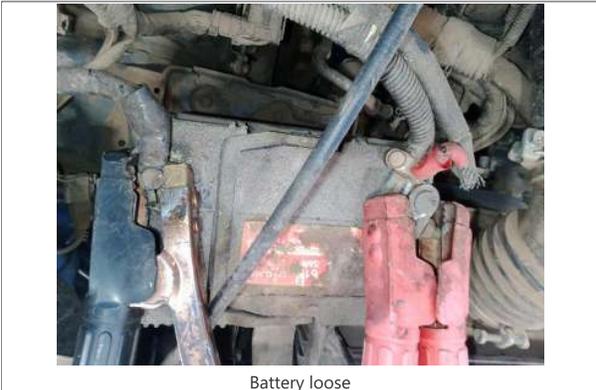
Battery loose

Damage	Repair Way
Body exterior	Signs of spray work done on some body panels
All four hup caps missing	Replace
Both front fender liner missing	Replace
Battery loose	Repair
ABS and traction control light on	Repair

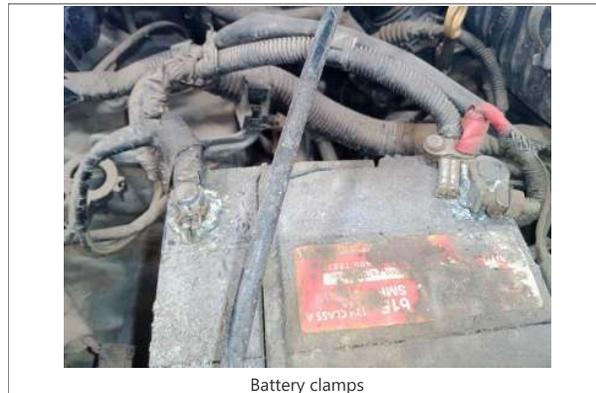
Damage	Repair Way
Battery clamps Defective	Repair
Central Air Vent Missing	Replace
Hooter Defective	Repair
Tail Light Right Damaged	Replace
Headlight Left Damaged	Replace
Dash Padding Damaged	Repair
Carpet Front Damaged	Repair
Carpet Rear Damaged	Replace
Number Plate Rear Missing	Replace
Front Bumper Paintwork • Scratched	Repair
Grill Cracked	Repair
Bonnet Dented	Repair
Front Fender Left Dented	Repair
Front Fender Right Dented	Repair
Rear Fender Left Paintwork • Scratched	Repair
Rear Fender Right Residual Traces of Repair	Repair
Door Front Left Dented	Repair
Door Front Right Dented	Repair
Door Rear Left Dented	Repair
Door Rear Right Paintwork • Scratched	Repair
Boot Lid / Hatch door Dented	Repair
Rear bumper Paintwork • Scratched	Repair
Windscreen Cracked	Replace
Shock Absorber Rear Left Leak	Replace
Shock Absorber Rear Right Leak	Replace
Control Arm(s) Front Axle Left Defective	Replace
Tyre Rear Left Smooth	Replace

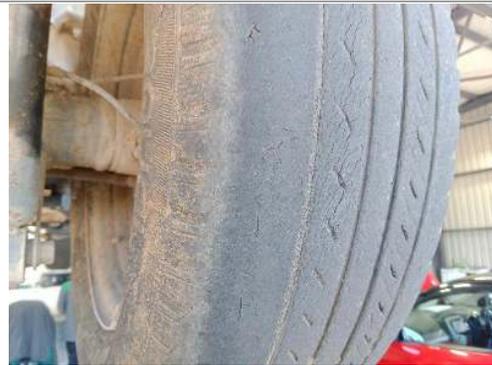
Tyre Rear Right Smooth	Replace
Body exterior	Vehicle got minor scratches, stone chips and dents
