## CONDITION REPORT

Report No:  
2017302460  
DATE  
23/09/2026

| Manufacturer | KIA | Registration Number | HMY089L |
| Model | SONET | Register Number | |

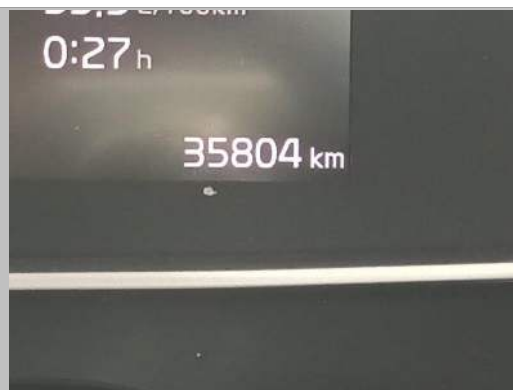
ODOMETER

| Km Reading | 35,804 KM | Fuel | PETROL |

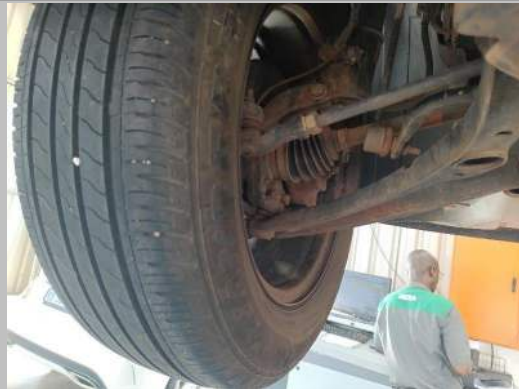
LF TYRE TREAD

| | Size | Load/Speed Index | Manufacture | Model | Type* | Production Date | Tread Depth (mm) |
|---|---|---|---|---|---|---|---|
| Front Left | 215/60R16 | 95H | MRF | Wanderer | V | 3624 | 5 mm |

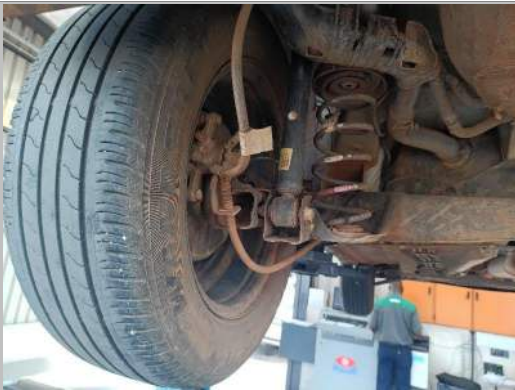
LR TYRE TREAD

| | Size | Load/Speed Index | Manufacture | Model | Type* | Production Date | Tread Depth (mm) |
|---|---|---|---|---|---|---|---|
| Rear Left | 215/60R16 | 95H | MRF | Wanderer | V | 3624 | 6 mm |

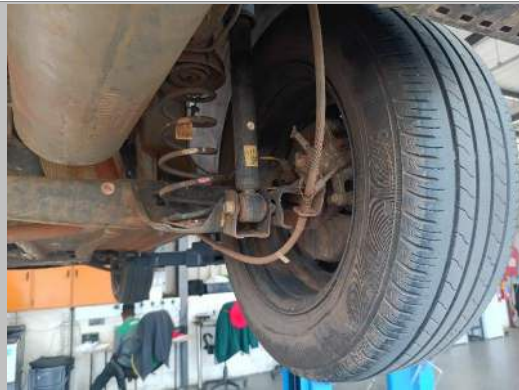
RR TYRE TREAD

| | Size | Load/Speed Index | Manufacture | Model | Type* | Production Date | Tread Depth (mm) |
|---|---|---|---|---|---|---|---|
| Rear Right | 215/60R16 | 95H | MRF | Wanderer | V | 3624 | 6 mm |

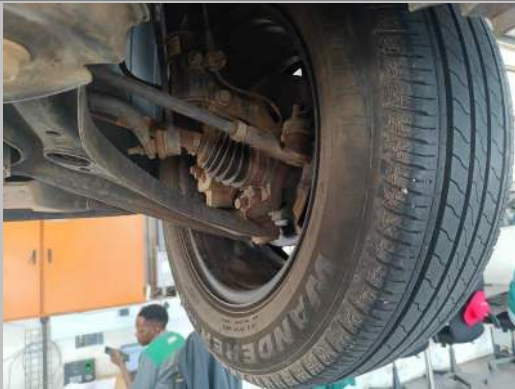
RF TYRE TREAD

| | Size | Load/Speed Index | Manufacture | Model | Type* | Production Date | Tread Depth (mm) |
|---|---|---|---|---|---|---|---|
| Front Right | 215/60R16 | 95H | MRF | Wanderer | V | 3624 | 6 mm |

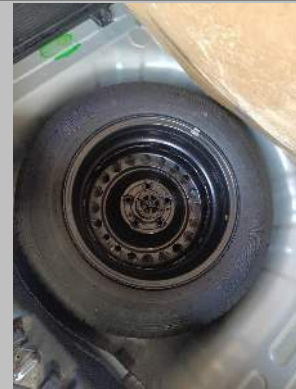
Sparewheel

| | Size | Load/Speed Index | Manufacture | Model | Type* | Production Date | Tread Depth (mm) |
|---|---|---|---|---|---|---|---|
| Spare | 195/60R15 | 91H | Goodyear | Assurance | V | 0000 | 6 mm |
