## CONDITION REPORT

Report No:  
2016924341  
DATE  
25/06/2025

| Manufacturer | LAND ROVER | Registration Number | KLK665NW |
| Model | RANGE ROVER SPORT 3.0 DSL HSE 4X4 AT [2010-2011] | Register Number | |

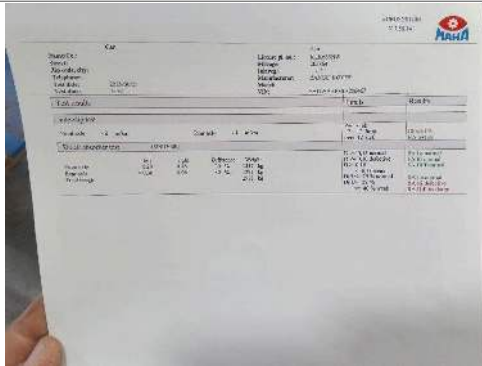
No Brake Test on a brake test machine has been performed.

Brake test.

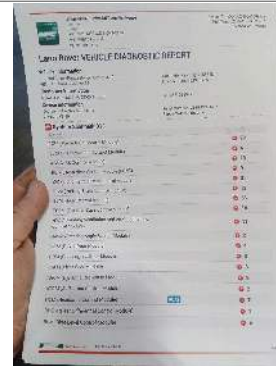
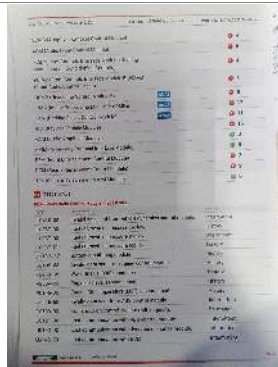
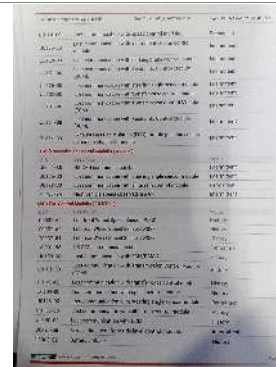
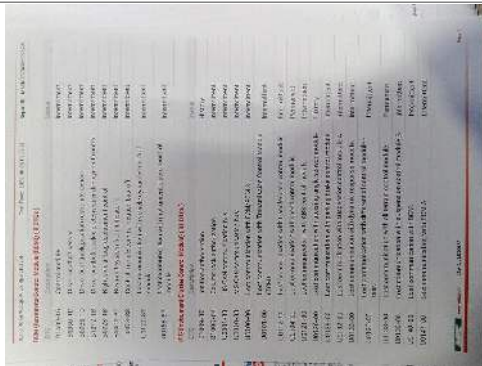
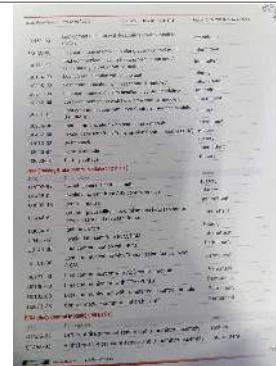
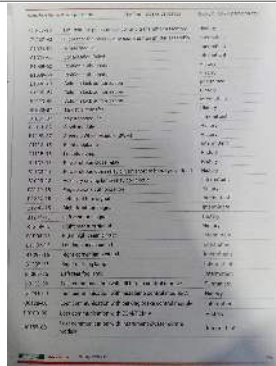
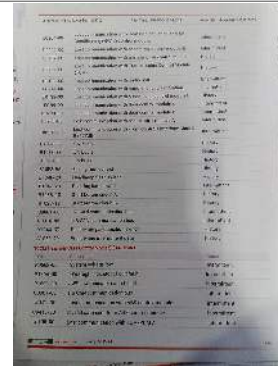
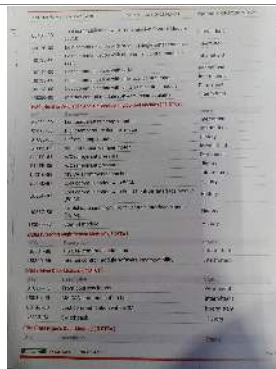
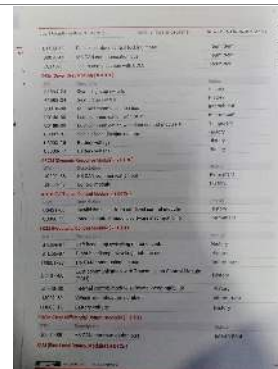
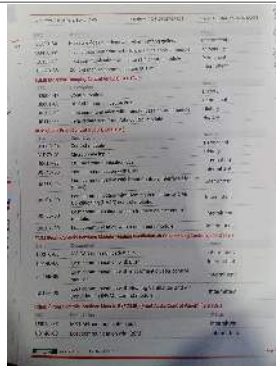
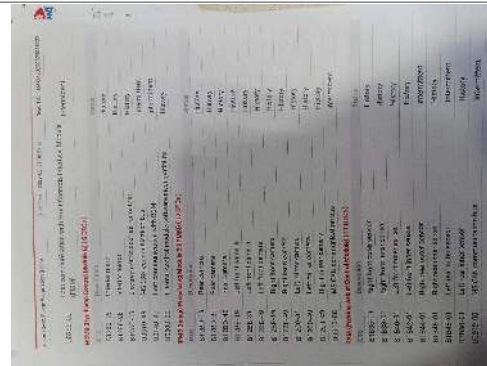
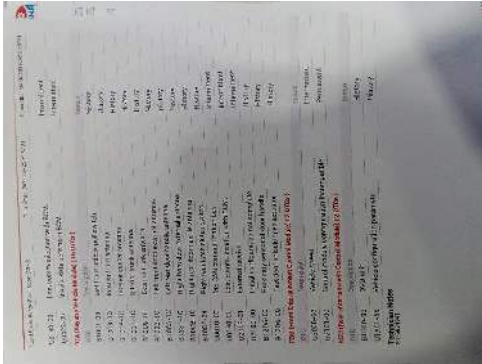
During the diagnostic the following error messages were detected: (See also attached Diagnostic Report. For more information regarding the Fault Codes (DTC) and the recommended rectifications please contact the workshops of the vehicle manufacture).

| No | System | Code | Description | Status |
|---|---|---|---|---|
| 1 | PCM | U0416-68 | INVALID DATA SENT FROM VEHICLE DYNAMICS CONTROL MODULE. | |

Diagnostic.

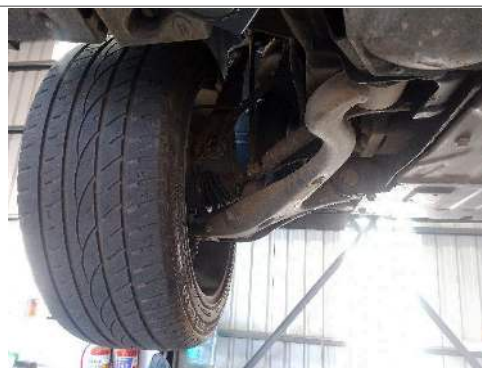
LF TYRE TREAD

| | Size | Load/Speed Index | Manufacture | Model | Type* | Production Date | Tread Depth (mm) |
|---|---|---|---|---|---|---|---|
| Front Left | 275/40R20 | 106V | Lanvigator | Radial | V | 0120 | 2 mm |

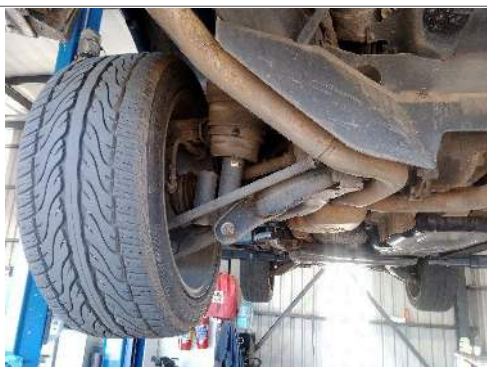
LR TYRE TREAD

| | Size | Load/Speed Index | Manufacture | Model | Type* | Production Date | Tread Depth (mm) |
|---|---|---|---|---|---|---|---|
| Rear Left | 275/40R20 | 106W | Zeta | Radial | V | 0717 | 3 mm |

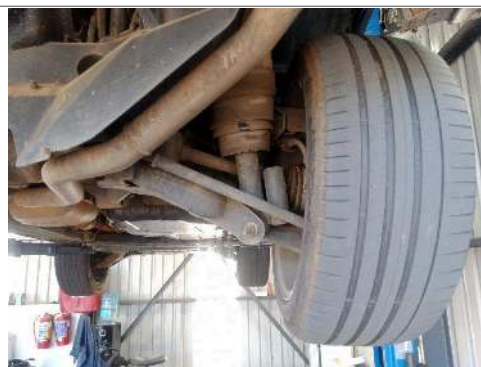
RR TYRE TREAD

| | Size | Load/Speed Index | Manufacture | Model | Type* | Production Date | Tread Depth (mm) |
|---|---|---|---|---|---|---|---|
| Rear Right | 275/40R20 | 106W | Pirelli | Radial | V | 4721 | 2 mm |

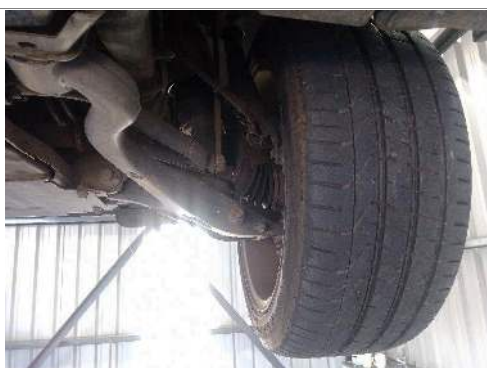
RF TYRE TREAD

| | Size | Load/Speed Index | Manufacture | Model | Type* | Production Date | Tread Depth (mm) |
|---|---|---|---|---|---|---|---|
| Front Right | 275/40R20 | 106Y | Pirelli | Radial | V | 1317 | 2 mm |

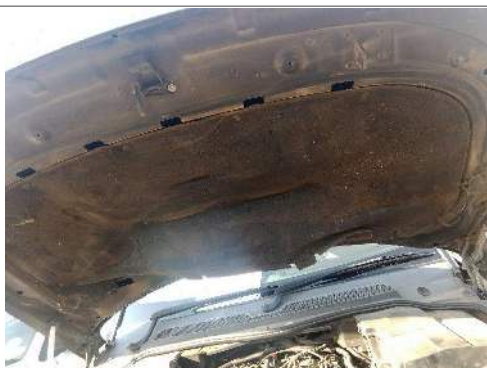
Under bonnet insulation cover

| | Damage | Repair Way |
|---|---|---|
| | Engine Oil Leak<br>Under bonnet insulation cover Damaged<br>Engine Management Lights Set<br>Hood Lining Damaged<br>Door Panel Front Left Damaged<br>Front Bumper Damaged<br>Bonnet Damaged<br>Front Fender Left Damaged<br>Front Fender Right Damaged<br>Rear Fender Left Damaged<br>Rear Fender Right Damaged<br>Door Front Left Damaged<br>Door Front Right Damaged<br>Door Rear Left Damaged<br>Door Rear Right Damaged<br>Boot Lid / Hatch door Damaged<br>Rear bumper Damaged<br>Steering box Leak<br>Gearbox Oil Leak<br>Brakes Insufficient | Repair<br><br>Repair<br>Repair<br>Repair<br>Repair<br>Repair<br>Repair<br>Repair<br>Repair<br>Repair<br>Repair<br>Repair<br>Repair<br>Repair<br>Repair<br>Repair<br>Repair<br>Repair<br>Repair<br>Repair |

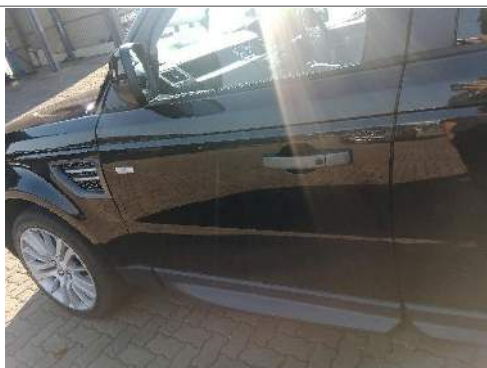
Door Front Left

General Comments: ACCORDING TO THE AGE AND MILEAGE OF THE VEHICLE, NORMAL WEAR AND TEAR MARKS ARE VISIBLE ON THE INTERIOR, EXTERIOR, ELECTRICAL AND MECHANICAL PARTS. 276 DTC'S AT TIME OF TESTING SEE DTC REPORT. VEHICLE ELECTRONICS MALFUNCTIONING. VEHICLE STRUGGLES TO START. Body • Exterior: Minor dents and scratches and stone chips to some body panels. Signs of repair work done to some body panels. Poor alignment to some body panels. hatch door glass does not close properly.
