## CONDITION REPORT

Report No:  
2016921182  
DATE  
23/06/2025

| Manufacturer | LAND ROVER | Registration Number | HS85XSGP |
| Model | RANGE ROVER EVOQUE COUPE 2.0 SI4<br>DYNAMIC 4WD AT [2012-2015] | Register Number | |

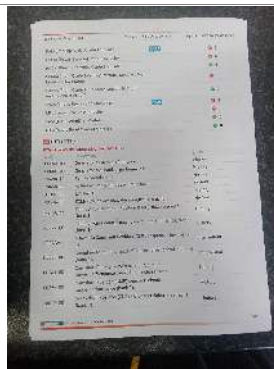
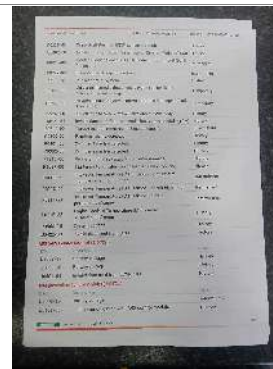
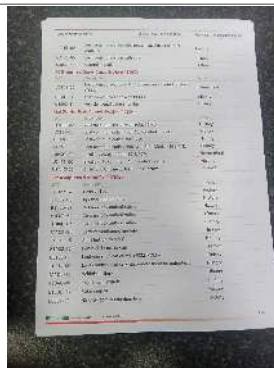
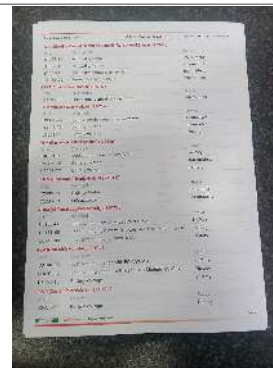
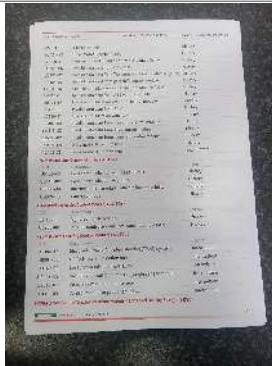
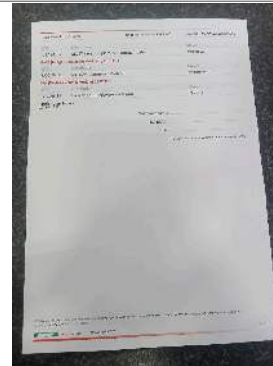
Diagnostic report

| No | System | Code | Description | Status |
|---|---|---|---|---|
| 1 | INTERMITTENT | B1A69-09 | HUMIDITY SENSOR CIRCUIT | |

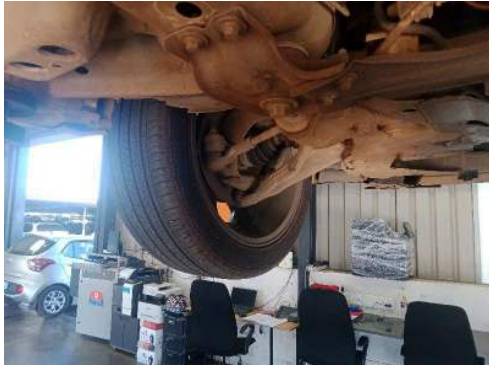
LF TYRE TREAD

| | Size | Load/Speed Index | Manufacture | Model | Type* | Production Date | Tread Depth (mm) |
|---|---|---|---|---|---|---|---|
| Front Left | 245/45R20 | 103Y | Anchee | Ac818 | V | 2024 | 4 mm |

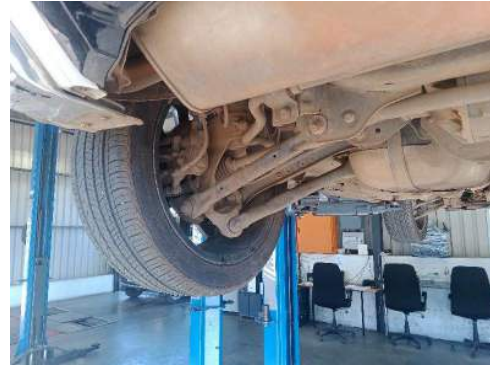
LR TYRE TREAD

| | Size | Load/Speed Index | Manufacture | Model | Type* | Production Date | Tread Depth (mm) |
|---|---|---|---|---|---|---|---|
| Rear Left | 245/45R20 | 103Y | Anchee | Ac818 | V | 4023 | 4 mm |

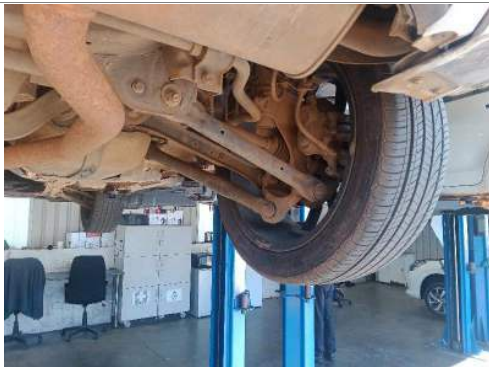
RR TYRE TREAD

| | Size | Load/Speed Index | Manufacture | Model | Type* | Production Date | Tread Depth (mm) |
|---|---|---|---|---|---|---|---|
| Rear Right | 245/45R20 | 103Y | Anchee | Ac818 | V | 4023 | 4 mm |

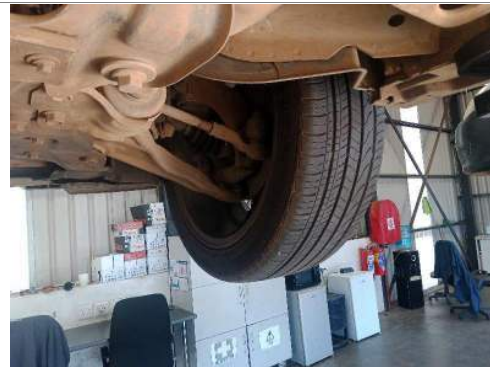
RF TYRE TREAD

| | Size | Load/Speed Index | Manufacture | Model | Type* | Production Date | Tread Depth (mm) |
|---|---|---|---|---|---|---|---|
| Front Right | 245/45R20 | 103Y | Anchee | Ac818 | V | 4023 | 4 mm |

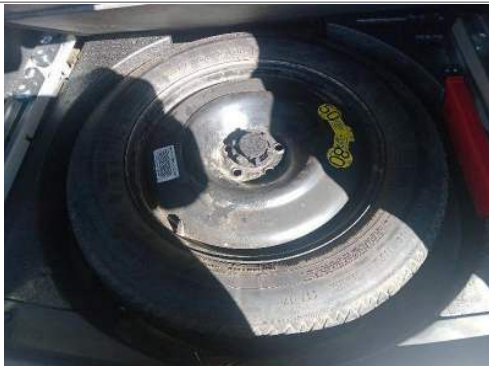
Spare wheel

| | Size | Load/Speed Index | Manufacture | Model | Type* | Production Date | Tread Depth (mm) |
|---|---|---|---|---|---|---|---|
| Spare | T155/85R18 | 115M | Continental | Temporary | V | 2218 | 3 mm |

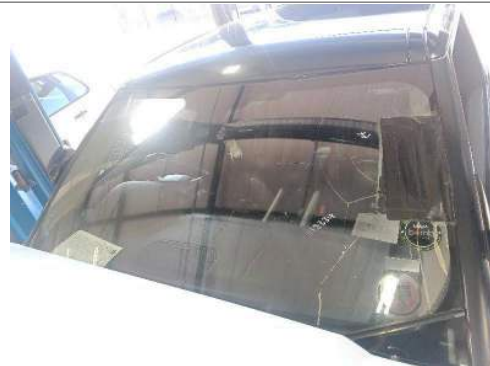
No license disc
