## CONDITION REPORT

Report No: 2016891329

MFC Auction House  
M57 Pretoria Rd, Glenmarais, KEMPTON PARK  
Gauteng

| Model | QASHQAI 1.6 VISIA 5-DR [2010-2015] | Register Number | |

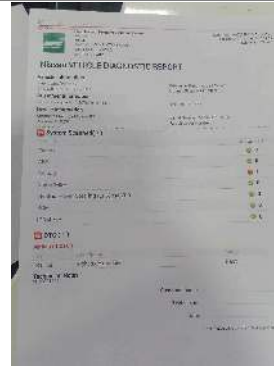
Diagnostic.

During the diagnostic no active error messages were detected. (See also attached Diagnostic Report. For more information regarding the Fault Codes (DTC) and the recommended rectifications please contact the workshops of the vehicle manufacture).

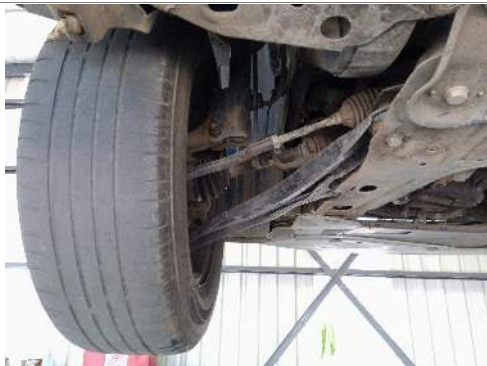
LF TYRE TREAD

| | Size | Load/Speed Index | Manufacture | Model | Type* | Production Date | Tread Depth (mm) |
|---|---|---|---|---|---|---|---|
| Front Left | 215/65R16 | 98H | Bridgestone | Radial | V | 0613 | 0 mm |

| Damage | Repair Way |
|---|---|
| Tyre Front Left Worn | Replace |

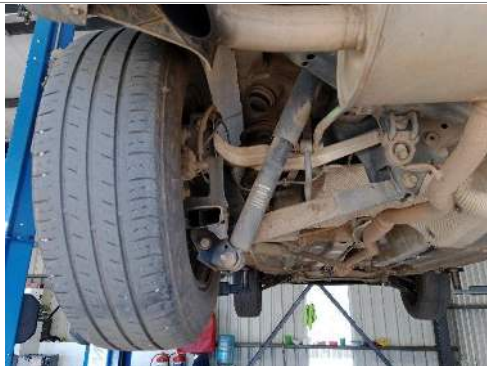
LR TYRE TREAD

| | Size | Load/Speed Index | Manufacture | Model | Type* | Production Date | Tread Depth (mm) |
|---|---|---|---|---|---|---|---|
| Rear Left | 205/65R16 | 95H | Kumho | Radial | V | 1720 | 1 mm |

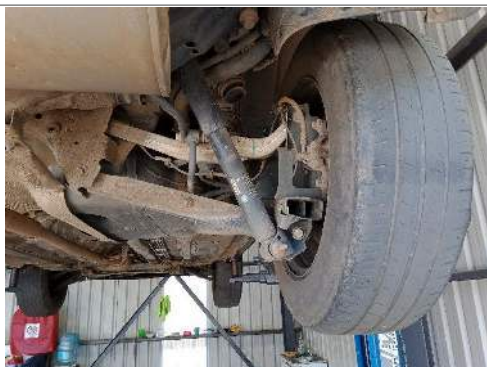
RR TYRE TREAD

| | Size | Load/Speed Index | Manufacture | Model | Type* | Production Date | Tread Depth (mm) |
|---|---|---|---|---|---|---|---|
| Rear Right | 205/65R16 | 95H | Kumho | Radial | V | 1720 | 0 mm |

| Damage | Repair Way |
|---|---|
| Tyre Rear Right Worn | Replace |

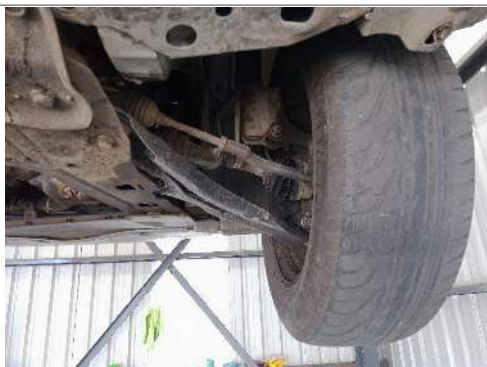
RF TYRE TREAD

| | Size | Load/Speed Index | Manufacture | Model | Type* | Production Date | Tread Depth (mm) |
|---|---|---|---|---|---|---|---|
| Front Right | 215/65R16 | 98H | Uniroyal | Radial | V | 1419 | 0 mm |

| Damage | Repair Way |
|---|---|
| Tyre Front Right Worn | Replace |
