CONDITION REPORT

Report No: 2016273841

DATE  
19/02/2024

Vehicle Type	PASSENGER VEHICLE	Registered Owner	MFC AUCTION HOUSE
Manufacturer	NISSAN	Registration Number	CG28XWGP
Model	JUKE	Register Number	
VIN	SJNFBAF15Z6287434	Date Of First Licensing	
Engine Number		Last COR	
Doors	5	License Expiry Date	31/12/2022
Color	WHITE	Power / Displacement	
Year Model		Paint Finish	C - COMMON
Km Reading	151,501 KM	Fuel	PETROL
Cab / Body Type	HATCHBACK	Transmission	MANUAL

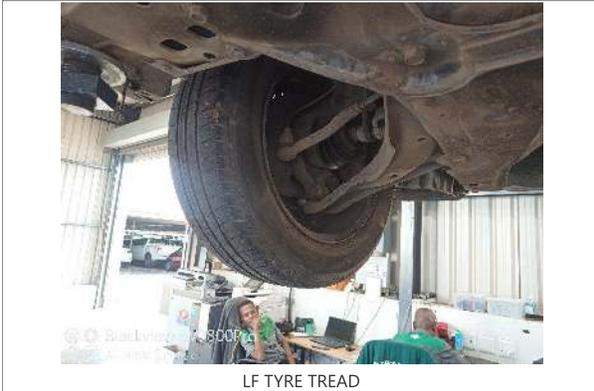
LF TYRE TREAD

Size	Load/Speed Index	Manufacture	Model	Type*	Production Date	Tread Depth (mm)
Front Left	205/60R16	92V	Hankook	Kinergy	V	4216	2 mm
Front Right	215/65R15	96H	Michelin	Primacy	V	1606	3 mm
Rear Left	205/60R16	92H	Bridgestone	Turanza	V	2712	3 mm
Rear Right	215/60R16	95V	Kumho	Solus	V	0911	2 mm

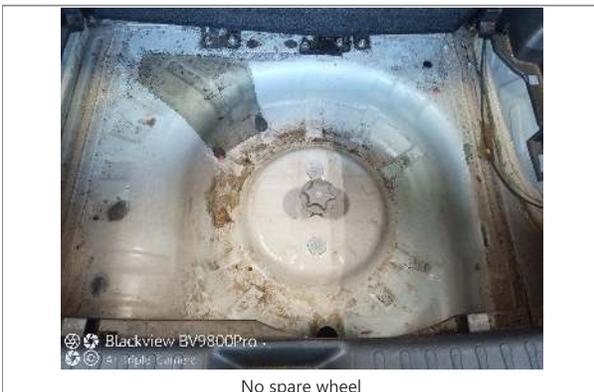
No spare wheel

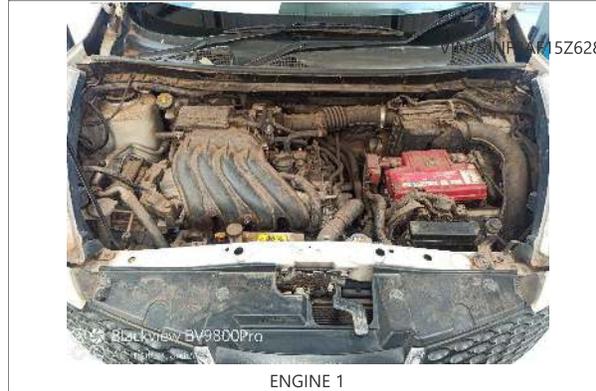
ENGINE 1

No Test Drive  
 Battery Flat  
 Engine number – not possible to verify engine number (not visible without dismantling)  
 Inspection conditions for the vehicle inspection were sufficient

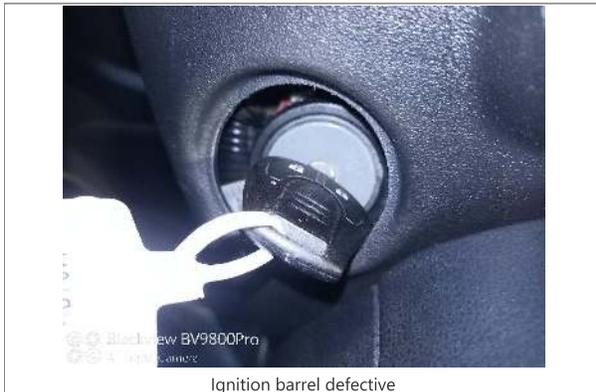
Ignition barrel defective

Damage	Repair Way
Under bonnet insulation cover Damaged	Replace
Indicator Light Front Right Malfunction	Repair
Seat Front Right Torn / Cut	Repair
Side Mirror Right Paintwork • Scratched	Repair
Front Bumper Paintwork • Scratched	Repair
Bonnet Paintwork • Chipmarks	Repair
Front Fender Left Dented	Repair
Front Fender Right Paintwork • Scratched	Repair
Door Front Left Dented	Repair
Door Front Right Damaged	Repair
Door Rear Left Dented	Repair
Windscreen Cracked	Replace
Tie Rod End right Defective	Replace
Body exterior	Vehicle got minor scratches, stone chips and dents
Ignition barrel defective	Repair
