## CONDITION REPORT

Report No:  
2016960627  
DATE  
28/07/2025

| Manufacturer | NISSAN | Registration Number | KGK429NW |
| Model | QASHQAI 1.2 T VISIA + ALLOYS 5-DR [2018-2020] | Register Number | |

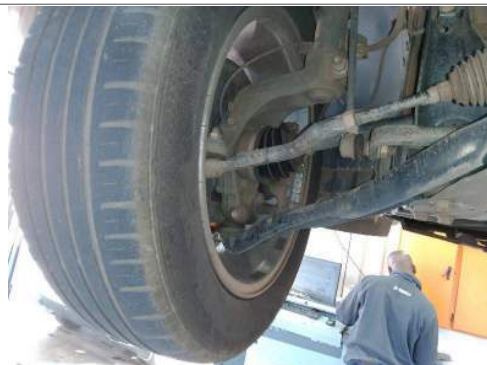
LF TYRE TREAD

| | Size | Load/Speed Index | Manufacture | Model | Type* | Production Date | Tread Depth (mm) |
|---|---|---|---|---|---|---|---|
| Front Left | 215/60R17 | 96H | Boto | Vantage | V | 2923 | 1 mm |

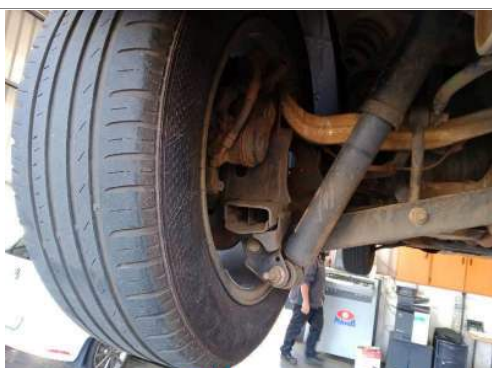
LR TYRE TREAD

| | Size | Load/Speed Index | Manufacture | Model | Type* | Production Date | Tread Depth (mm) |
|---|---|---|---|---|---|---|---|
| Rear Left | 215/60R17 | 96H | Boto | Vantage | V | 2923 | 2 mm |

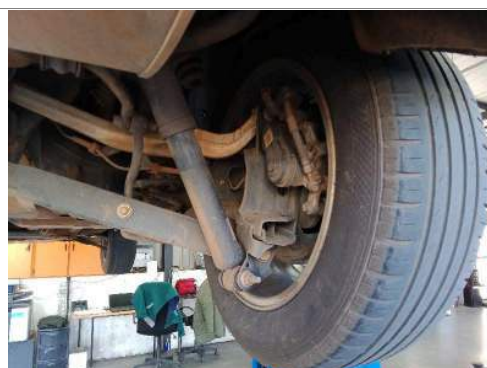
RR TYRE TREAD

| | Size | Load/Speed Index | Manufacture | Model | Type* | Production Date | Tread Depth (mm) |
|---|---|---|---|---|---|---|---|
| Rear Right | 215/60R17 | 96H | Boto | Vantage | V | 2923 | 3 mm |

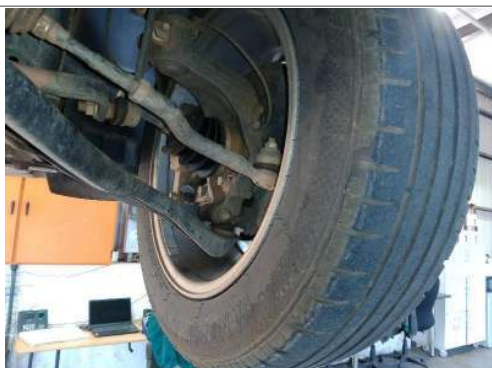
RF TYRE TREAD

| | Size | Load/Speed Index | Manufacture | Model | Type* | Production Date | Tread Depth (mm) |
|---|---|---|---|---|---|---|---|
| Front Right | 215/60R17 | 96H | Boto | Vantage | V | 2923 | 2 mm |

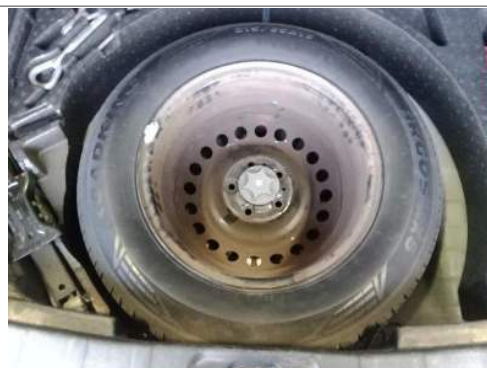
Sparewheel

| | Size | Load/Speed Index | Manufacture | Model | Type* | Production Date | Tread Depth (mm) |
|---|---|---|---|---|---|---|---|
| Spare | 215/65R16 | 88H | Roadking | Argos | V | 0000 | 5 mm |

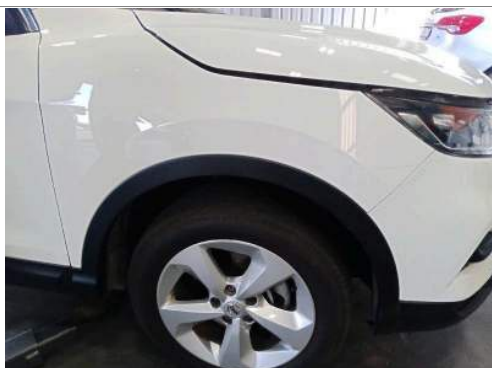
| Damage | Repair Way |
|---|---|
| Front Fender Right Paintwork • Scratched | Repair |

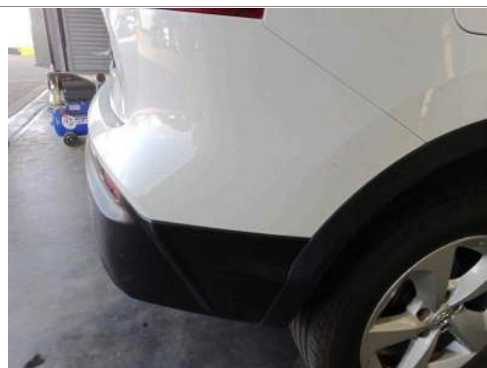
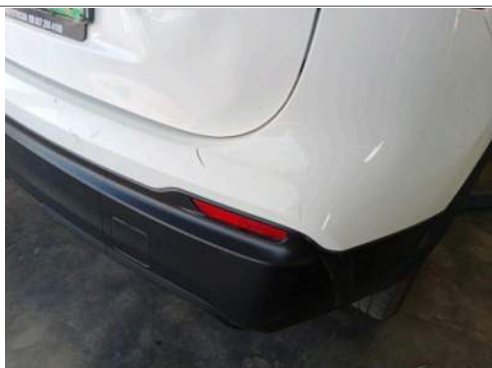
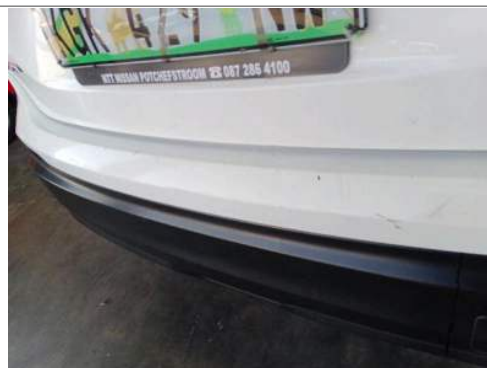
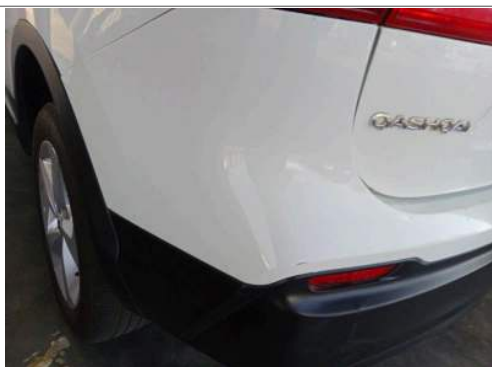
| Damage | Repair Way |
|---|---|
| Rear bumper Paintwork • Scratched | Repair |

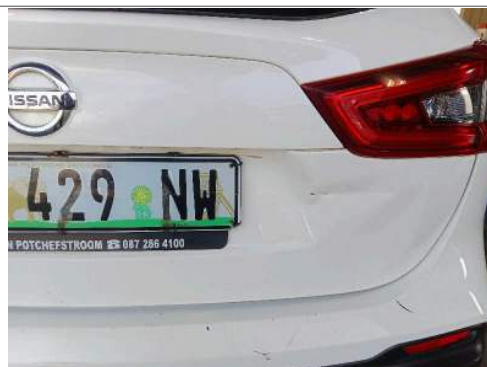
| Damage | Repair Way |
|---|---|
| Boot Lid / Hatch door Dented | Repair |

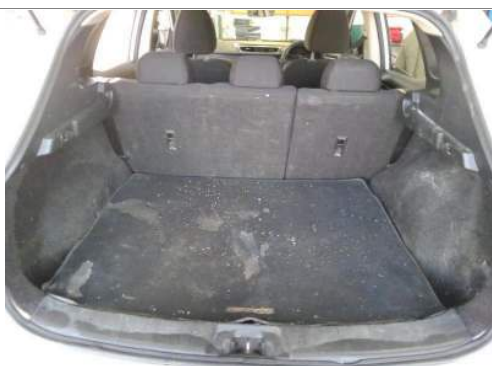
| Damage | Repair Way |
|---|---|
| Parcel Tray Missing | Replace |

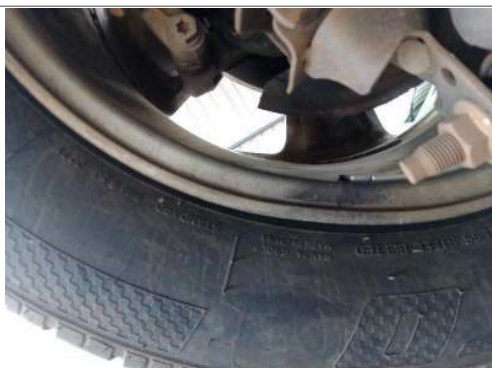
| Damage | Repair Way |
|---|---|
| Rim Rear Left Dented | Repair |
