## CONDITION REPORT

Report No: 2016824283

Vehicle Type	PASSENGER VEHICLE	Registered Owner	
Manufacturer	RENAULT	Registration Number	FM70FHGP
Model	SANDERO II 0.9 STEPWAY 66KW TURBO 5-DR [2014-2017]	Register Number	
VIN	VF15SRAAC55714984	Date Of First Licensing	
Engine Number		Last COR	
Doors	5	License Expiry Date	
Color	BLUE	Power / Displacement	
Year Model	2016	Paint Finish	M - METALLIC
Km Reading	116,874 KM	Fuel	PETROL
Cab / Body Type	HATCHBACK	Transmission	MANUAL

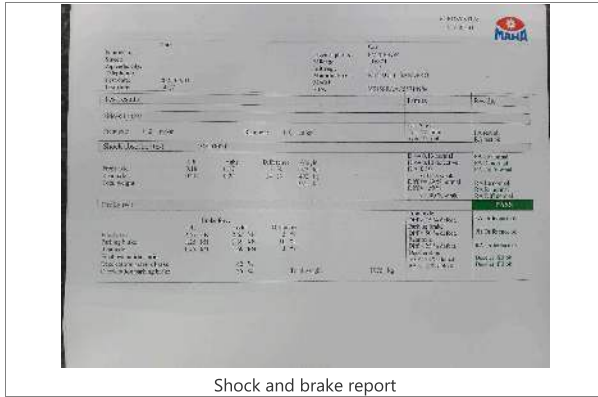
Shock and brake report

Left	Right	Axle Weight [KG]	Deceleration [m/s <sup>2</sup> ]
	Braking Force [KN]	Braking Force [KN]		
Front	2.5	2.6	-	
Rear	1.7	1.6	-	
Emergency / Parking	1.2	1.3	-

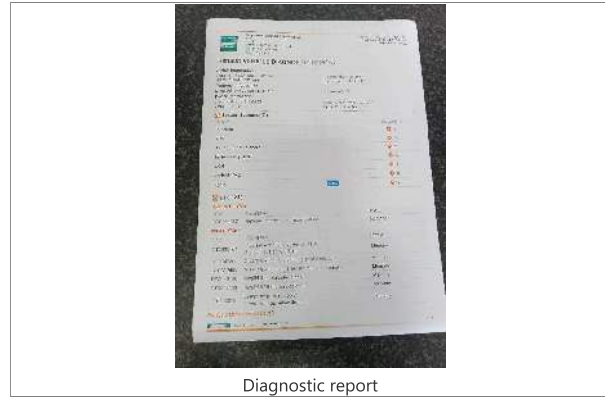
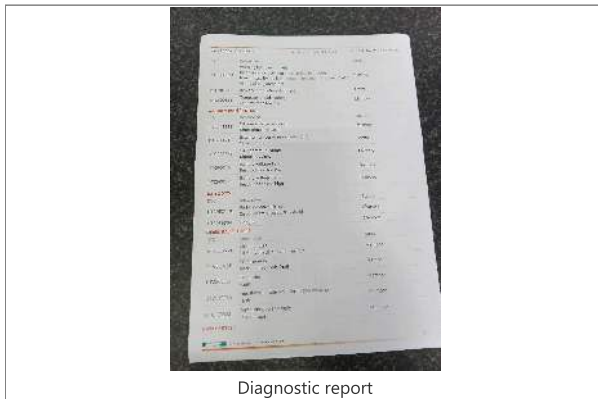
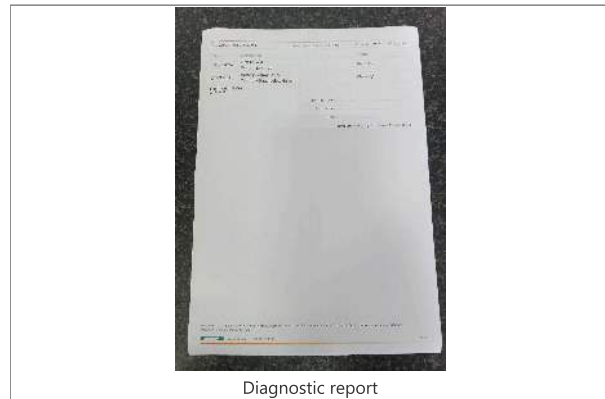
Diagnostic report

No	System	Code	Description	Status
1	ACTIVE	DTC907F49	REPLACE COMPUTER AFTER IMPACT

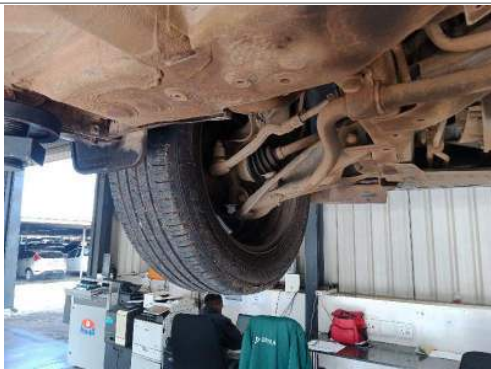
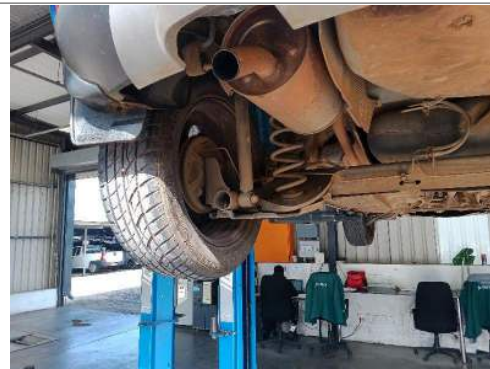
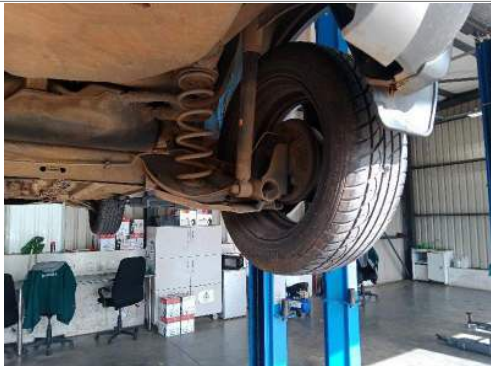
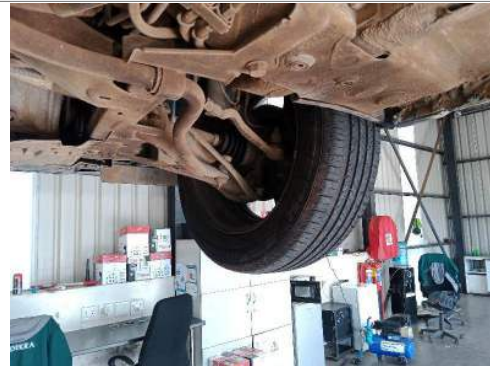
Size	Load/Speed Index	Manufacture	Model	Type*	Production Date	Tread Depth (mm)
Front Left	205/55R16	91V	Tracmax	X-privilo	V	3023	3 mm
Front Right	205/55R16	91V	Tracmax	X-privilo	V	3023	3 mm
Rear Left	205/55R16	91W	Rovelo	Rpx-988	V	3820	3 mm
Rear Right	205/55R16	91W	Rovelo	Rpx-988	V	3820	3 mm
Spare	185/65R15	88T	Barum	Brilliants	V	2018	5 mm

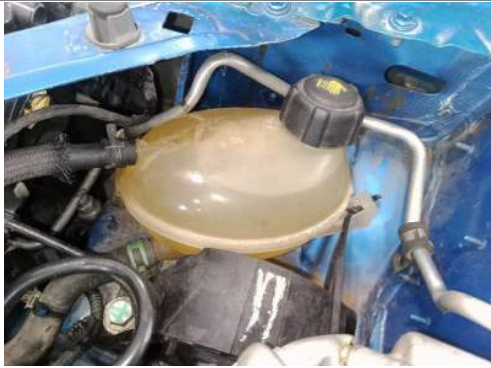
Expection bottle

Damage	Repair Way
Expansion Bottle Defective	Repair
Air conditioner pipes Damaged	Replace
Fog Light Front Right Malfunction	Repair
Interior Mirror Missing	Replace
Dash Padding Damaged	Repair
Steering Wheel Trim Damaged	Repair
Side Mirror Left Paintwork • Scratched	Repair
Side Mirror Right Residual Traces of Repair	Repair
Front Bumper Damaged	Repair
Bonnet slam plate (Shock tower/ Inner tray) Dented	Repair
Front Fender Left Residual Traces of Repair	Repair
Front Fender Right Residual Traces of Repair	Repair
Rear Fender Left Dented	Repair
Rear Fender Right Dented	Repair
Door Front Left Residual Traces of Repair	Repair
Door Front Right Residual Traces of Repair	Repair
Door Rear Left Paintwork • Scratched	Repair
Door Rear Right Dented	Repair
Boot Lid / Hatch door Paintwork • Scratched	Repair

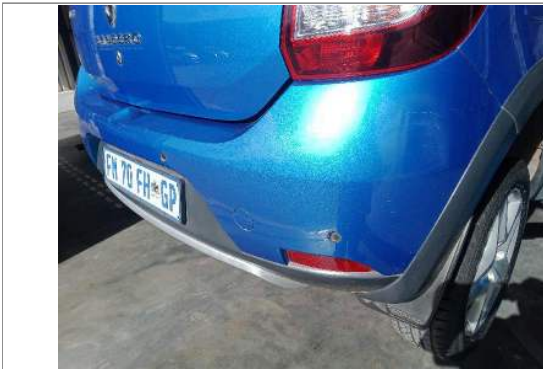
Damage	Repair Way
Rear bumper Paintwork • Scratched	Repair
Body exterior	Vehicle got minor scratches, stone chips and dents
Body exterior	Signs of spray work done on some body panels
Airbag light on	Repair
