MFC Auction House
M57 Pretoria Rd, Glenmarais, KEMPTON PARK
Gauteng

DEKRA MFC
M57 Pretoria Rd - 1619
KEMPTON PARK - GT
08610 33572

VEHICLE INSPECTION

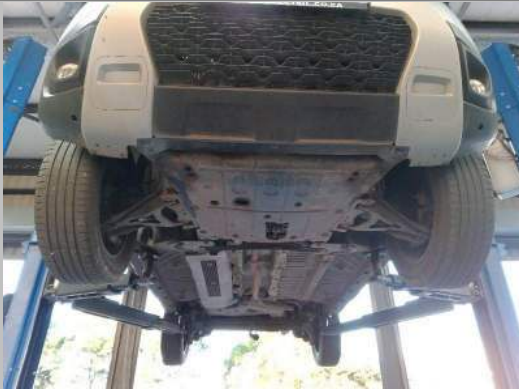
Front chassis

Damage	Repair Way
Side Mirror Left Paintwork • Scratched	Repair
Side Mirror Right Paintwork • Scratched	Repair
Front Bumper Paintwork • Scratched	Repair
Bonnet Paintwork • Chipmarks	Repair
Front Fender Right Paintwork • Scratched	Repair
Rear Fender Left Paintwork • Scratched	Repair
Rear Fender Right Dented	Repair
Door Front Left Paintwork • Scratched	Repair
Door Front Right Paintwork • Scratched	Repair
Door Rear Left Paintwork • Scratched	Repair
Door Rear Right Paintwork • Scratched	Repair
Rear bumper Paintwork • Scratched	Repair
Rim Front Right Scratched	Repair
Brakes Noisy	Repair
Undercarriage	Bottom of engine and gearbox fully covered
Body and Exterior	Minor dents and scratches on some body panels

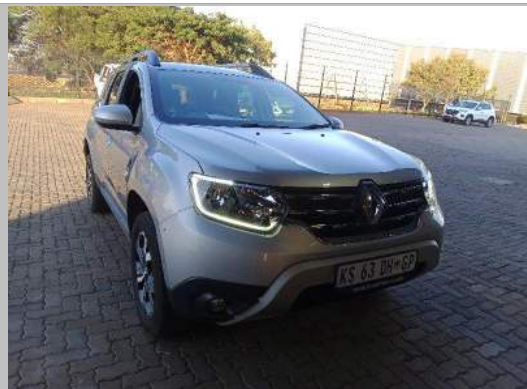
Spare wheel

Size	Load/Speed Index	Manufacture	Model	Type*	Production Date	Tread Depth (mm)
Front Left	215/60 R17	96H	Bridgestone	Alvenza	V	3523	1 mm
Front Right	215/60 R17	96H	Bridgestone	Alenza	V	1723	2 mm
Rear Left	215/60 R17	96H	Goodyear	Efficient	V	0722	1 mm
Rear Right	215/60 R17	96H	Goodyear	Efficient	V	0722	1 mm
Spare	215/65 R16	98H	Continental	ContiEco	V	2122	7 mm
