CONDITION REPORT

Report No: 2016212429

Vehicle Type	PASSENGER VEHICLE	Registered Owner	MFC
Manufacturer	RENAULT	Registration Number	JL68VHGP
Model	DUSTER	Register Number	
VIN	VF1HJD20463044318	Date Of First Licensing	
Engine Number		Last COR	
Doors	5	License Expiry Date	31/01/2024
Color	SILVER	Power / Displacement	
Year Model		Paint Finish	M - METALLIC
Km Reading	118,739 KM	Fuel	DIESEL
Cab / Body Type	HATCHBACK	Transmission	AUTOMATIC

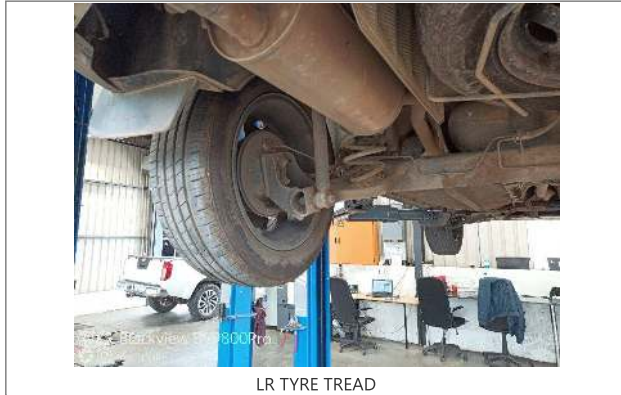
LR TYRE TREAD

Size	Load/Speed Index	Manufacture	Model	Type*	Production Date	Tread Depth (mm)
Front Left	225/65R17	102H	Yokohama	Geolandar	V	5018	0 mm
Front Right	215/60R17	96H	Nexen	N fera	V	0923	3 mm
Rear Left	215/60R17	96H	Nexen	N fera	V	3622	3 mm
Rear Right	215/60R17	96H	Bridgestone	Dueler	V	2219	3 mm
Spare	215/65R16	98H	Continental	Contact	V	2219	4 mm

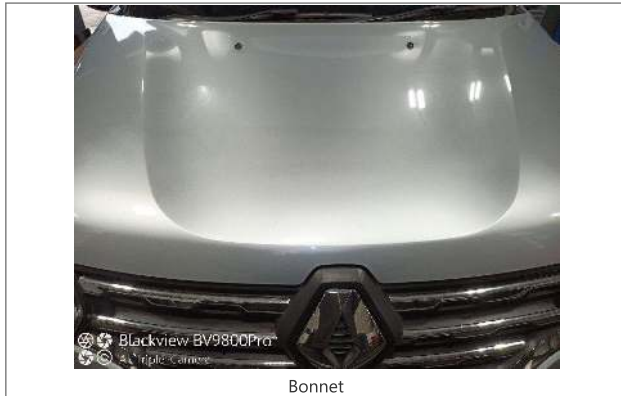
Damage	Repair Way
Seat Front Right Torn / Cut	Repair
Front Bumper Paintwork • Scratched	Repair
Bonnet Paintwork • Scratched	Repair
Front Fender Right Paintwork • Scratched	Repair
Rear Fender Left Paintwork • Scratched	Repair
Rear Fender Right Dented	Repair
Door Rear Left Paintwork • Scratched	Repair
Door Rear Right Paintwork • Scratched	Repair
Boot Lid / Hatch door Dented	Repair
Rear bumper Damaged	Repair
Windscreen Cracked	Replace
Parking Brake Performance Left / Right Difference out of legal range	Repair
Tyre Front Left Smooth	Replace
Rim Rear Left Scratched	Repair
