## CONDITION REPORT

Report No:  
2017302004  
DATE  
22/09/2026

| Manufacturer | RENAULT | Registration Number | HL89RKGP |
| Model | DUSTER | Register Number | |

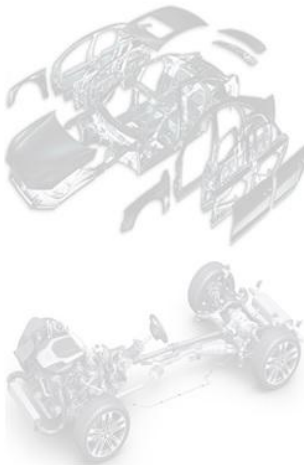
| Damage | Repair Way |
|---|---|
| Front Bumper Paintwork • Scratched | Repair |
| Bonnet Paintwork • Chipmarks | Repair |
| Front Fender Left Dented | Repair |
| Front Fender Right Paintwork • Scratched | Repair |
| Rear Fender Left Paintwork • Scratched | Repair |
| Rear Fender Right Defective | Repair |
| Door Front Left Paintwork • Scratched | Repair |
| Door Front Right Paintwork • Scratched | Repair |
| Door Rear Left Dented | Repair |
| Door Rear Right Paintwork • Scratched | Repair |
| Boot Lid / Hatch door Dented | Repair |
| Rear bumper Paintwork • Scratched | Repair |

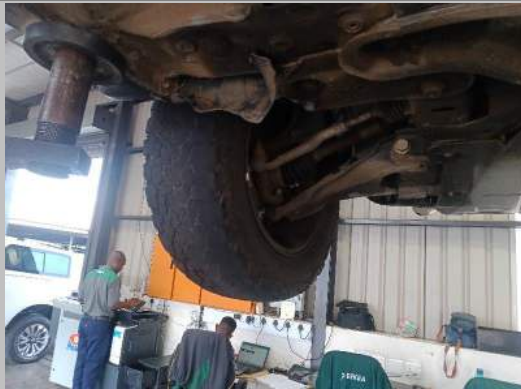
LF TYRE TREAD

| | Size | Load/Speed Index | Manufacture | Model | Type* | Production Date | Tread Depth (mm) |
|---|---|---|---|---|---|---|---|
| Front Left | 215/65R16 | 103/100S | Bf Goodrich | All-Terrain | V | 2920 | 1 mm |

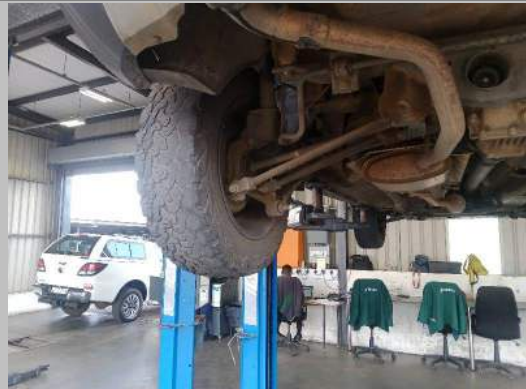
LR TYRE TREAD

| | Size | Load/Speed Index | Manufacture | Model | Type* | Production Date | Tread Depth (mm) |
|---|---|---|---|---|---|---|---|
| Rear Left | 215/65R16 | 103/100S | Bf Goodrich | All-Terrain | V | 5219 | 2 mm |

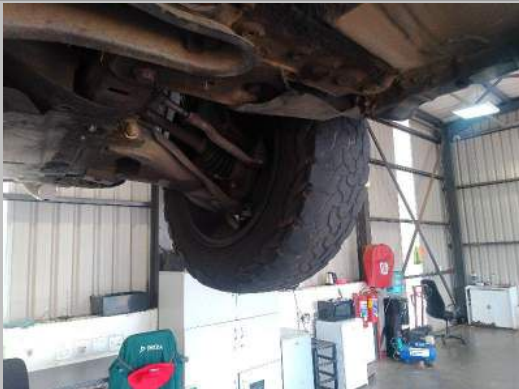
RF TYRE TREAD

| | Size | Load/Speed Index | Manufacture | Model | Type* | Production Date | Tread Depth (mm) |
|---|---|---|---|---|---|---|---|
| Front Right | 215/65R16 | 103/100S | Bf Goodrich | All-Terrain | V | 3219 | 1 mm |

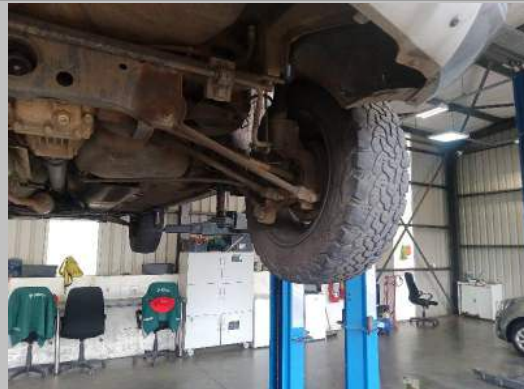
RR TYRE TREAD

| | Size | Load/Speed Index | Manufacture | Model | Type* | Production Date | Tread Depth (mm) |
|---|---|---|---|---|---|---|---|
| Rear Right | 215/65R16 | 103/100S | Bf Goodrich | All-Terrain | V | 3219 | 2 mm |

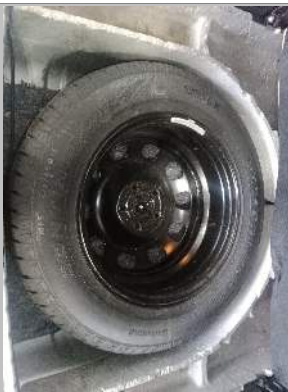
Spare wheel

| | Size | Load/Speed Index | Manufacture | Model | Type* | Production Date | Tread Depth (mm) |
|---|---|---|---|---|---|---|---|
| Spare | 215/65R16 | 98H | Continental | Contact | V | //// | 5 mm |
