CONDITION REPORT

Report No: 2016271100

MFC Auction House  
M57 Pretoria Rd, Glenmarais, KEMPTON PARK  
Gauteng

Vehicle Type	PASSENGER VEHICLE	Registered Owner	MFC AUCTION HOUSE
Manufacturer	PEUGEOT	Registration Number	JZX581MP
Model	308	Register Number	
VIN	VF3LPHNZBFS247656	Date Of First Licensing	
Engine Number		Last COR	
Doors	5	License Expiry Date	30/04/2024
Color	BLACK	Power / Displacement	
Year Model		Paint Finish	TWO COAT METALLIC
Km Reading	98,676 KM	Fuel	PETROL
Cab / Body Type	HATCHBACK	Transmission	MANUAL

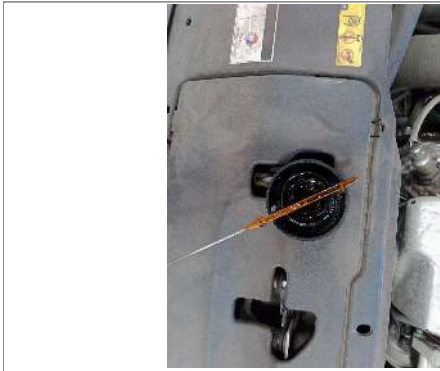
Oil cap and dipstick

Damage	Repair Way
Engine Oil Leak	Repair
Engine Wiring Defective	Repair
Oil level Insufficient	Replace
Bonnet stay and shocks Defective	Repair
Central Air Vent Defective	Repair
Seat Front Left Dirty	Repair
Seat Rear Dirty	Repair
Sun Visor Left Defective	Repair
Sun Visor Right Defective	Repair
Side Mirror Left Paintwork • Scratched	Repair
Front Bumper Paintwork • Scratched	Repair
Bonnet Paintwork • Scratched	Smart Repair
C • Pillar Right Paintwork • Scratched	Repair
Front Fender Left Paintwork • Scratched	Repair
Front Fender Right Paintwork • Scratched	Smart Repair
Rear Fender Left Paintwork • Scratched	Repair
Rear Fender Right Paintwork • Scratched	Repair
Door Front Left Paintwork • Scratched	Repair
Door Front Right Paintwork • Scratched	Repair
Door Rear Left Paintwork • Scratched	Repair
Door Rear Right Paintwork • Scratched	Repair
Boot Lid / Hatch door Paintwork • Scratched	Repair
Rear bumper Paintwork • Scratched	Repair

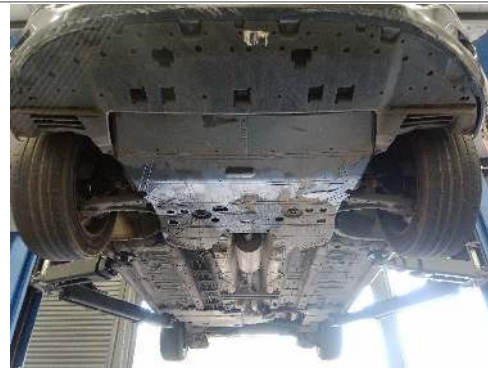
Front chassis

Damage	Repair Way
Tyre Rear Right Worn	Replace
Chassis Dented	Repair
Belly plates Damaged	Repair
Gearbox Oil Leak	Repair
Brakes Noisy	Repair
Interior	Vehicle interior dirty.
Axle and suspension	Abnormal noise coming from front and rear suspensi
Tyres and Rims	Spare wheel tyre has reached legal limit.
Lights	Left number plate lights not working.
Body and Exterior	Minor dents and scratches on some body panels.
Body and Exterior	Some body panels misaligned
Body and Exterior	Spray work on some body panels
Tyres and Rims	Alloy rims scratched
Engine	Engine bay dirty and brake fluid level ok
Undercarriage	Bottom of engine and gearbox fully covered
Undercarriage	Signs of oil leak on engine splash plate
Undercarriage	Vehicle undercarriage dirty.
Undercarriage	Exhaust heat shield damaged.
Tyres and Rims	Front left tyre has reached legal limit
Body and Exterior	Front left and right inner fender liners damaged
Body and Exterior	Signs of impact damage to front of vehicle.

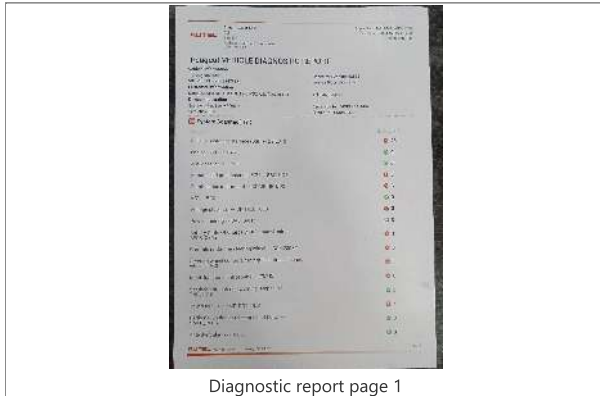
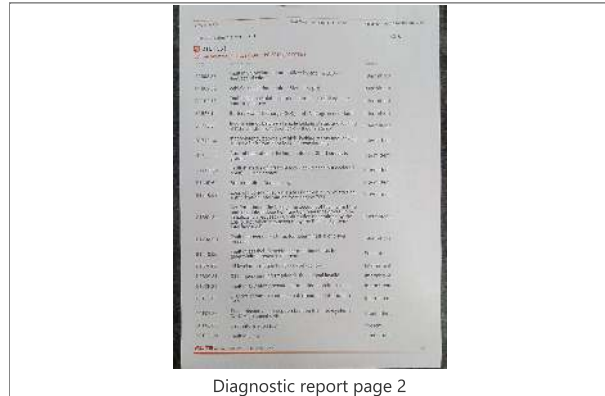
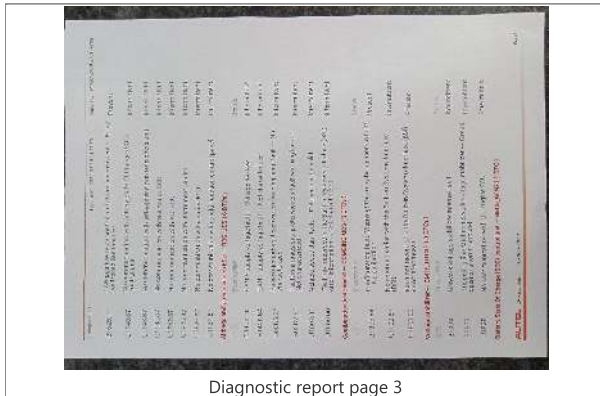
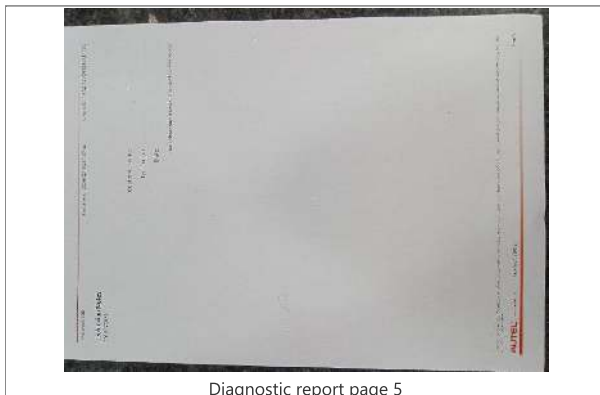
Diagnostic report page 1

No	System	Code	Description	Status
1	BUILT-IN SYSTEMS INTERFACE(BSI)	B1808:87	FAULT IN UNLOCKING OF IMMOBILIZER BY ENGINE ECU QU

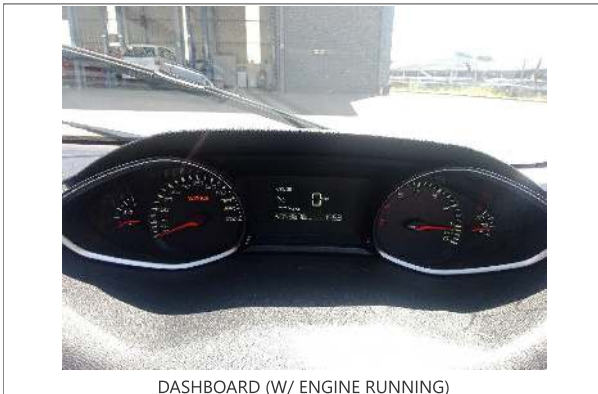
DASHBOARD (W/ ENGINE RUNNING)

Vehicle electronics malfunctioning	Repair
Electrical Components and Instruments	Front wipers faulty
Interior	Rear right seat belt buckle damaged
Drivers seat belt sensor malfunctioning	Repair
Engine management light illuminated on dashboard	Repair

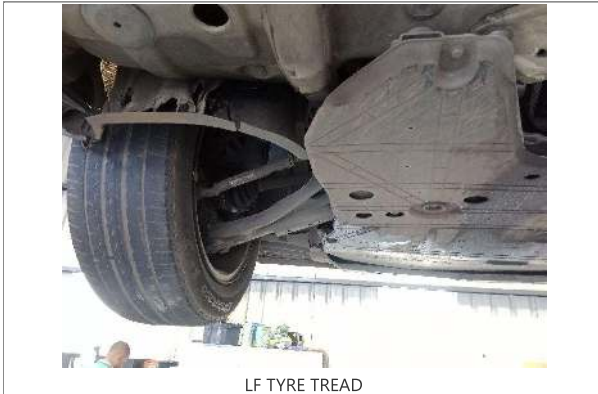
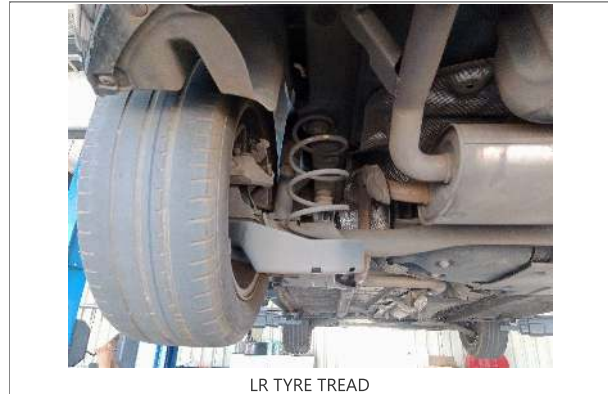
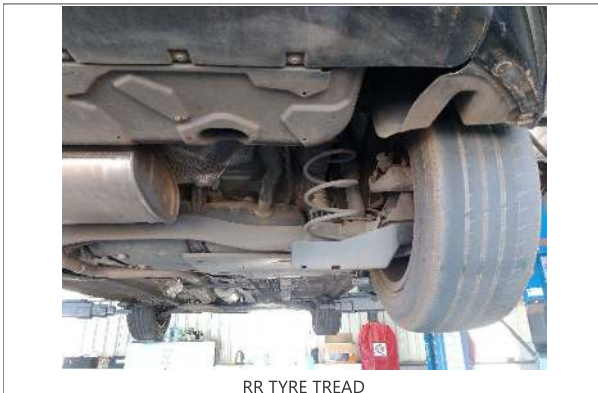
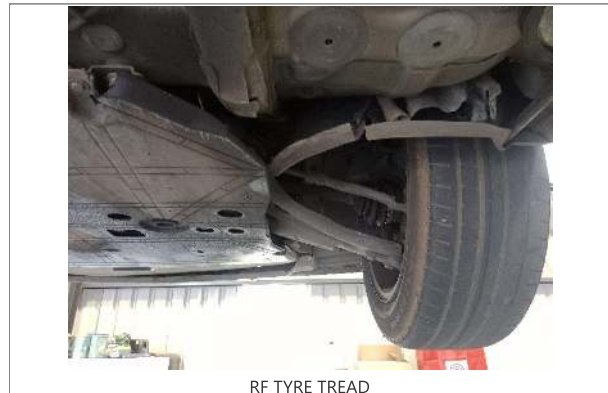
Size	Load/Speed Index	Manufacture	Model	Type*	Production Date	Tread Depth (mm)
Front Left	205/55 R16	91H	Pirelli	Cinturato	V	0218	1 mm
Front Right	205/55 R16	91H	Pirelli	Cinturato	V	0218	0 mm
Rear Left	205/55 R16	91V	Goodyear	Efficient	V	3415	0 mm
Rear Right	205/55 R16	94W	Triangle	Sportex	V	3920	0 mm
Spare	205/55 R16	91H	Pirelli	Cinturato	V	0218	1 mm

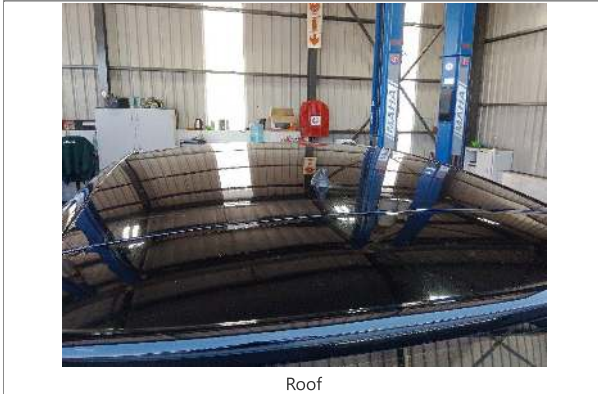
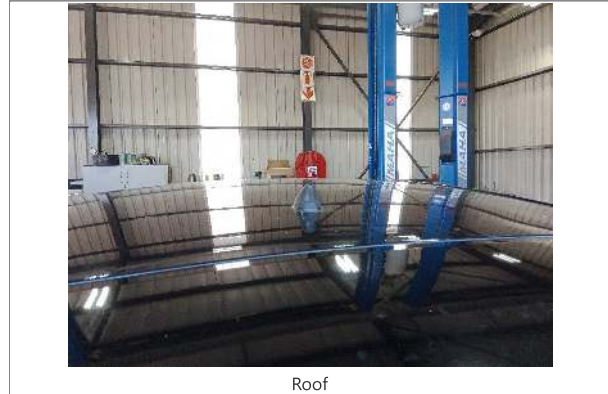
Rocker Panel Left Dented	Repair
Rocker Panel Right Paintwork • Scratched	Repair
Roof Paintwork • Scratched	Repair
Windscreen Chipped	Smart Repair
Tyre Front Right Worn	Replace
Tyre Rear Left Worn	Replace
