## CONDITION REPORT

Report No:  
2017303140  
DATE  
25/09/2026

| Manufacturer | OPEL | Registration Number | KPY814NW |
| Model | CROSSLAND 1.2 EDITION [2021-2022] | Register Number | |

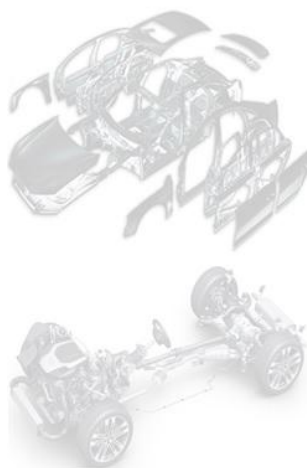
Engine Management Lights Set  
 Headlight Left Damaged  
 Front Bumper Damaged  
 Bonnet Damaged  
 Front Fender Left Damaged  
 Front Fender Right Damaged  
 Rear Fender Right Damaged  
 Door Front Left Damaged  
 Door Front Right Damaged  
 Door Rear Left Damaged  
 Door Rear Right Damaged  
 Spare Tyre Worn

Repair  
 Replace  
 Repair  
 Repair  
 Repair  
 Repair  
 Repair  
 Repair  
 Repair  
 Repair  
 Repair  
 Replace

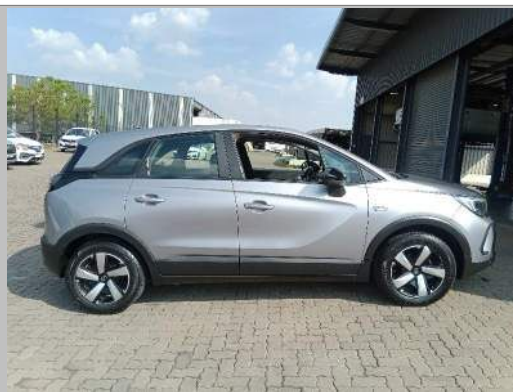
90 DEGREE RIGHT

Body • Exterior: Minor dents and scratches and stone chips to body panels. Signs of repair work done to body panels. Poor alignment to somebody panels.

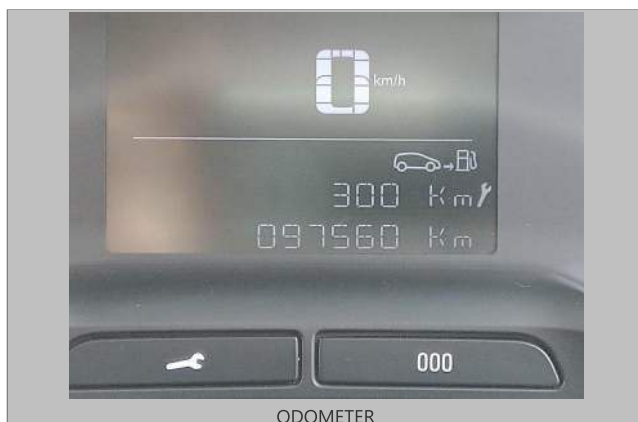
ODOMETER

| Km Reading | 97,560 KM | Fuel | PETROL |

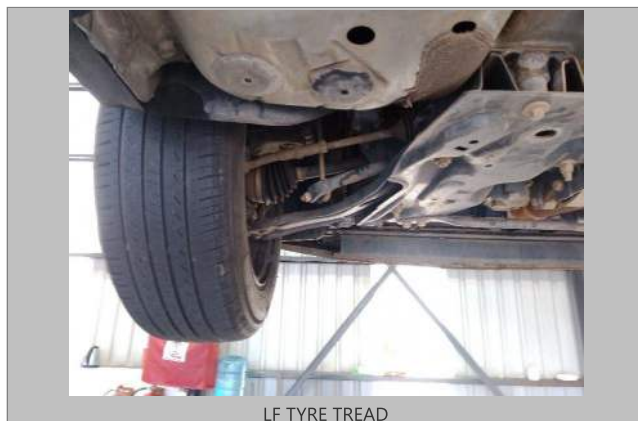
| | Size | Load/Speed Index | Manufacture | Model | Type* | Production Date | Tread Depth (mm) |
|---|---|---|---|---|---|---|---|
| Front Left | 205/60R16 | 92V | Hilo | Radial | V | 1624 | 2 mm |

LF TYRE TREAD

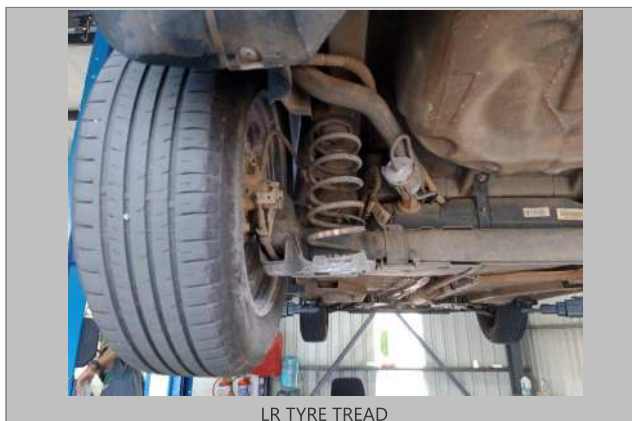
| | Size | Load/Speed Index | Manufacture | Model | Type* | Production Date | Tread Depth (mm) |
|---|---|---|---|---|---|---|---|
| Rear Left | 205/60R16 | 92V | Invovic | Radial | V | 3025 | 1 mm |

LR TYRE TREAD

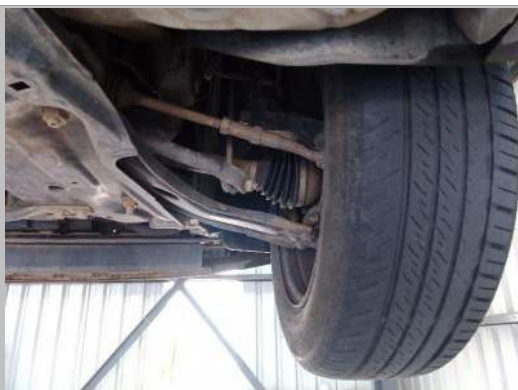
| | Size | Load/Speed Index | Manufacture | Model | Type* | Production Date | Tread Depth (mm) |
|---|---|---|---|---|---|---|---|
| Front Right | 205/60R16 | 92H | Autogrip | Radial | V | 3924 | 2 mm |

RF TYRE TREAD

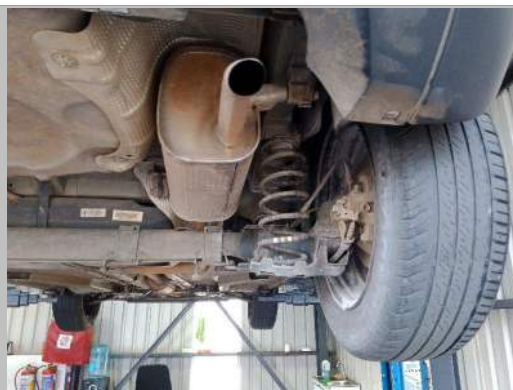
| | Size | Load/Speed Index | Manufacture | Model | Type* | Production Date | Tread Depth (mm) |
|---|---|---|---|---|---|---|---|
| Rear Right | 205/60R16 | 92H | Autogrip | Radial | V | 1224 | 2 mm |

RR TYRE TREAD

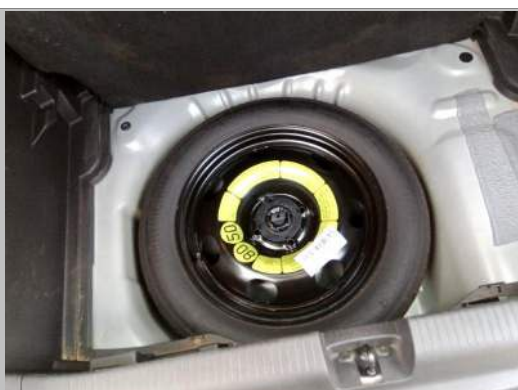
| | Size | Load/Speed Index | Manufacture | Model | Type* | Production Date | Tread Depth (mm) |
|---|---|---|---|---|---|---|---|
| Spare | T125/85R16 | 99M | Continental | Temporary | V | 3521 | 0 mm |

spare wheel.

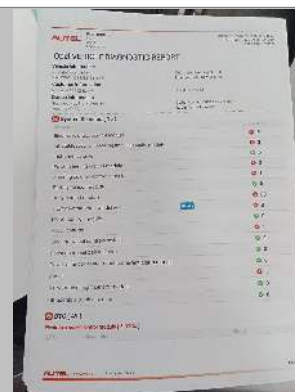
DIAGNOSTIC REPORT PAGE 1

| No | System | Code | Description | Status |
|---|---|---|---|---|
| 1 | ELECTRONIC BRAKE CONTROL MODULE | C1383:00 | BRIGHT FLUID LEVEL SENSOR CIRCUIT MALFUNCTION | |

General Comments: 49 DTC'S AT TIME OF TESTING SEE DTC REPORT. ACCORDING TO THE AGE AND MILEAGE OF THE VEHICLE, NORMAL WEAR AND TEAR MARKS ARE VISIBLE ON THE INTERIOR, EXTERIOR, ELECTRICAL AND MECHANICAL PARTS. Engine Compartment: micro cracks visible in timing belt.
