## CONDITION REPORT

Report No: 2016284790

DATE  
28/02/2024

Vehicle Type	PASSENGER VEHICLE	Registered Owner	MFC AUCTION HOUSE
Manufacturer	AUDI	Registration Number	CW45FNGP
Model	A4	Register Number	
VIN	WAUZZZ8K1EA056020	Date Of First Licensing	
Engine Number		Last COR	
Doors	4	License Expiry Date	30/11/2023
Color	WHITE	Power / Displacement	
Year Model		Paint Finish	C - COMMON
Km Reading	257,302 KM	Fuel	PETROL
Cab / Body Type	SEDAN	Transmission	AUTOMATIC

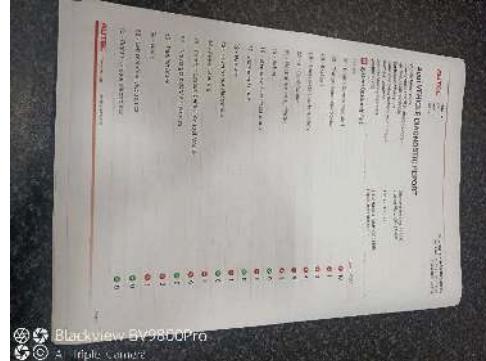
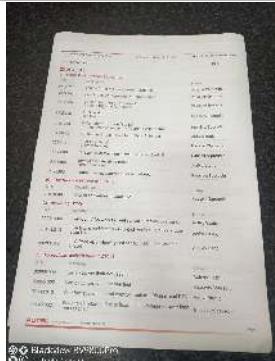
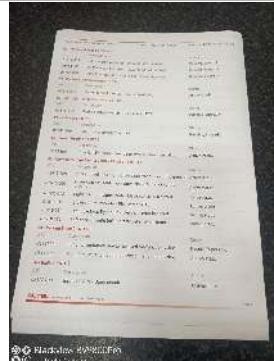
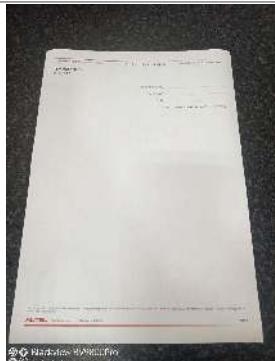
Diagnostic report

During the diagnostic no active error messages were detected. (See also attached Diagnostic Report. For more information regarding the Fault Codes (DTC) and the recommended rectifications please contact the workshops of the vehicle manufacture).

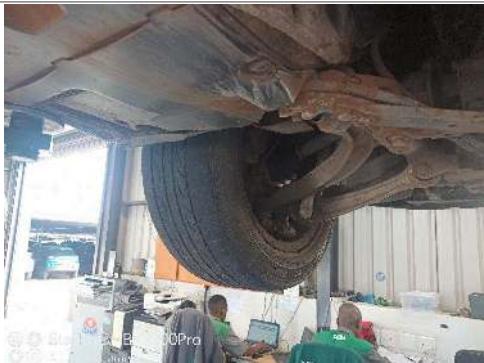
LF TYRE TREAD

Size	Load/Speed Index	Manufacture	Model	Type*	Production Date	Tread Depth (mm)
Front Left	225/55R16	95V	Dunlop	Sp sport	V	3321	2 mm
Front Right	225/55R16	95V	Dunlop	Sp sport	V	3321	3 mm
Rear Left	225/55R16	95V	Dunlop	Sp sport	V	3321	3 mm
Rear Right	225/55R16	95V	Dunlop	Sp sport	V	3421	3 mm

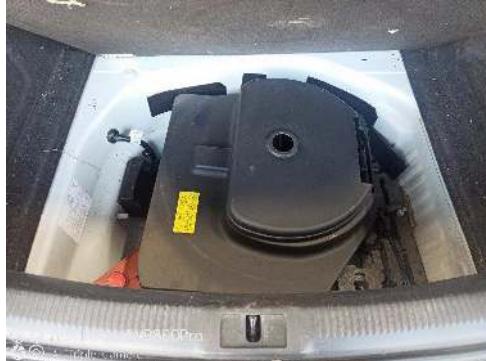
No spare wheel

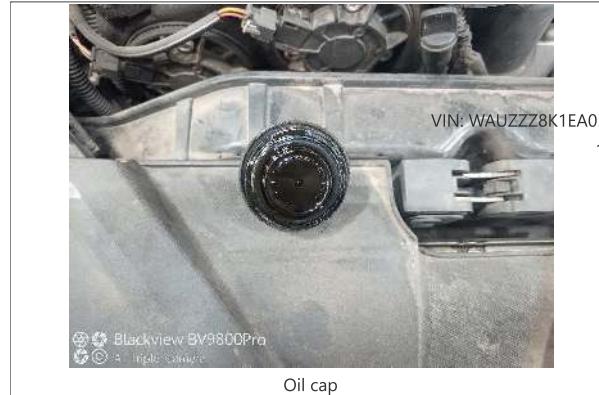
Oil cap

Damage	Repair Way
Engine Oil Leak	Repair
Expansion Bottle Water Leak	Replace
Water level Insufficient	Repair
Bonnet stay and shocks Defective	Replace
Center Console / Cubbyhole + Lid Damaged	Repair
Seat Front Right Cracked	Repair
Side Mirror Right Paintwork • Flaking	Repair
Front Bumper Paintwork • Scratched	Repair
Bonnet Paintwork • Chipmarks	Repair
Front Fender Left Paintwork • Scratched	Repair
Front Fender Right Paintwork • Scratched	Repair
Rear Fender Left Paintwork • Scratched	Repair
Door Front Left Residual Traces of Repair	Repair
Door Front Right Paintwork • Scratched	Repair
Door Rear Left Residual Traces of Repair	Repair
Door Rear Right Paintwork • Scratched	Repair
Rear bumper Paintwork • Scratched	Repair
Windscreen Cracked	Replace
Brake disc 1. Axle left Defective	Replace
Brake disc 1. Axle right Defective	Replace
Parking Brake Performance Left / Right Difference out of legal range	Repair
ABS and traction control light on	Repair
