CONDITION REPORT

Report No: 2016254577

MFC Auction House
M57 Pretoria Rd, Glenmarais, KEMPTON PARK
Gauteng

Vehicle Type	PASSENGER VEHICLE	Registered Owner	MFC AUCTION HOUSE
Manufacturer	AUDI	Registration Number	KN92CYGP
Model	A3 TFSI	Register Number	
VIN	WAUZZZ8V0KA126905	Date Of First Licensing	
Engine Number		Last COR	
Doors	5	License Expiry Date	30/04/2024
Color	WHITE	Power / Displacement	
Year Model		Paint Finish	TWO COAT METALLIC
Km Reading	64,378 KM	Fuel	PETROL
Cab / Body Type	HATCHBACK	Transmission	AUTOMATIC

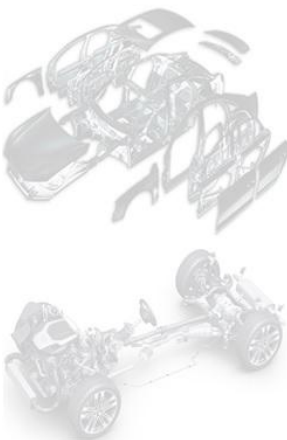
Damage	Repair Way
Front Bumper Damaged	Repair
Front Fender Left Damaged	Repair
Door Front Right Damaged	Repair
Door Rear Right Damaged	Repair
Rear bumper Damaged	Repair
Tyre Rear Left Worn	Replace
Steering Malfunction	Repair

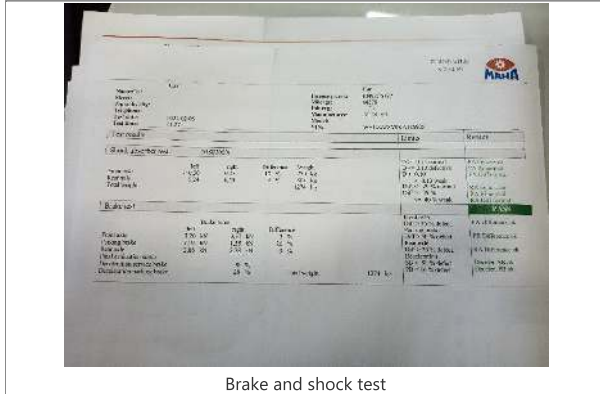
Brake and shock test

Left	Right	Axle Weight [KG]	Deceleration [m/s ²]
	Braking Force [KN]	Braking Force [KN]		
Front	3.26	3.37	-	
Rear	2.86	2.78	-	
Emergency / Parking	1.92	1.52	-

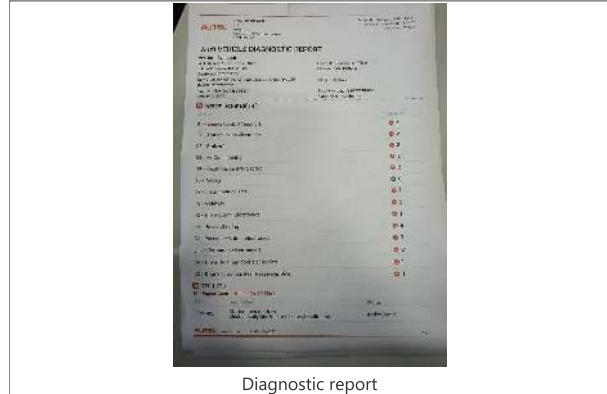
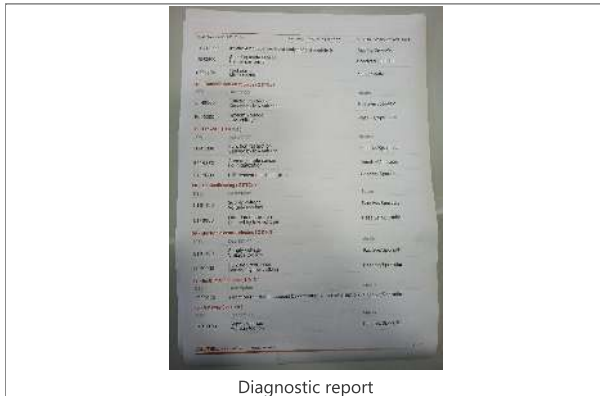
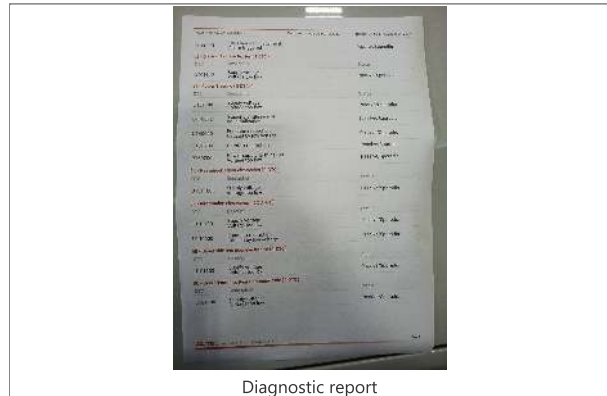
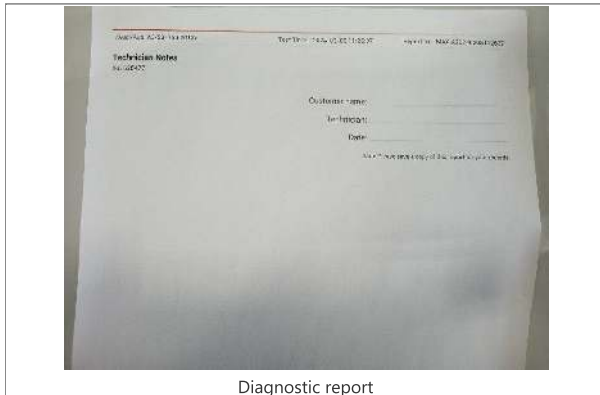
Diagnostic report

During the diagnostic no active error messages were detected. (See also attached Diagnostic Report. For more information regarding the Fault Codes (DTC) and the recommended rectifications please contact the workshops of the vehicle manufacture).

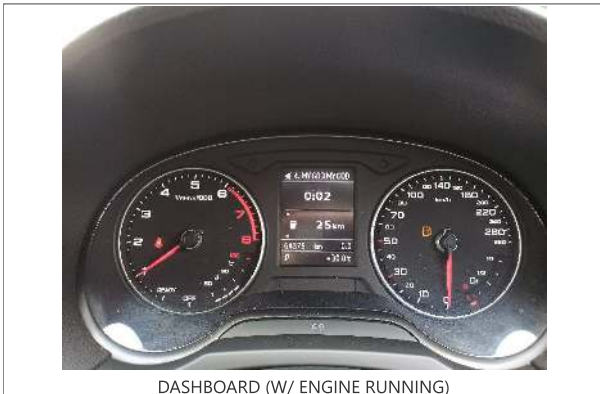
DASHBOARD (W/ ENGINE RUNNING)

General Comments: STEERING LIGHT ON CLUSTER INTERMITTED. Body • Exterior: Minor dents and scratches and stone chips to some body panels. Signs of repair work done to some body panels.

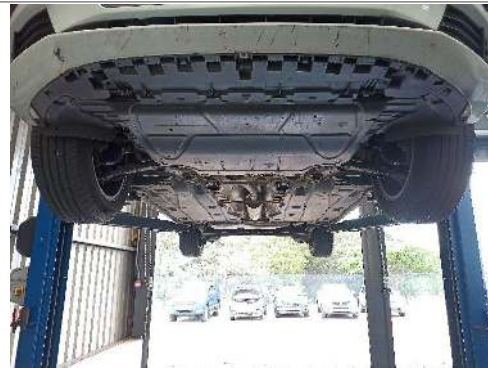
CHASSI

Undercarriage: Bottom of engine and gearbox fully covered.

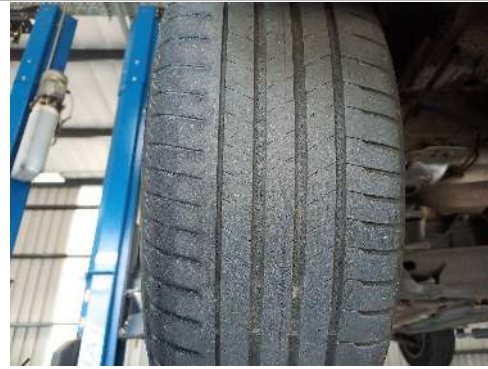
Tyre Rear Left

Size	Load/Speed Index	Manufacture	Model	Type*	Production Date	Tread Depth (mm)
Front Left	205/60R16	92V	Autogrip	Radial	V	0421	3 mm
Front Right	205/60R16	92V	Autogrip	Radial	V	0421	3 mm
Rear Left	205/55R16	91W	Bridgestone	Radial	V	2119	0 mm
Rear Right	205/55R16	91W	Bridgestone	Radial	V	2619	2 mm
