## CONDITION REPORT

Report No:  
2016993250  
DATE  
27/08/2025

| Manufacturer | AUDI | Registration Number | JR25BKGP |
| Model | S3 2.0T FSI QUATTRO 3-DR S TRONIC [2014-2017] | Register Number | |

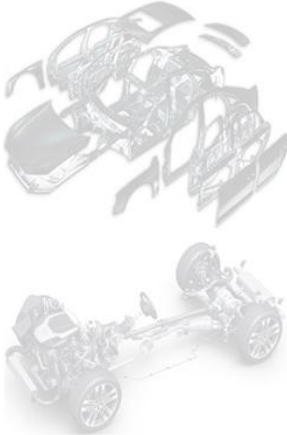
| | Damage | Repair Way |
|---|---|---|
| | Engine Oil Leak<br>Dim Light Right Malfunction<br>Front Bumper Paintwork • Scratched<br>Bonnet Paintwork • Chipmarks<br>Front Fender Left Paintwork • Flaking<br>Front Fender Right Paintwork • Flaking<br>Rear Fender Left Paintwork • Flaking<br>Rear Fender Right Paintwork • Flaking<br>Door Front Left Paintwork • Scratched<br>Door Front Right Paintwork • Scratched<br>Rear bumper Paintwork • Scratched<br>Sill Panel Right Defective<br>Tyre Front Left Defective<br>Tyre Rear Right Damaged<br>Brakes | Repair<br>Repair<br>Repair<br>Repair<br>Repair<br>Repair<br>Repair<br>Repair<br>Repair<br>Repair<br>Repair<br>Repair<br>Replace<br>Replace<br>No brake test done vehicle is 4wd |

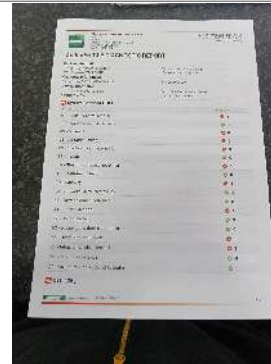
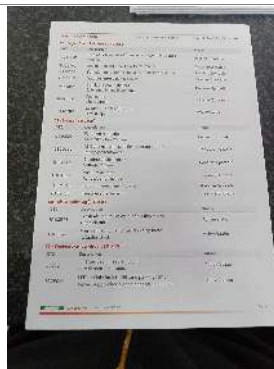
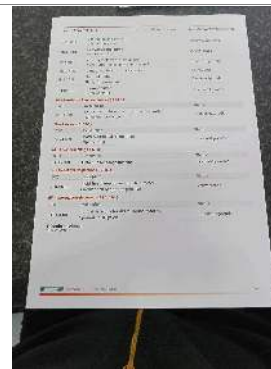
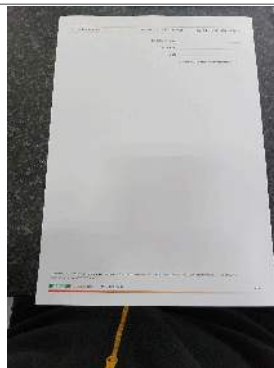
| No | System | Code | Description | Status |
|---|---|---|---|---|
| 1 | PASSIVE/SPORADIC | B13C401 | SUNROOF BUTTON ELECTRICAL FAULT | |

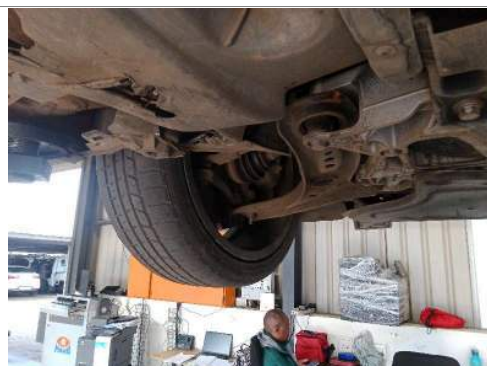
LF TYRE TREAD

| | Size | Load/Speed Index | Manufacture | Model | Type* | Production Date | Tread Depth (mm) |
|---|---|---|---|---|---|---|---|
| Front Left | 225/40R18 | 92W | Sun wide | Rs-one | V | 4520 | 3 mm |

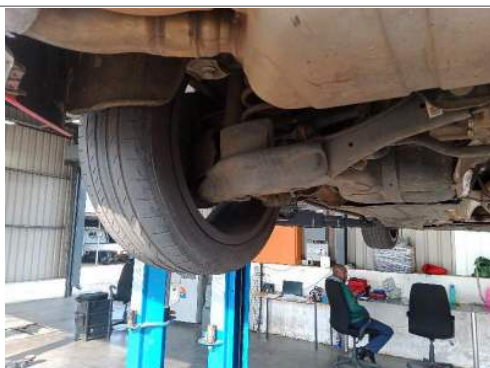
LR TYRE TREAD

| | Size | Load/Speed Index | Manufacture | Model | Type* | Production Date | Tread Depth (mm) |
|---|---|---|---|---|---|---|---|
| Rear Left | 225/45R18 | 91Y | Continental | Contact | V | 3016 | 3 mm |

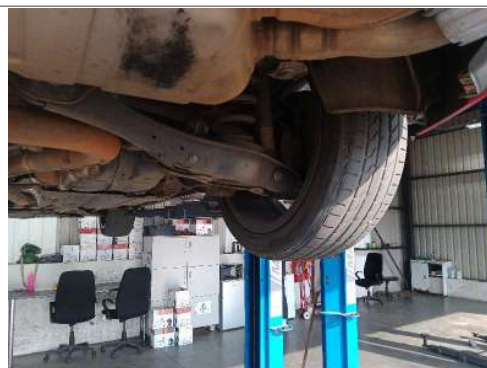
RR TYRE TREAD

| | Size | Load/Speed Index | Manufacture | Model | Type* | Production Date | Tread Depth (mm) |
|---|---|---|---|---|---|---|---|
| Rear Right | 225/45R18 | 91Y | Continental | Contact | V | 4119 | 2 mm |

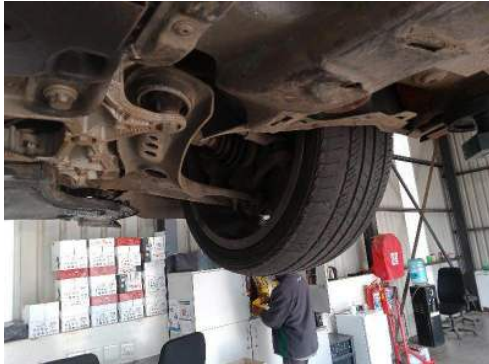
RF TYRE TREAD

| | Size | Load/Speed Index | Manufacture | Model | Type* | Production Date | Tread Depth (mm) |
|---|---|---|---|---|---|---|---|
| Front Right | 225/40R18 | 92W | Good ride | Sa-07 | V | 4918 | 3 mm |

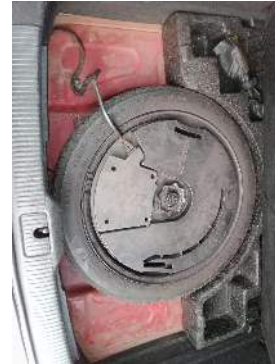
Spare wheel

| | Size | Load/Speed Index | Manufacture | Model | Type* | Production Date | Tread Depth (mm) |
|---|---|---|---|---|---|---|---|
| Spare | T125/70R18 | 99M | Continental | Contact | V | 00000 | 4 mm |
