## CONDITION REPORT

Report No:  
2017299426  
DATE  
16/09/2026

| Manufacturer | AUDI | Registration Number | BY10BBZN |
| VIN | WAUZZZF38R1157136 | Date Of First Licensing | |

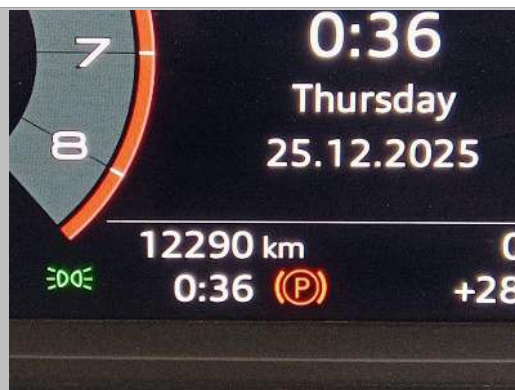
ODOMETER

| Km Reading | 12,290 KM | Fuel | PETROL |

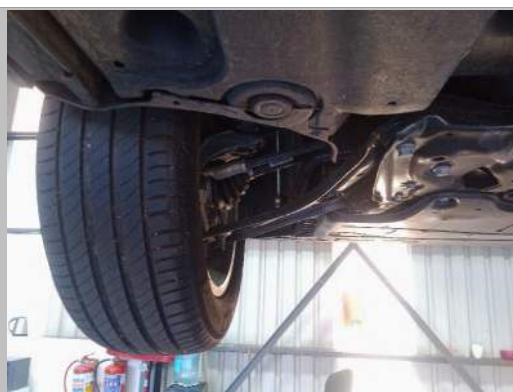
LF TYRE TREAD

| | Size | Load/Speed Index | Manufacture | Model | Type* | Production Date | Tread Depth (mm) |
|---|---|---|---|---|---|---|---|
| Front Left | 235/55R18 | 100V | Michelin | Radial | V | 1524 | 3 mm |

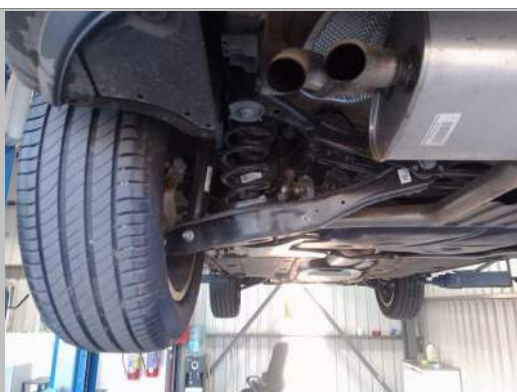
LR TYRE TREAD

| | Size | Load/Speed Index | Manufacture | Model | Type* | Production Date | Tread Depth (mm) |
|---|---|---|---|---|---|---|---|
| Rear Left | 235/55R18 | 100V | Michelin | Radial | V | 1524 | 3 mm |

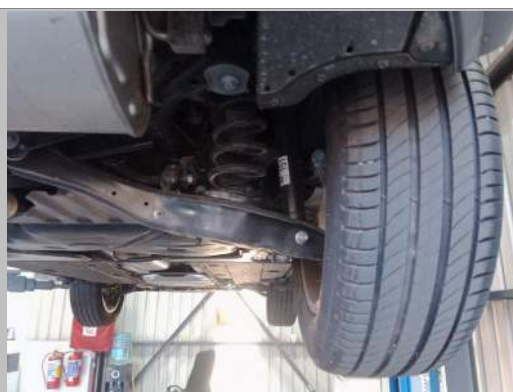
RR TYRE TREAD

| | Size | Load/Speed Index | Manufacture | Model | Type* | Production Date | Tread Depth (mm) |
|---|---|---|---|---|---|---|---|
| Rear Right | 235/55R18 | 100V | Michelin | Radial | V | 1524 | 3 mm |

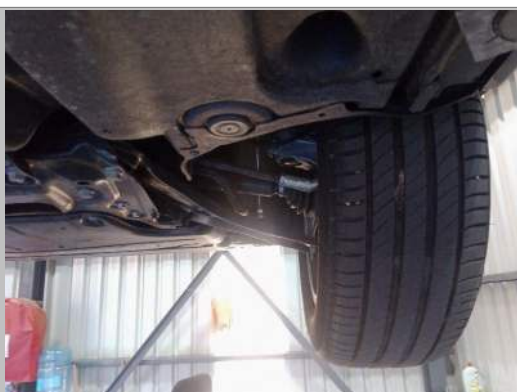
RF TYRE TREAD

| | Size | Load/Speed Index | Manufacture | Model | Type* | Production Date | Tread Depth (mm) |
|---|---|---|---|---|---|---|---|
| Front Right | 235/55R18 | 100V | Michelin | Radial | V | 1524 | 3 mm |
