CONDITION REPORT

Report No: 2016285396

DATE
28/02/2024

Vehicle Type	PASSENGER VEHICLE	Registered Owner	MFC AUCTION HOUSE
Manufacturer	BMW	Registration Number	JW01KDGP
Model	320I	Register Number	
VIN	WBA3B16030NP58161	Date Of First Licensing	
Engine Number		Last COR	
Doors	4	License Expiry Date	31/08/2023
Color	BLUE	Power / Displacement	
Year Model		Paint Finish	M - METALLIC
Km Reading	207,712 KM	Fuel	PETROL
Cab / Body Type	SEDAN	Transmission	AUTOMATIC

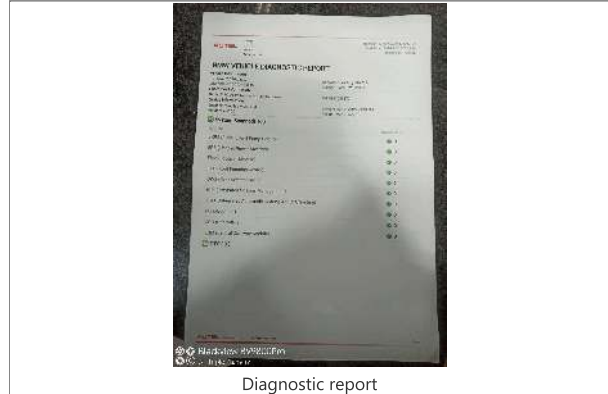
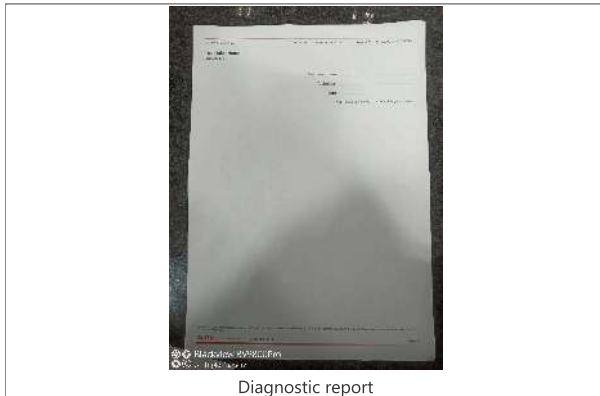
Diagnostic report

During the diagnostic no active error messages were detected. (See also attached Diagnostic Report. For more information regarding the Fault Codes (DTC) and the recommended rectifications please contact the workshops of the vehicle manufacture).

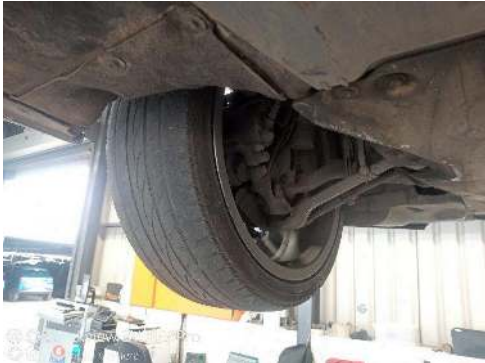
LF TYRE TREAD

Size	Load/Speed Index	Manufacture	Model	Type*	Production Date	Tread Depth (mm)
Front Left	235/35R19	91W	Windforce	Catchpower	V	1118	1 mm
Front Right	235/35R19	91W	Windforce	Catchpower	V	1118	0 mm
Rear Left	235/35R19	91W	Royal black	Royal perfor	V	2321	3 mm
Rear Right	255/35R19	96Y	Continental	Contact	V	4519	3 mm

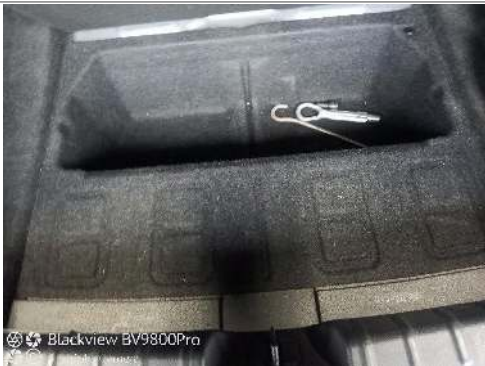
No spare wheel

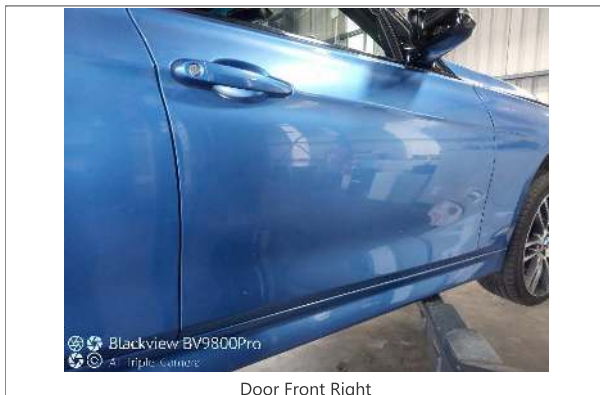
Damage	Repair Way
Seat Front Right Torn / Cut	Repair
Door Panel Front Right Damaged	Repair
Front Bumper Paintwork • Scratched	Repair
Grill Damaged	Replace
Front Fender Right Paintwork • Scratched	Repair
Rear Fender Right Paintwork • Scratched	Repair
Door Front Right Paintwork • Scratched	Repair
Door Rear Left Paintwork • Scratched	Repair
Door Rear Right Paintwork • Scratched	Repair
Rear bumper Paintwork • Scratched	Repair
Windscreen Chipped	Repair
Parking Brake Performance Left / Right Difference out of legal range	Repair
Tyre Front Right Smooth	Replace
Bolt(s) / Nut(s) Front Wheel Left Missing	Replace
Bolt(s) / Nut(s) Front Wheel Right Missing	Replace
Engine Performance Insufficient	Repair
Engine Noise Idling / Hunting	Repair
Parking brake light on	Repair
