## CONDITION REPORT

Report No:  
2017303921  
DATE  
28/09/2026

| Manufacturer | BMW | Registration Number | KJZ464MP |
| Model | 320I | Register Number | |

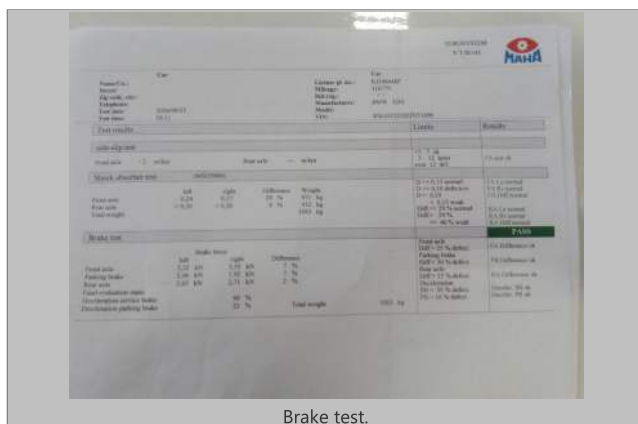
Brake test.

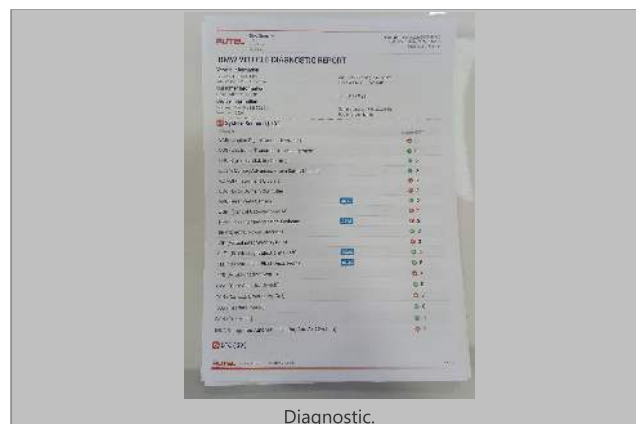
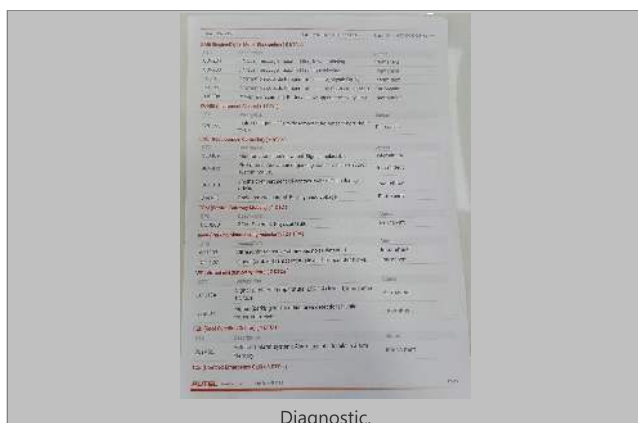
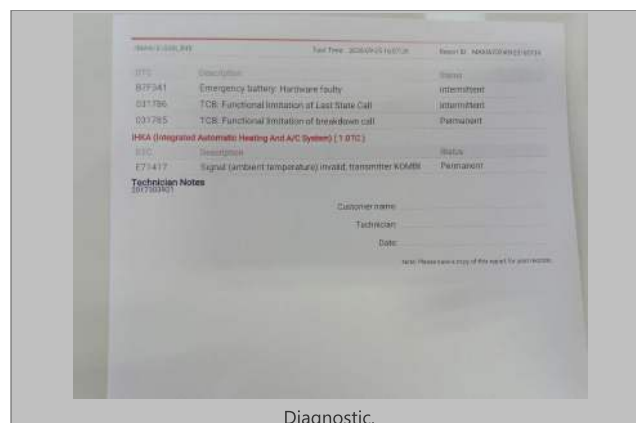
| No | System | Code | Description | Status |
|---|---|---|---|---|
| 1 | DME | CD9204 | LIN BUS, MESSAGE; RADIATOR BLIND, LOWER: MISSING | |

Diagnostic.

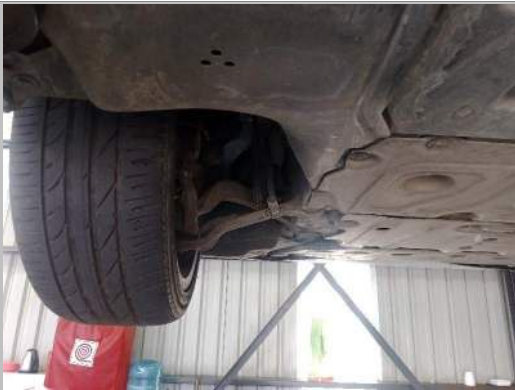
LF TYRE TREAD

| | Size | Load/Speed Index | Manufacture | Model | Type* | Production Date | Tread Depth (mm) |
|---|---|---|---|---|---|---|---|
| Front Left | 225/40R18 | 92W | Sailun | Radial | V | 3620 | 0 mm |

| Tyre Front Left Worn | Replace |

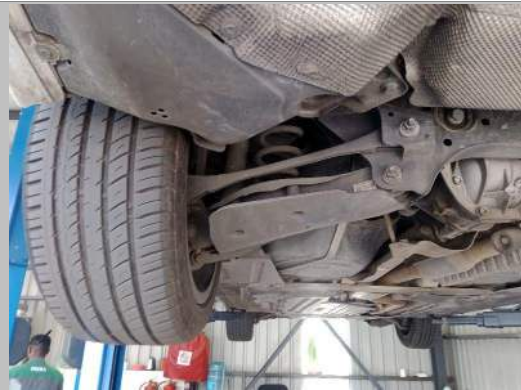
LR TYRE TREAD

| | Size | Load/Speed Index | Manufacture | Model | Type* | Production Date | Tread Depth (mm) |
|---|---|---|---|---|---|---|---|
| Rear Left | 255/40R18 | 99Y | Radar | radial | V | 4824 | 3 mm |

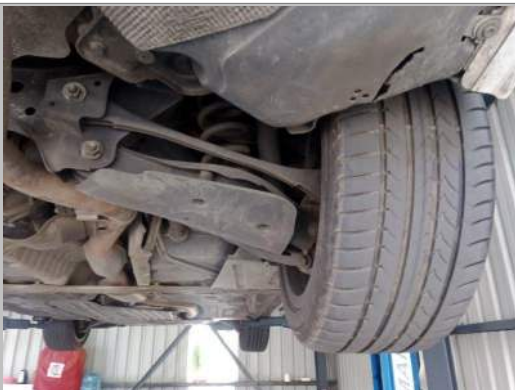
RR TYRE TREAD

| | Size | Load/Speed Index | Manufacture | Model | Type* | Production Date | Tread Depth (mm) |
|---|---|---|---|---|---|---|---|
| Rear Right | 255/40R18 | 95W | Goodyear | Efficient | V | 1120 | 2 mm |

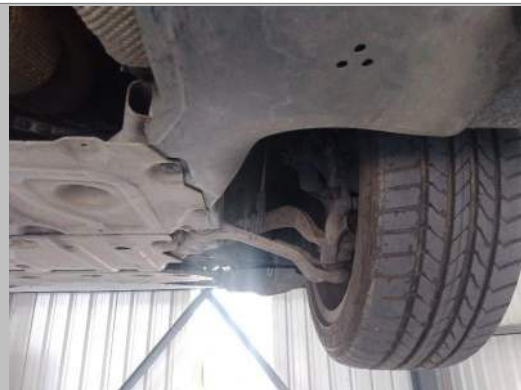
RF TYRE TREAD

| | Size | Load/Speed Index | Manufacture | Model | Type* | Production Date | Tread Depth (mm) |
|---|---|---|---|---|---|---|---|
| Front Right | 225/45R18 | 91Y | Goodyear | Radial | V | 0122 | 2 mm |

| Front tyres size differs | Replace |
