## CONDITION REPORT

Report No: 2016733166

MFC Auction House  
M57 Pretoria Rd, Glenmarais, KEMPTON PARK  
Gauteng

| Model | 730D DSL SPORT STEPTRONIC [2016-2019] | Register Number | |

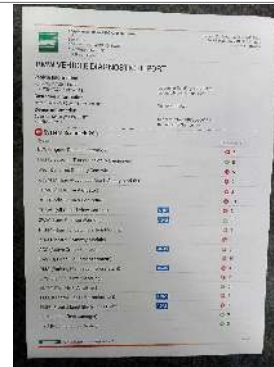
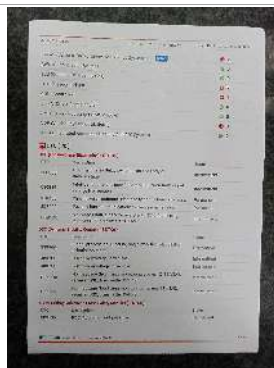
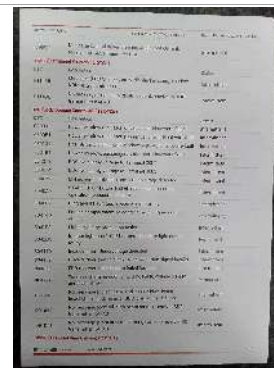
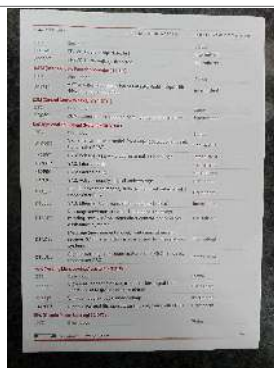
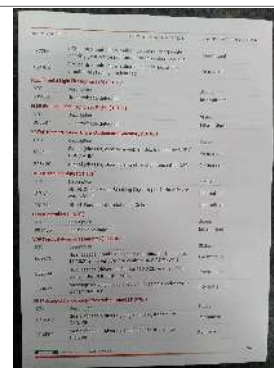
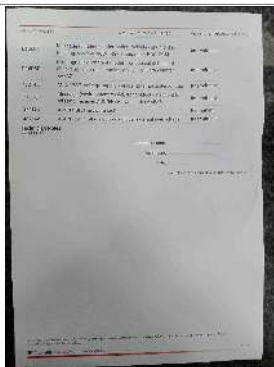
Diagnostic test

During the diagnostic the following error messages were detected: (See also attached Diagnostic Report. For more information regarding the Fault Codes (DTC) and the recommended rectifications please contact the workshops of the vehicle manufacture).

| No | System | Code | Description | Status |
|---|---|---|---|---|
| 1 | ELECTRIC POWER STEERING | 4822E5 | EPS CONTROL UNIT INITIALISATION FAULT OF STEERING | |
| 2 | ENGINE DIESEL ELECTRONICS | 300C00 | DDE MAIN RELAY SWITCHES OFF TOO EARLY OR UNDER VOL | |

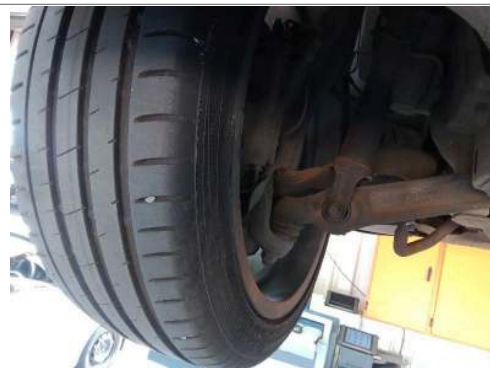
LF TYRE TREAD

| | Size | Load/Speed Index | Manufacture | Model | Type* | Production Date | Tread Depth (mm) |
|---|---|---|---|---|---|---|---|
| Front Left | 245/40R20 | 99Y | Apollo | Aspire | V | 3922 | 6 mm |

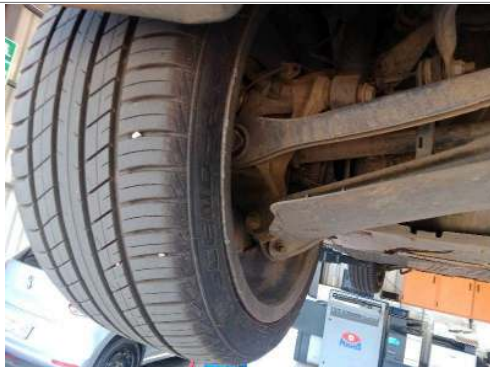
LR TYRE TREAD

| | Size | Load/Speed Index | Manufacture | Model | Type* | Production Date | Tread Depth (mm) |
|---|---|---|---|---|---|---|---|
| Rear Left | 275/35R20 | 102W | Blackhawk | Hiscend | V | 2722 | 6 mm |

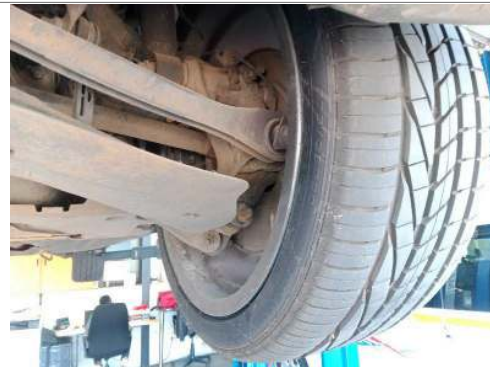
RR TYRE TREAD

| | Size | Load/Speed Index | Manufacture | Model | Type* | Production Date | Tread Depth (mm) |
|---|---|---|---|---|---|---|---|
| Rear Right | 275/35R20 | 102Y | Goodyear | Excellence | V | 4119 | 7 mm |

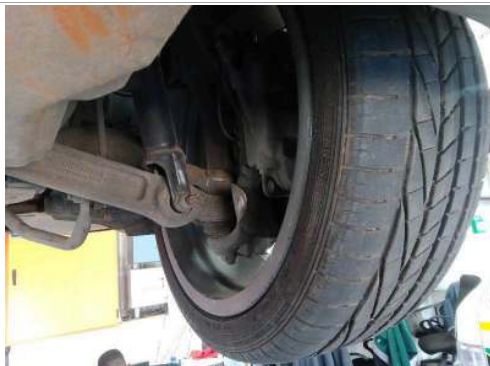
RF TYRE TREAD

| | Size | Load/Speed Index | Manufacture | Model | Type* | Production Date | Tread Depth (mm) |
|---|---|---|---|---|---|---|---|
| Front Right | 245/40R20 | 99Y | Goodyear | Excellence | V | 4119 | 3 mm |

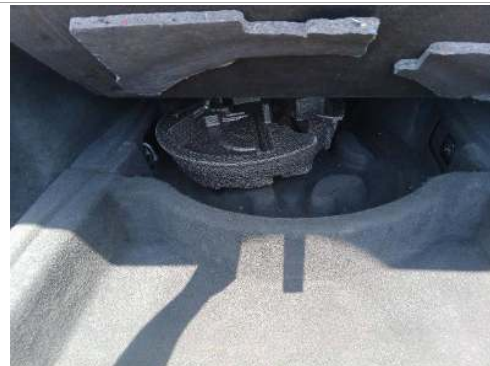
No sparewheel

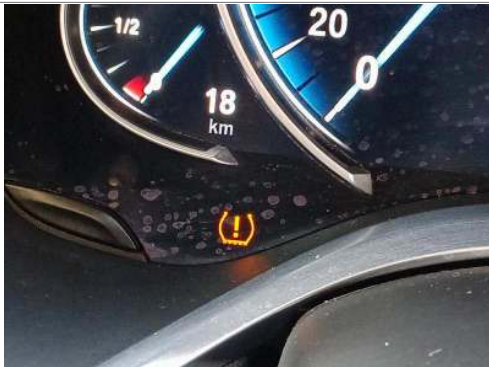
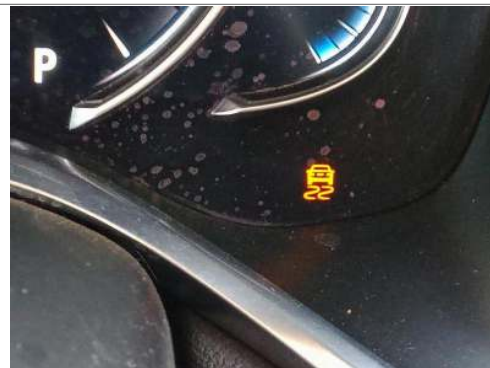
| Damage | Repair Way |
|---|---|
| Warning lights illuminated | Repair |

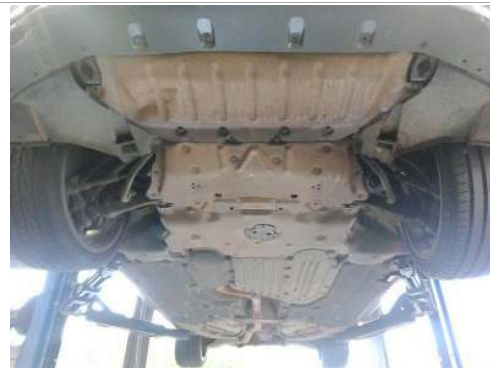
CHASSIS

General Comments: ACCORDING TO THE AGE AND MILEAGE OF THE VEHICLE, NORMAL WEAR AND TEAR MARKS ARE VISIBLE ON THE INTERIOR, EXTERIOR, ELECTRICAL AND MECHANICAL PARTS. Engine Compartment: Bottom of engine is fully covered.  
Body • Exterior: Minor dents scratches stone chips on some body panels. Signs of spray work done on some body panels  
Undercarriage: Undercarriage is fully covered.

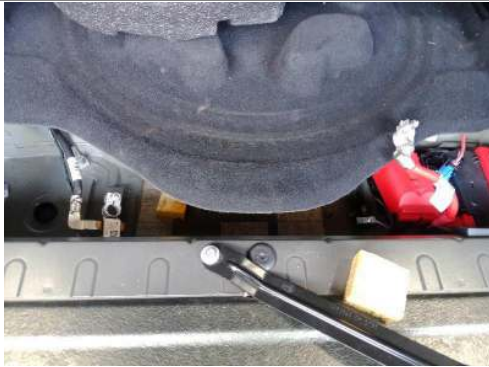
| Damage | Repair Way |
|---|---|
| Vehicle has no battery | Replace. |

No battery

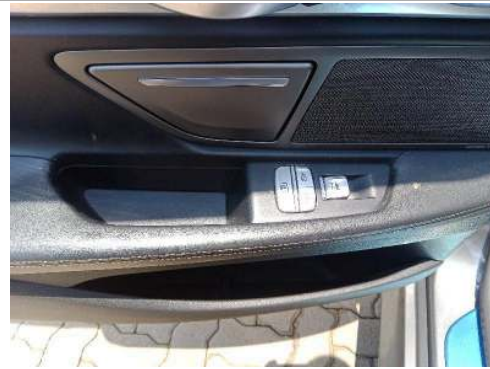
| Damage | Repair Way |
|---|---|
| Switch Electrical Window Winder rear left Defective | Repair |

Switch Electrical Window Winder rear left

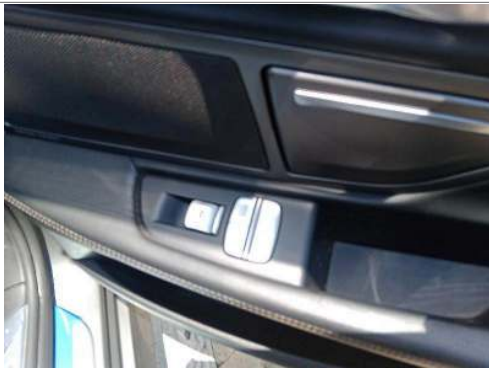
| Damage | Repair Way |
|---|---|
| Switch Electrical Window Winder rear right Defective | Repair |

Switch Electrical Window Winder rear right

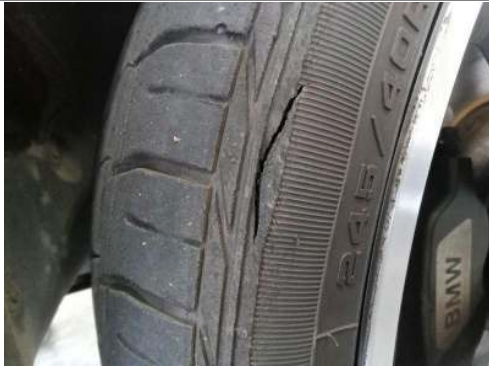
| Damage | Repair Way |
|---|---|
| Tyre Front Right Torn / Cut | Replace |

Tyre Front Right

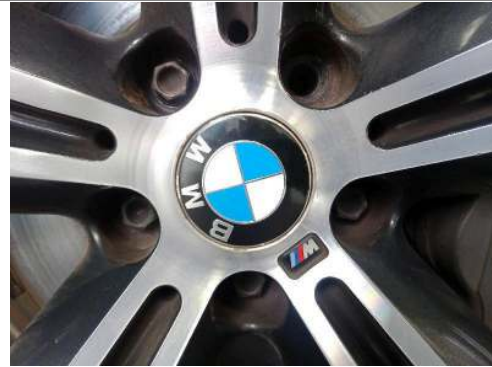
| Damage | Repair Way |
|---|---|
| Bolt(s) / Nut(s) Front Wheel Left Missing | Replace |

Bolt(s) / Nut(s) Front Wheel Left

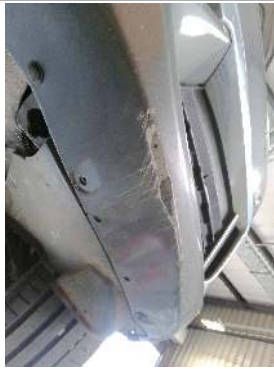
| Damage | Repair Way |
|---|---|
| Front Bumper Paintwork • Scratched | Repair |

Front Bumper

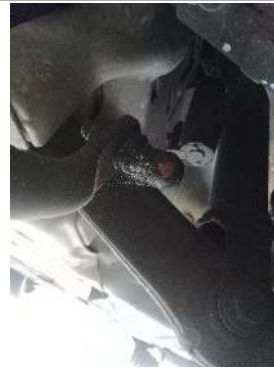
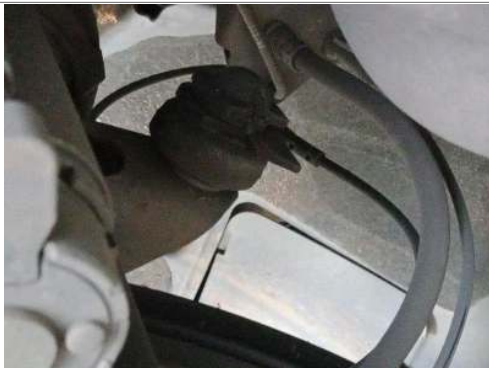
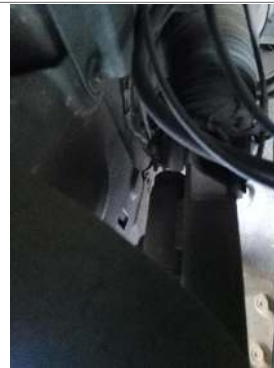
| Damage | Repair Way |
|---|---|
| Stabilizer Mounting Front Left Missing | Replace |

Stabilizer Mounting Front Left
