CONDITION REPORT

Report No:
2016977551
DATE
13/08/2025

Vehicle Type	PASSENGER VEHICLE	Registered Owner	
Manufacturer	BMW	Registration Number	MG40VJGP
Model	M3 COMPETITION AWD STEPTRONIC [2021-2025]	Register Number	
VIN	WBS42AY060FP17613	Date Of First Licensing	
Engine Number		Last COR	
Doors	4	License Expiry Date	28/02/2026
Color	BLACK	Power / Displacement	
Year Model	2023	Paint Finish	M - METALLIC
Km Reading	33,143 KM	Fuel	PETROL
Cab / Body Type	SEDAN	Transmission	AUTOMATIC

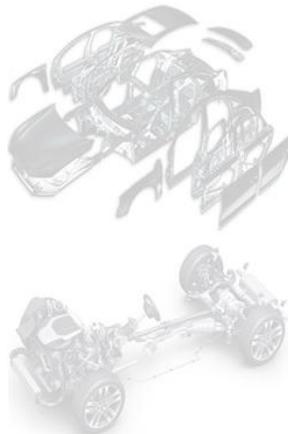
Damage	Repair Way
Side Mirror Left Paintwork • Blisters	Repair
Side Mirror Right Paintwork • Blisters	Repair
Front Bumper Damaged	Repair
Bonnet Paintwork • Scratched	Repair
Front Fender Left Paintwork • Scratched	Repair
Front Fender Right Paintwork • Scratched	Repair
Rear Fender Right Paintwork • Scratched	Repair
Door Front Left Paintwork • Scratched	Repair
Door Front Right Paintwork • Scratched	Repair
Door Rear Left Paintwork • Scratched	Repair
Door Rear Right Paintwork • Scratched	Repair
Rear bumper Paintwork • Scratched	Repair
Windscreen Chipped	Repair
Tyre Front Left Smooth	Replace
Tyre Rear Left Smooth	Replace
Tyre Rear Right Smooth	Replace
Brakes	No brake test done vehicle is 4wd
Body exterior	Vehicle got clear wrap on some body panels
Front and rear tires deferred sizes	Repair

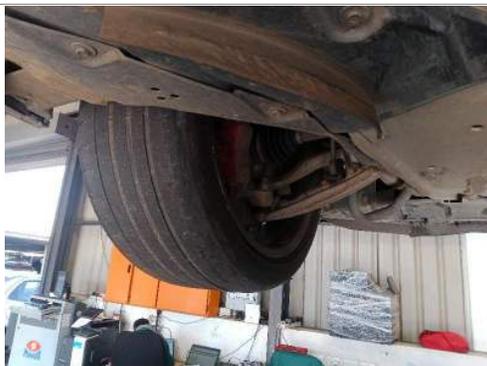
LF TYRE TREAD

Size	Load/Speed Index	Manufacture	Model	Type*	Production Date	Tread Depth (mm)
Front Left	275/35R19	100Y	Pirelli	Pzero	V	0122	0 mm
Front Right	275/35R19	100Y	Pirelli	Pzero	V	4722	1 mm
Rear Left	285/30R20	99Y	Pirelli	Pzero	V	4722	0 mm
Rear Right	285/30R20	99Y	Pirelli	Pzero	V	4722	0 mm

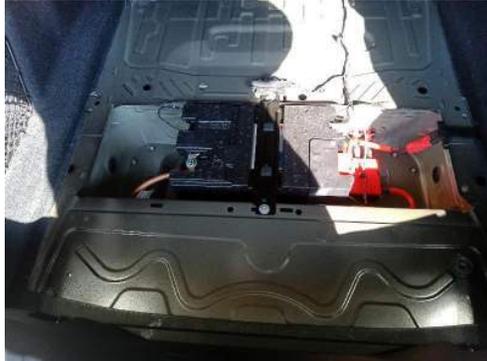
No spare wheel
