CONDITION REPORT

Report No: 2016357219

MFC Auction House
M57 Pretoria Rd, Glenmarais, KEMPTON PARK
Gauteng

Vehicle Type	PASSENGER VEHICLE	Registered Owner	MFC AUCTION HOUSE
Manufacturer	FORD	Registration Number	FML864L
Model	FOCUS	Register Number	
VIN	WF05XXGCC5GT66367	Date Of First Licensing	
Engine Number		Last COR	
Doors	5	License Expiry Date	31/12/2023
Color	WHITE	Power / Displacement	
Year Model		Paint Finish	TWO COAT UNI
Km Reading	154,449 KM	Fuel	PETROL
Cab / Body Type	HATCHBACK	Transmission	MANUAL

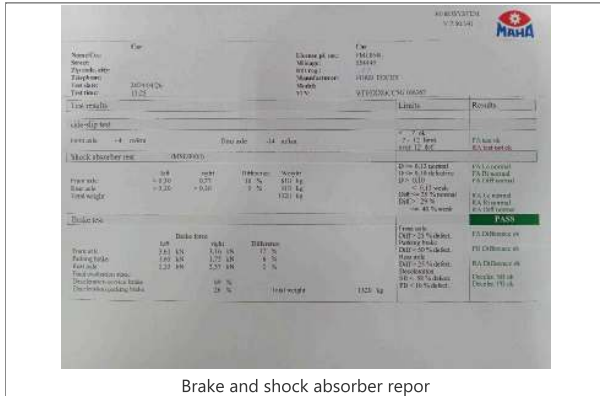
Brake and shock absorber repor

Left	Right	Axle Weight [KG]	Deceleration [m/s ²]
	Braking Force [KN]	Braking Force [KN]		
Front	3.61	3.16	-	
Rear	2.33	2.37	-	
Emergency / Parking	1.65	1.75	-

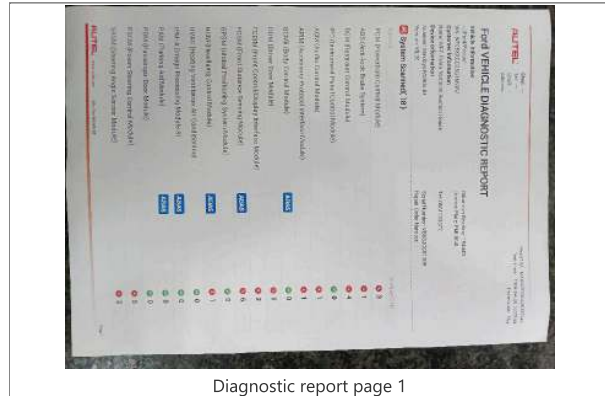
Diagnostic report page 1

No	System	Code	Description	Status
1	PCM(POWERTRAIN CONTROL MODULE)	P0299:0-68	TURBOCHARGER/SUPERCHARGER A UNDER BOOST CONDITION

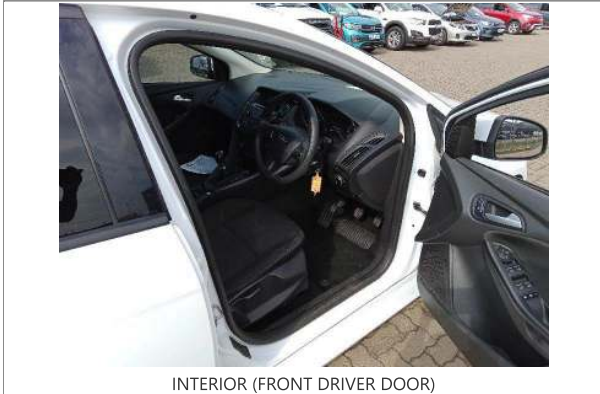
INTERIOR (FRONT DRIVER DOOR)

Damage	Repair Way
Engine	Front exhaust heat shield loose
Electrical instruments and components	Boot release switch damaged
Undercarriage	Vehicle undercarriage dirty
Interior	Vehicle interior dirty and some panels scratched
Body and Exterior	Dents and scratches on some body panels
Body and Exterior	Stone chips and spray work on some body panels

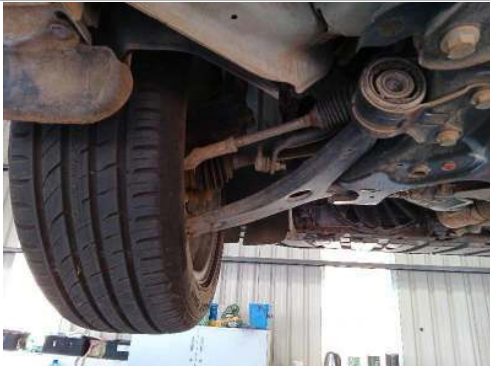
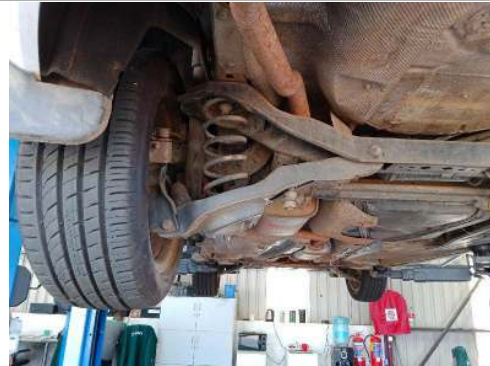
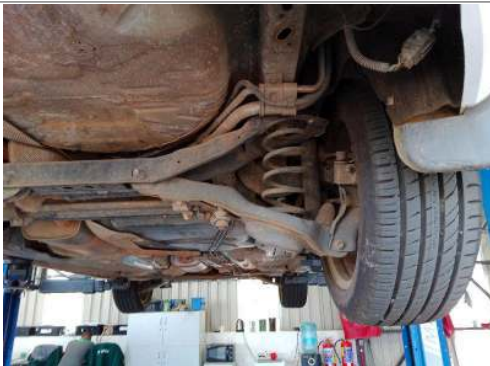
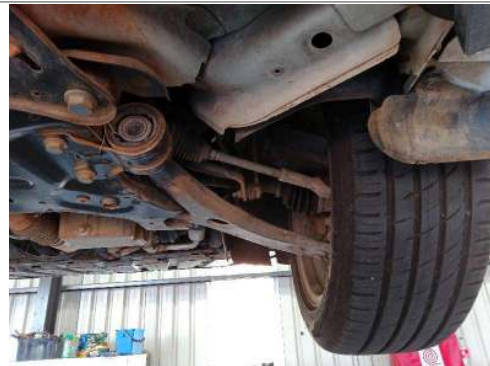
LF TYRE TREAD

Size	Load/Speed Index	Manufacture	Model	Type*	Production Date	Tread Depth (mm)
Front Left	215/50 R17	95Y	General	Altimax	V	3621	6 mm
Front Right	215/50 R17	95Y	General	Altimax	V	3721	5 mm
Rear Left	215/50 R17	95Y	General	Altimax	V	4321	5 mm
Rear Right	215/50 R17	95Y	General	Altimax	V	3621	6 mm
Spare	T125/90 R16	98M	Hankook	Temporary	V	2616	3 mm

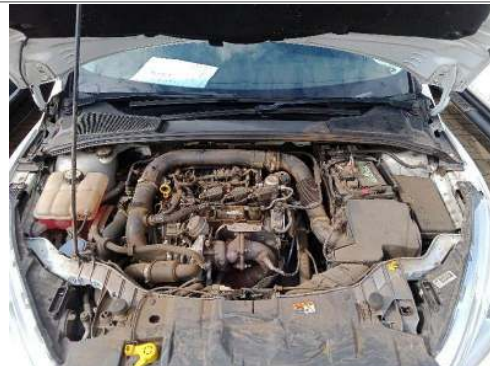
ENGINE 1

Triangle Missing	Replace
Engine	Engine bay dirty

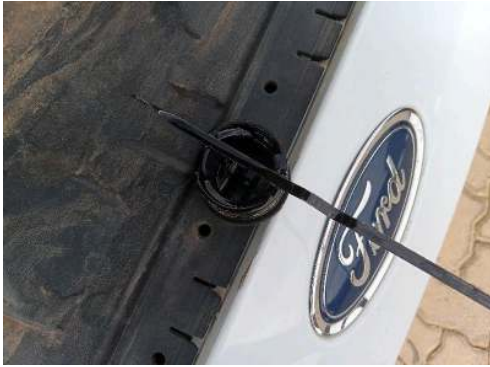
Oil cap and dipstick

Damage	Repair Way
Engine Oil Sweat	Repair
Battery box Defective	Repair
Headlight Left Defective	Repair
Headlight Right Defective	Repair
Seat Front Left Dirty	Repair
Seat Front Right Damaged	Repair
Seat Rear Dirty	Repair
Steering Wheel Trim Worn	Repair
Front Bumper Paintwork • Scratched	Repair
Front Fender Left Residual Traces of Repair	Repair
Door Front Right Paintwork • Scratched	Repair
Door Rear Left Paintwork • Chipmarks	Repair
Door Rear Right Paintwork • Scratched	Replace
Rear bumper Paintwork • Scratched	Repair
Windscreen Chipped	Repair
Rim Front Left Dented	Repair
Rim Front Right Scratched	Repair
Rim Rear Left Scratched	Repair
Rim Rear Right Scratched	Repair
Sub Frame Scratched	Repair
Engine mountings Defective	Repair
Belly plates Damaged	Replace
Gearbox Mountings Broken	Replace
Gearbox Oil Sweat	Repair
CV Joint(s) Boot(s) Front Left (inner/outer) Defective	Replace
Jack Missing	Replace
Wheel Spanner Missing	Replace
