## CONDITION REPORT

Report No: 2016309534

Vehicle Type	PASSENGER VEHICLE	Registered Owner	MFC AUCTION HOUSE
Manufacturer	MINI	Registration Number	JG15TBGP
Model	COOPER JCW CLUBMAN	Register Number	
VIN	WMWLV920602G34529	Date Of First Licensing	
Engine Number		Last COR	
Doors	5	License Expiry Date	30/11/2024
Color	BLUE	Power / Displacement	
Year Model		Paint Finish	M - METALLIC
Km Reading	193,199 KM	Fuel	PETROL
Cab / Body Type	STATION WAGON	Transmission	AUTOMATIC

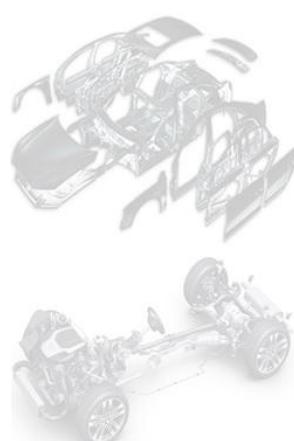
Damage	Repair Way
Center Console / Cubbyhole + Lid Damaged	Repair
Number Plate Front Missing	Replace
Number Plate Rear Missing	Replace
Front Bumper Paintwork • Scratched	Repair
Grill Cracked	Repair
Bonnet Paintwork • Scratched	Repair
Rear Fender Left Paintwork • Scratched	Repair
Rear Fender Right Paintwork • Scratched	Repair
Door Front Left Paintwork • Scratched	Repair
Door Front Right Dented	Repair
Door Rear Left Paintwork • Scratched	Repair
Door Rear Right Paintwork • Scratched	Repair
Rear bumper Paintwork • Scratched	Repair
Windscreen Cracked	Replace
Tyre Rear Right Defective	Replace
Bolt(s) / Nut(s) Front Wheel Left Missing	Replace
Bolt(s) / Nut(s) Front Wheel Right Missing	Replace
Bolt(s) / Nut(s) Rear Wheel Left Missing	Replace
Bolt(s) / Nut(s) Rear Wheel Right Missing	Replace
Both number plate missing	Replace
Airbag and brake light on	Repair

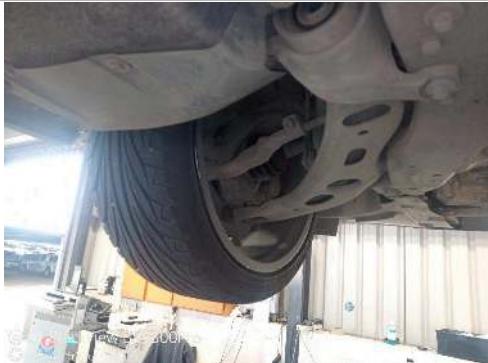
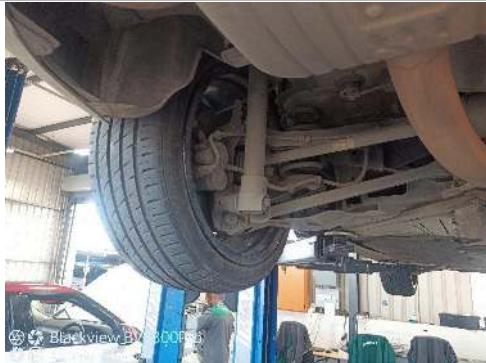
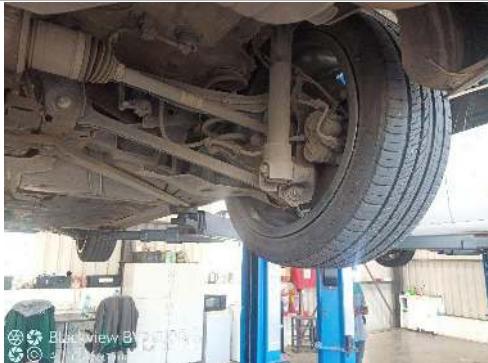
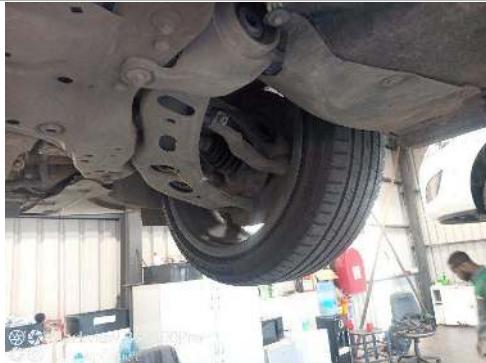
Size	Load/Speed Index	Manufacture	Model	Type*	Production Date	Tread Depth (mm)
Front Left	225/40R18	92H	Kenda	Kaiser	V	2020	4 mm
Front Right	225/40R18	92Y	Pirelli	Cinturato	V	2722	4 mm
Rear Left	225/40R18	92Y	General	Altimax	V	3622	4 mm
Rear Right	225/40R18	92W	Autogrip	Grip 200	V	3122	4 mm

LF TYRE TREAD

LR TYRE TREAD

RR TYRE TREAD

RF TYRE TREAD

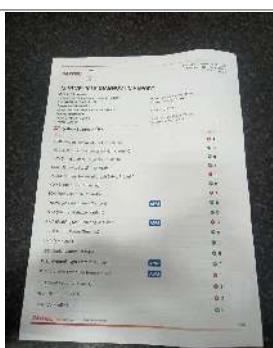
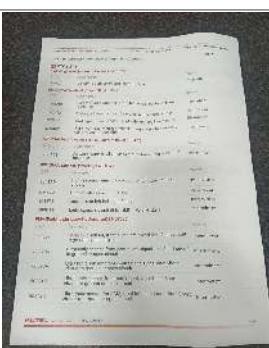
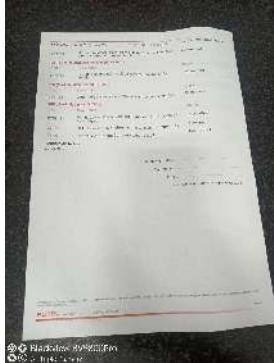
During the diagnostic no active error messages were detected. (See also attached Diagnostic Report. For more information regarding the Fault Codes (DTC) and the recommended rectifications please contact the workshops of the vehicle manufacture).

DIAGNOSTIC REPORT PAGE 1

DIAGNOSTIC REPORT PAGE 2

DIAGNOSTIC REPORT PAGE 3
