CONDITION REPORT

Report No: 2016376766

Vehicle Type	PASSENGER VEHICLE	Registered Owner	MFC AUCTION HOUSE
Manufacturer	MINI	Registration Number	KN10MXGP
Model	COOPER S COUNTRYMAN	Register Number	
VIN	WMWZC32020WN04475	Date Of First Licensing	
Engine Number		Last COR	
Doors	5	License Expiry Date	31/03/2025
Color	WHITE	Power / Displacement	
Year Model		Paint Finish	C - COMMON
Km Reading	168,496 KM	Fuel	PETROL
Cab / Body Type	STATION WAGON	Transmission	MANUAL

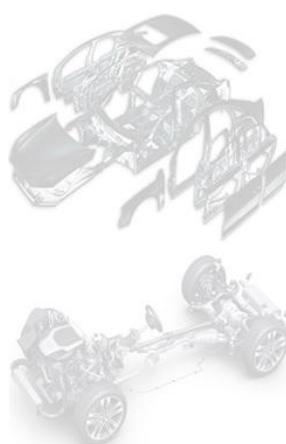
VEHICLE INSPECTION

Damage	Repair Way
Engine Oil Leak	Repair
Fog Light Front Left Cracked	Replace
Fog Light Front Right Cracked	Replace
Front Bumper Cracked	Repair
Rear Fender Right Residual Traces of Repair	Repair
Rear bumper Cracked	Repair
Rim Front Left Damaged	Repair
Rim Rear Left Scratched	Repair
Tyre Front Left Smooth	Replace
Gearbox Oil Leak	Repair
Engine Noise Excessive	Repair
Body exterior	Signs of spray work done on some body panels
Body exterior	Minor dents scratches and stone chips on some body
Tyre pressure warning lights illuminated	Repair.
Foreign substance on oil cap see additional 10	Repair.

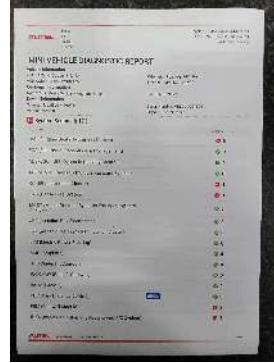
Diagnostic test

During the diagnostic no active error messages were detected. (See also attached Diagnostic Report. For more information regarding the Fault Codes (DTC) and the recommended rectifications please contact the workshops of the vehicle manufacture).

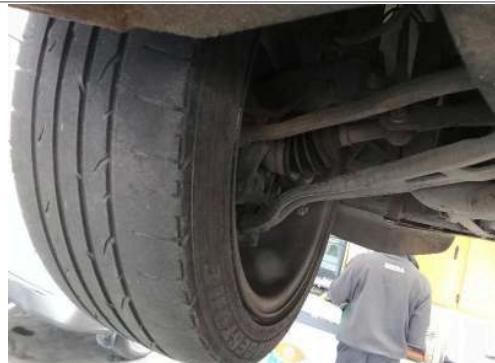
LF TYRE TREAD

Size	Load/Speed Index	Manufacture	Model	Type*	Production Date	Tread Depth (mm)
Front Left	225/45R18	91V	Bridgestone	Dueler	V	4915	0 mm
Front Right	225/45R18	91W	Kumho	Ecsta	V	1716	4 mm
Rear Left	225/45R18	91W	Bridgestone	Turanza	V	2022	6 mm
Rear Right	225/45R18	91W	Bridgestone	Turanza	V	4021	6 mm

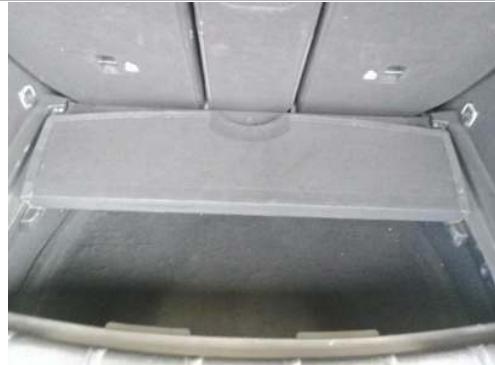
No sparewheel

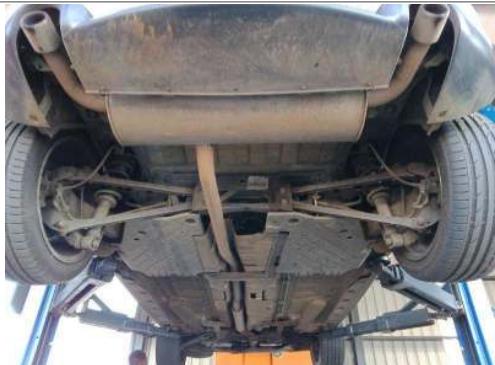
Rear end

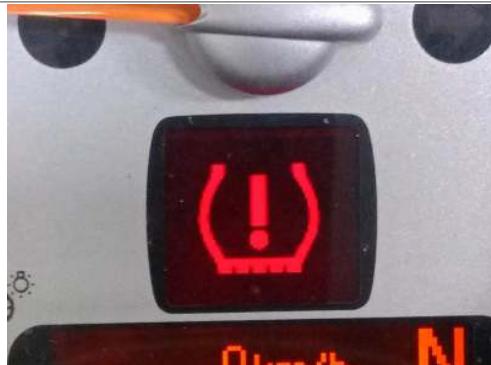
Tyre pressure warning lights i

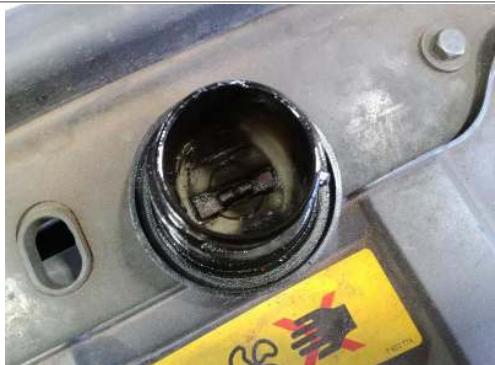
Foreign substance on oil cap

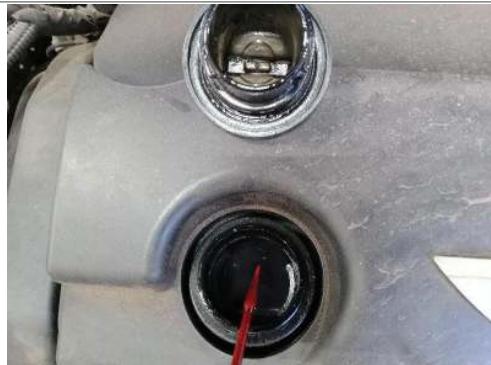
Oil cap and dipstick

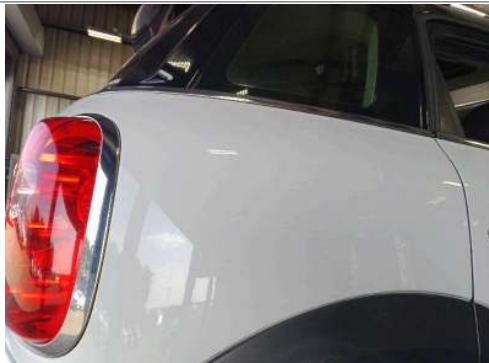
Rear Fender Right

General Comments: ACCORDING TO THE AGE AND MILEAGE OF THE VEHICLE, NORMAL WEAR AND TEAR MARKS ARE VISIBLE ON THE INTERIOR, EXTERIOR, ELECTRICAL AND MECHANICAL PARTS. RESIDUAL TRACES OF REPAIR WORK DONE ON SOME BODY PANELS.
