CONDITION REPORT

Report No:
2016992901
DATE
28/08/2025

Vehicle Type	PASSENGER VEHICLE	Registered Owner	MFC
Manufacturer	VOLKSWAGEN	Registration Number	LM48ZPGP
Model	KOMBI T6.1 SWB 2.0 TDI TRENDLINE MPV DSL 110KW DSG [2021-2022]	Register Number	
VIN	WV2ZZZ7HZMH114718	Date Of First Licensing	
Engine Number		Last COR	
Doors	5	License Expiry Date	30/06/2026
Color	SILVER	Power / Displacement	
Year Model	2021	Paint Finish	TWO COAT METALLIC
Km Reading	121,552 KM	Fuel	DIESEL
Cab / Body Type	STATION WAGON	Transmission	AUTOMATIC

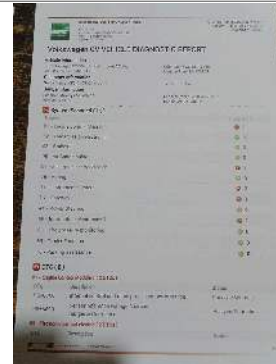
Diagnostic.

No	System	Code	Description	Status
1	ENGINE CONTROL MODULE 1	P060C00	INTERNAL CONTROL UNIT MAIN PROCESSOR PERFORMANCE

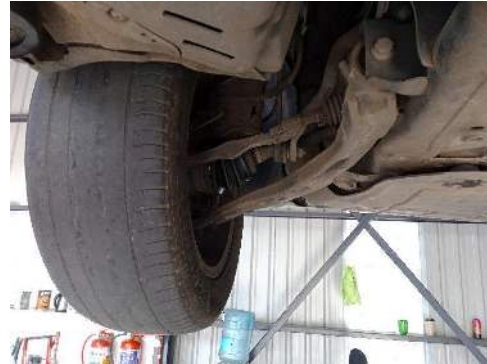
LF TYRE TREAD

Size	Load/Speed Index	Manufacture	Model	Type*	Production Date	Tread Depth (mm)
Front Left	235/55R17	103Y	Michelin	Radial	V	0223	0 mm
Front Right	235/55R17	103Y	Michelin	Radial	V	3724	3 mm
Rear Left	235/55R17	103Y	Michelin	Radial	V	5023	3 mm
Rear Right	235/55R17	103W	Michelin	Radial	V	2921	0 mm
Spare	235/55R17	103W	Bridgestone	Radial	V	0000	4 mm

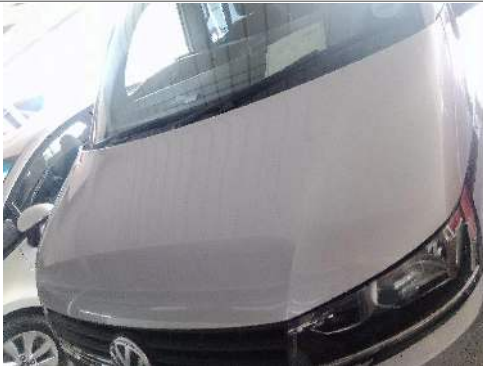
Damage	Repair Way
	Side Mirror Right Damaged	Replace
	Front Bumper Damaged	Repair
	Bonnet Damaged	Repair
	Front Fender Right Damaged	Repair
	Rear Fender Left Damaged	Repair
	Door Front Left Damaged	Repair
	Door Front Right Damaged	Repair
	Door Rear Left Damaged	Repair
	Door Rear Right Damaged	Repair
	Boot Lid / Hatch door Damaged	Repair
	Rear bumper Damaged	Repair
	Tyre Front Left Worn	Replace
	Tyre Rear Right Worn	Replace
	Belly plates Damaged	Repair
