CONDITION REPORT

Report No: 2016206388

Vehicle Type	PASSENGER VEHICLE	Registered Owner	MFC
Manufacturer	VOLKSWAGEN	Registration Number	FWP833L
Model	T-CROSS	Register Number	
VIN	WVGZZC1ZNY109380	Date Of First Licensing	
Engine Number		Last COR	
Doors	5	License Expiry Date	31/10/2024
Color	BLUE	Power / Displacement	
Year Model		Paint Finish	TWO COAT METALLIC
Km Reading	13,164 KM	Fuel	PETROL
Cab / Body Type	HATCHBACK	Transmission	AUTOMATIC

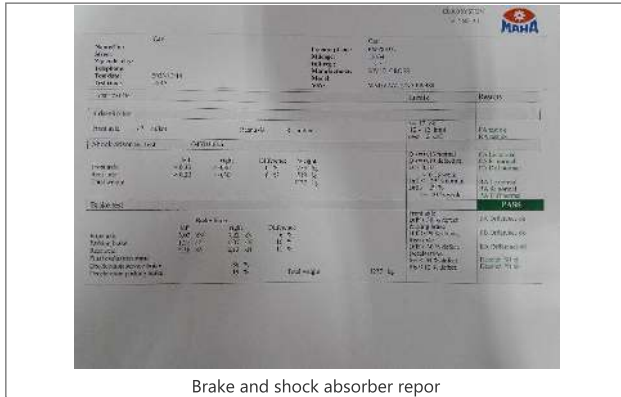
Brake and shock absorber report

Left	Right	Axle Weight [KG]	Deceleration [m/s ²]
	Braking Force [KN]	Braking Force [KN]		
Front	3.03	3.22	-	
Rear	2.38	2.13	-	
Emergency / Parking	1.27	1.07	-

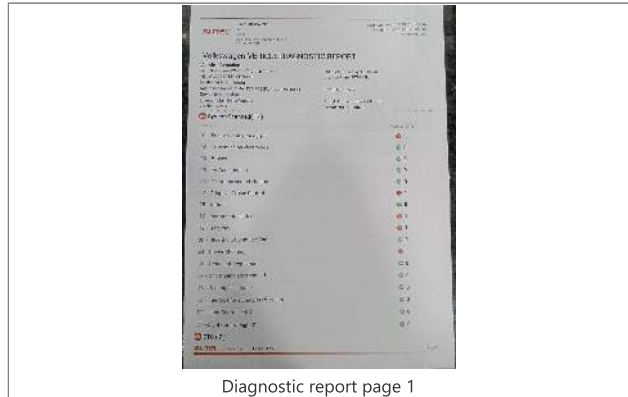
Diagnostic report page 1

No	System	Code	Description	Status
1	01-ENGINE CONTROL MODULE 1	P119A00	FUEL PRESSURE SENSOR MALFUNCTION

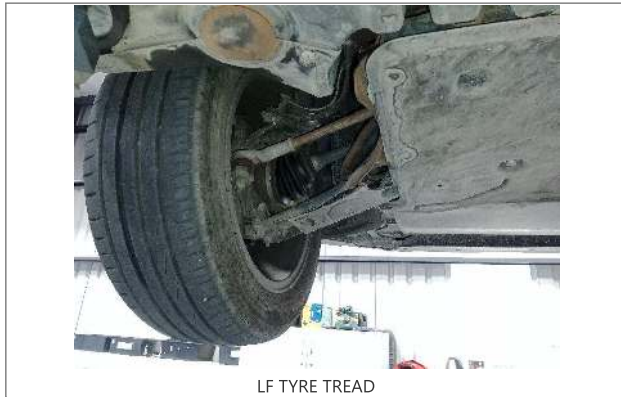
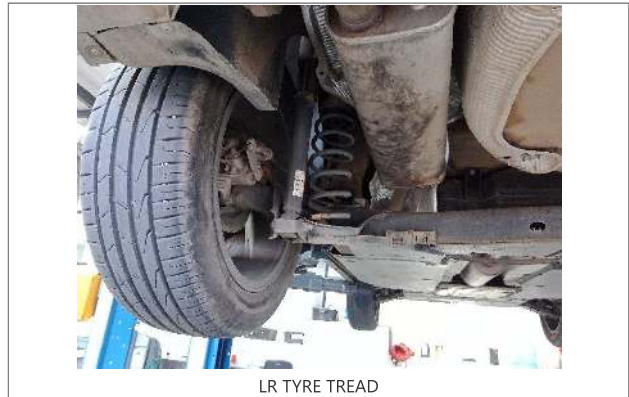
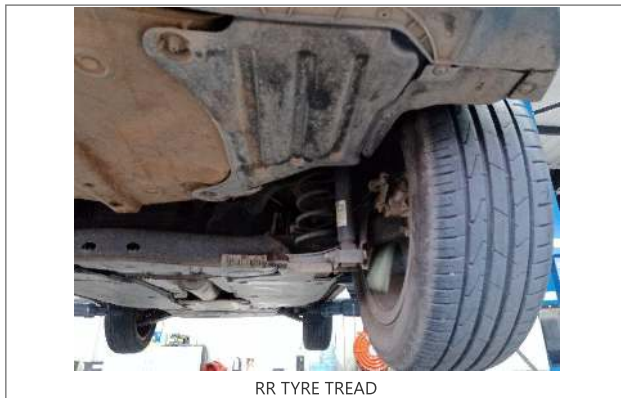
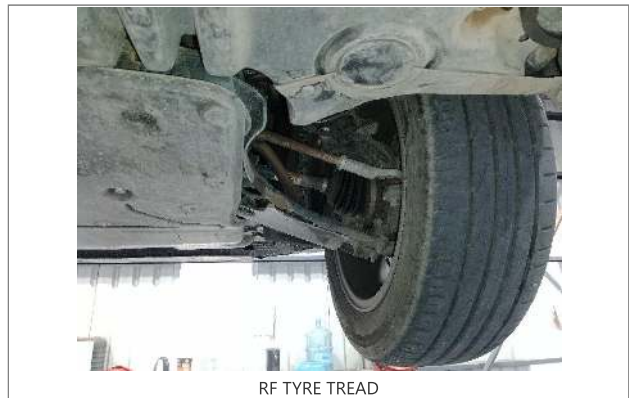
Size	Load/Speed Index	Manufacture	Model	Type*	Production Date	Tread Depth (mm)
Front Left	205/55 R17	91V	Hankook	Ventus	V	5121	4 mm
Front Right	205/55 R17	91V	Hankook	Ventus	V	5121	4 mm
Rear Left	205/55 R17	91V	Hankook	Ventus	V	5121	5 mm
Rear Right	205/55 R17	91V	Hankook	Ventus	V	5121	5 mm
Spare	T125/70 R18	99M	Linglong	Temporary	V	0522	3 mm

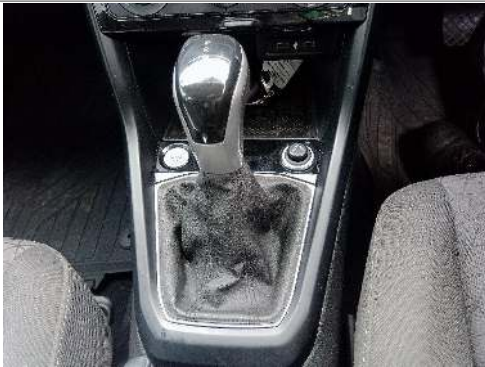
Automatic Transmission

Damage	Repair Way
Engine Oil Sweat	Repair
Seat Front Left Dirty	Repair
Seat Rear Dirty	Repair
Sun Visor Right Dirty	Repair
Hood Lining Dirty	Repair
Front Bumper Paintwork • Scratched	Repair
Bonnet Dented	Repair
C • Pillar Left Dented	Repair
Front Fender Left Dented	Repair
Front Fender Right Paintwork • Scratched	Repair
Rear Fender Left Dented	Repair
Door Front Left Paintwork • Scratched	Repair
Door Front Right Paintwork • Scratched	Repair
Door Rear Left Dented	Repair
Door Rear Right Paintwork • Scratched	Repair
Rear bumper Paintwork • Scratched	Repair
Roof Dented	Repair
Windscreen Chipped	Repair
