CONDITION REPORT

Report No:
2017310479
DATE
12/10/2026

Vehicle Type	PASSENGER VEHICLE	Registered Owner	MFC
Manufacturer	JEEP	Registration Number	FTB508L
Model	WRANGLER UNLIMITED 3.8 SAHARA 4X4 AT [2007-2012]	Register Number	
		Date Of First Licensing	
VIN	1J4BE5H14BL533677	Last COR	
Engine Number		License Expiry Date	31/03/2027
Doors	4	Power / Displacement	
Color	YELLOW	Paint Finish	TWO COAT METALLIC
Year Model	2011	Fuel	PETROL
Km Reading	240,486 KM	Transmission	AUTOMATIC
Cab / Body Type	SUV

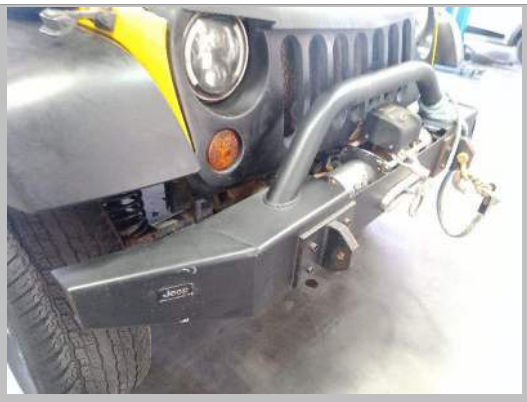
Damage	Repair Way
Engine Oil Leak	Repair
Under bonnet insulation cover Damaged	Repair
Front Bumper Damaged	Repair
Bonnet Damaged	Repair
Front Fender Right Damaged	Repair
Roof Damaged	Repair
Engine to silencer pipe Welded	Repair
Catalytic converter Welded	Replace
Gearbox Oil Leak	Replace

Front Bumper

Under bonnet insulation cover

Bonnet

Roof

Catalytic converter

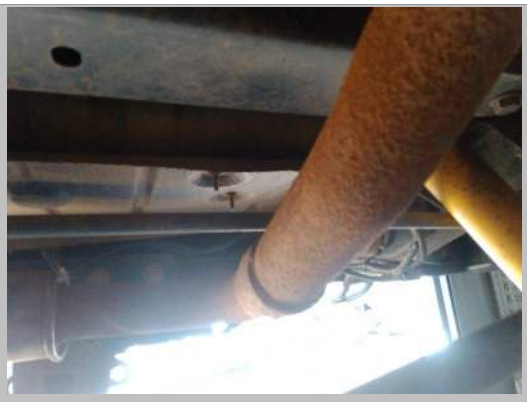
Catalytic converter

Engine to silencer pipe

Engine

Gearbox

Front Fender Right
