CONDITION REPORT

Report No:
2017317553
DATE
26/10/2026

Vehicle Type	PASSENGER VEHICLE	Registered Owner	
Manufacturer	VOLKSWAGEN	Registration Number	LV34THGP
Model	POLO VIVO 1.4 55KW TRENDLINE 5-DR [2023-2024]	Register Number	
		Date Of First Licensing	
VIN	AAVZZZ6RXRU015818	Last COR	
Engine Number		License Expiry Date	31/05/2026
Doors	5	Power / Displacement	
Color	WHITE	Paint Finish	C - COMMON
Year Model	2024	Fuel	PETROL
Km Reading	52,546 KM	Transmission	MANUAL
Cab / Body Type	HATCHBACK

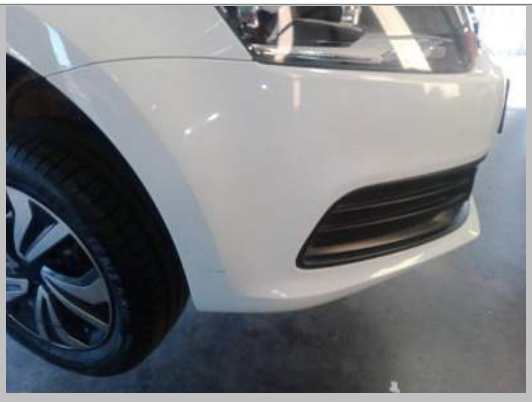
Damage	Repair Way
Side Mirror Right Damaged	Repair
Front Bumper Paintwork • Scratched	Repair
Front Fender Left Paintwork • Scratched	Repair
Rear Fender Left Dented	Repair
Rear Fender Right Paintwork • Scratched	Repair
Door Front Left Paintwork • Scratched	Repair
Door Rear Left Dented	Repair
Door Rear Right Paintwork • Scratched	Repair
Boot Lid / Hatch door Paintwork • Scratched	Repair
Rear bumper Paintwork • Scratched	Repair
Sill Panel Right Dented	Repair
Radiator Cradle Damaged	Repair
R/R tire deferred size	Repair
