CONDITION REPORT

Report No:
2017317562
DATE
26/10/2026

Vehicle Type	PASSENGER VEHICLE	Registered Owner	MFC AUCTION HOUSE
Manufacturer	VOLKSWAGEN	Registration Number	JN34SVGP
Model	POLO VIVO 1.4 55KW TRENDLINE 5-DR [2018-2020]	Register Number	
		Date Of First Licensing	
VIN	AAVZZZ6RZKU010790	Last COR	
Engine Number		License Expiry Date	30/11/2026
Doors	5	Power / Displacement	
Color	WHITE	Paint Finish	TWO COAT UNI
Year Model	2019	Fuel	PETROL
Km Reading	147,118 KM	Transmission	MANUAL
Cab / Body Type	HATCHBACK

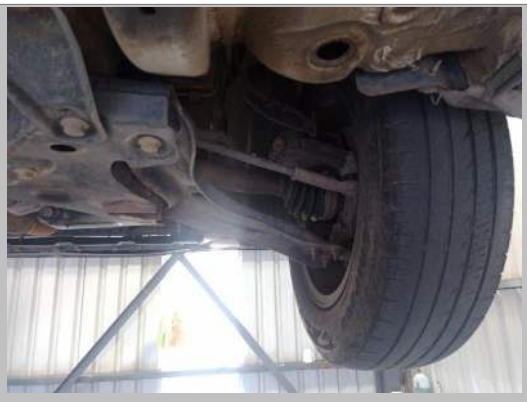
LR TYRE TREAD

Size	Load/Speed Index	Manufacture	Model	Type*	Production Date	Tread Depth (mm)
Front Left	185/65R15	92T	Barum	Radial	V	4623	0 mm
Front Right	185/65R15	88H	Autogrip	Radial	V	1222	0 mm
Rear Left	185/65R15	88H	Nexen	Radial	V	1822	2 mm
Rear Right	185/65R15	92T	Dunlop	Radial	V	2224	2 mm
