CONDITION REPORT

Report No:
2017324144
DATE
11/11/2026

Vehicle Type	PASSENGER VEHICLE	Registered Owner	MFC AUCTION HOUSE
Manufacturer	VOLKSWAGEN	Registration Number	JB03YWGP
Model	POLO VIVO 1.6 77KW HIGHLINE 5-DR [2018-2020]	Register Number	
		Date Of First Licensing	
VIN	AAVZZZ6RZKU019029	Last COR	
Engine Number		License Expiry Date	31/01/2027
Doors	5	Power / Displacement	
Color	BLUE	Paint Finish	C - COMMON
Year Model	2019	Fuel	PETROL
Km Reading	217,028 KM	Transmission	MANUAL
Cab / Body Type	HATCHBACK

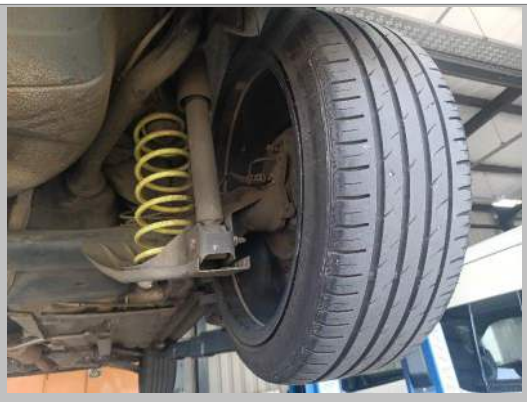
LR TYRE TREAD

Size	Load/Speed Index	Manufacture	Model	Type*	Production Date	Tread Depth (mm)
Front Left	205/40ZR17	84W	NEXEN	N FERASU4	V	4524	3 mm
Front Right	205/40ZR17	84W	NEXEN	N FERA SU4	V	4424	3 mm
Rear Left	205/40ZR17	84W	NEXEN	N FERA SU4	V	1623	3 mm
Rear Right	205/40ZR17	84W	NEXEN	N FERA SU4	V	1623	3 mm
Spare	175/65R14	82T	CONTINENTAL	CONTICONTACT	V	////	5 mm
