# CONDITION REPORT

**Report No:**
**2017313886**
**DATE**
**19/10/2026**

| Manufacturer | VOLKSWAGEN | Registration Number | MC03JFGP |
| Model | POLO VIVO 1.4 55KW TRENDLINE 5-DR [2020-2022] | Register Number | |

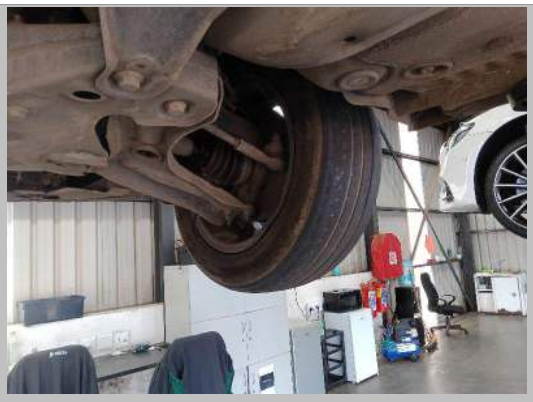
LF TYRE TREAD

| | Size | Load/Speed Index | Manufacture | Model | Type* | Production Date | Tread Depth (mm) |
|---|---|---|---|---|---|---|---|
| **Front Left** | 185/60R14 | 82H | Goodyear | Efficient gr | V | 2924 | 3 mm |
