CONDITION REPORT

Report No:
2017314605
DATE
20/10/2026

Vehicle Type	PASSENGER VEHICLE	Registered Owner	MFC AUCTION HOUSE
Manufacturer	VOLKSWAGEN	Registration Number	KHZ221MP
Model	POLO VIVO 1.4 55KW TRENDLINE 5-DR [2020-2022]	Register Number	
		Date Of First Licensing	
VIN	AAVZZZ6RZMU008980	Last COR	
Engine Number		License Expiry Date	
Doors	5	Power / Displacement	
Color	GREY	Paint Finish	TWO COAT UNI
Year Model	2021	Fuel	PETROL
Km Reading	122,519 KM	Transmission	MANUAL
Cab / Body Type	HATCHBACK

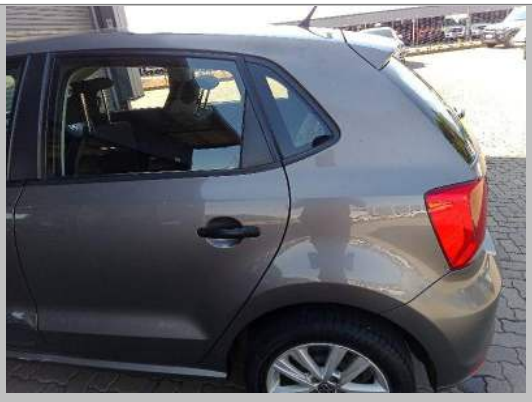
Damage	Repair Way
Windscreen Wiper Missing	Replace
Seat Front Left Dirty	Repair
Seat Rear Dirty	Repair
Sun Visor Right Damaged	Repair
Hood Lining Dirty	Repair
Parcel Tray Damaged	Repair
Boot Carpet Damaged	Repair
Steering Wheel Trim Excessive Wear & Tear	Repair
Side Mirror Left Paintwork • Scratched	Repair
Front Bumper Paintwork • Scratched	Repair
Bonnet Paintwork • Chipmarks	Repair
A • Pillar Left Residual Traces of Repair	Repair
A • Pillar Right Residual Traces of Repair	Repair
B • Pillar Left Residual Traces of Repair	Repair
B • Pillar Right Residual Traces of Repair	Repair
C • Pillar Left Residual Traces of Repair	Repair
C • Pillar Right Residual Traces of Repair	Repair
Front Fender Right Dented	Repair
Rear Fender Left Residual Traces of Repair	Repair
Rear Fender Right Residual Traces of Repair	Repair
Rear Fender Right / Inner Tray Damaged	Repair
Door Front Left Damaged	Repair
Door Front Right Paintwork • Scratched	Repair
