CONDITION REPORT

Report No:
2017316749
DATE
23/10/2026

Vehicle Type	PASSENGER VEHICLE	Registered Owner	
Manufacturer	VOLKSWAGEN	Registration Number	MD82BZGP
Model	POLO VIVO 1.4 63KW COMFORTLINE 5-DR [2021-2023]	Register Number	
		Date Of First Licensing	
VIN	AAVZZZ6RZMU020001	Last COR	
Engine Number		License Expiry Date	31/01/2027
Doors	5	Power / Displacement	
Color	GREY	Paint Finish	M - METALLIC
Year Model	2021	Fuel	PETROL
Km Reading	120,603 KM	Transmission	MANUAL
Cab / Body Type	HATCHBACK

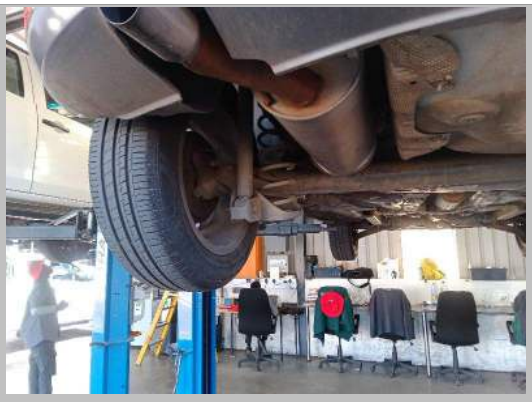
LF TYRE TREAD

Size	Load/Speed Index	Manufacture	Model	Type*	Production Date	Tread Depth (mm)
Front Left	185/60R15	84H	Royal black	Royal mile	V	2625	3 mm
Front Right	185/60R15	84H	Royal black	Royal mile	V	3025	3 mm
Rear Left	185/60R15	84H	Royal black	Royal mile	V	2625	3 mm
Rear Right	185/60R15	84H	Royal black	Royal mile	V	3025	3 mm
Spare	175/65R14	82T	Dunlop	Sp sport	V	0822	4 mm
