CONDITION REPORT

Report No:
2017326886
DATE
18/11/2026

Vehicle Type	PASSENGER VEHICLE	Registered Owner	MFC AUCTION HOUSE
Manufacturer	VOLKSWAGEN	Registration Number	KX87FSGP
Model	POLO VIVO 1.4 55KW TRENDLINE 5-DR [2021-2023]	Register Number	
		Date Of First Licensing	
VIN	AAVZZZ6RZNU018826	Last COR	
Engine Number		License Expiry Date	31/03/2027
Doors	5	Power / Displacement	
Color	BLUE	Paint Finish	TWO COAT METALLIC
Year Model	2022	Fuel	PETROL
Km Reading	230,090 KM	Transmission	MANUAL
Cab / Body Type	HATCHBACK

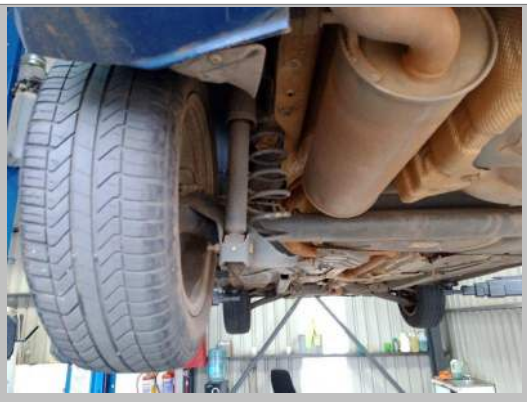
RF TYRE TREAD

Size	Load/Speed Index	Manufacture	Model	Type*	Production Date	Tread Depth (mm)
Front Left	185/60R15	84H	Continental	Contipremiu	V	3619	0 mm
Front Right	185/60R15	84H	Sumitomo	Radial	V	1724	0 mm
Rear Left	185/60R15	84H	Sumitomo	Radial	V	2524	0 mm
Rear Right	185/60R15	84H	Sumitomo	Radial	V	2524	0 mm
