CONDITION REPORT

Report No:
2017316610
DATE
23/10/2026

Vehicle Type	PASSENGER VEHICLE	Registered Owner	
Manufacturer	VOLKSWAGEN	Registration Number	LL83DYGP
Model	POLO VIVO 1.4 55KW TRENDLINE 5-DR [2022-2024]	Register Number	
		Date Of First Licensing	
VIN	AAVZZZ6RZPU002826	Last COR	
Engine Number		License Expiry Date	31/01/2027
Doors	5	Power / Displacement	
Color	SILVER	Paint Finish	TWO COAT UNI
Year Model	2022	Fuel	PETROL
Km Reading	87,210 KM	Transmission	MANUAL
Cab / Body Type	HATCHBACK

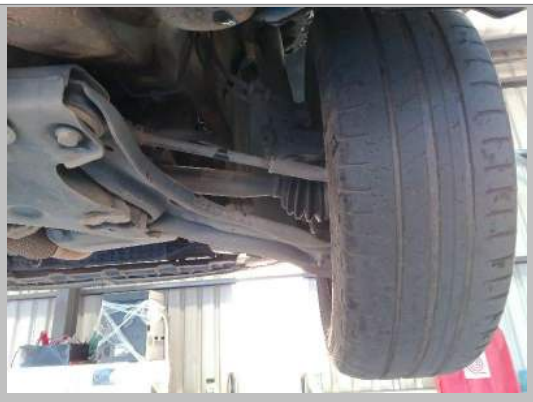
LF TYRE TREAD

Size	Load/Speed Index	Manufacture	Model	Type*	Production Date	Tread Depth (mm)
Front Left	185/60 R14	82H	Goodyear	Efficient	V	3822	1 mm
Front Right	185/60 R14	82H	Goodyear	Efficient	V	3822	1 mm
Rear Left	185/60 R14	82H	Invovic	EL601	V	4825	4 mm
Rear Right	185/60 R14	82H	Invovic	EL601	V	4825	4 mm
Spare	185/65 R15	88T	Goodyear	Duragrip	V	0617	2 mm
