CONDITION REPORT

Report No:
2017317658
DATE
27/10/2026

Vehicle Type	PASSENGER VEHICLE	Registered Owner	
Manufacturer	VOLKSWAGEN	Registration Number	CB18FKGP
Model	POLO VIVO 1.6 BASE 5-DR [2010-2015]	Register Number	
VIN	AAVZZZ6SZDU003875	Date Of First Licensing	
Engine Number		Last COR	
Doors	5	License Expiry Date	28/02/2027
Color	WHITE	Power / Displacement	
Year Model	2012	Paint Finish	C - COMMON
Km Reading	239,503 KM	Fuel	PETROL
Cab / Body Type	HATCHBACK	Transmission	MANUAL

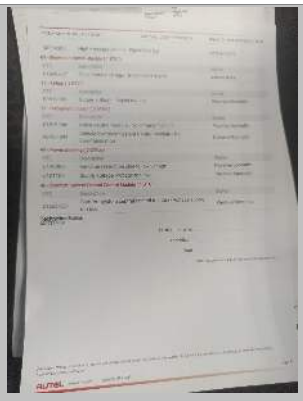
DIAGNOSTICS

No	System	Code	Description	Status
1	ENGINE CONTROL MODULE 1	16711:000	KNOCK SENSOR 1 CIRC. LOW INPUT
