CONDITION REPORT

Report No:
2017317853
DATE
27/10/2026

Vehicle Type	PASSENGER VEHICLE	Registered Owner	
Manufacturer	VOLKSWAGEN	Registration Number	JNG860NW
Model	POLO VIVO GP 1.4 CONCEPTLINE 5-DR [2014-2016]	Register Number	
		Date Of First Licensing	
VIN	AAVZZZ6SZFU015228	Last COR	
Engine Number		License Expiry Date	
Doors	5	Power / Displacement	
Color	GOLDEN	Paint Finish	TWO COAT UNI
Year Model	2015	Fuel	PETROL
Km Reading	218,015 KM	Transmission	MANUAL
Cab / Body Type	HATCHBACK

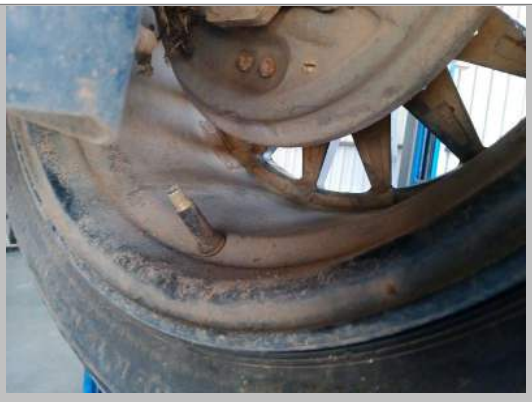
Damage	Repair Way
Shock Absorber Front Right Sweat	Replace
Stabilizer Mounting Front Left Damaged	Replace
Stabilizer Mounting Front Right Damaged	Replace
Control Arm Bush(es) Front Axle Left Damaged	Replace
Control Arm Bush(es) Front Axle Right Damaged	Replace
Tyre Front Left Damaged	Replace
Tyre Front Right Damaged	Replace
Tyre Rear Left Torn / Cut	Replace
Tyre Rear Right Damaged	Replace
Spare Tyre Damaged	Replace
Rim Front Left Damaged	Replace
Rim Rear Right Damaged	Repair
Rim Spare Wheel Dented	Repair
Main Beam Right Dented	Repair
Chassis Damaged	Repair
Sub Frame Dented	Repair
Engine to silencer pipe Damaged	Repair
Silencer Damaged	Replace
Belly plates Damaged	Replace
Gearbox Oil Sweat	Repair
Fuel Tank Damaged	Replace
CV Joint(s) Boot(s) Front Left (inner/outer) Damaged	Replace
Engine Performance Idling / Hunting	Repair
Engine Noise Excessive	Repair
Triangle Missing	Replace
Gear knob damaged	Replace
Warning lights illuminated on dashboard	Repair
