CONDITION REPORT

Report No:
2017317187
DATE
26/10/2026

Vehicle Type	PASSENGER VEHICLE	Registered Owner	MFC AUCTION HOUSE
Manufacturer	VOLKSWAGEN	Registration Number	KX58YBHP
Model	POLO VIVO GP 1.4 63KW TRENDLINE 5-DR [2016-2018]	Register Number	
		Date Of First Licensing	
VIN	AAVZZZ6SZHU010822	Last COR	
Engine Number		License Expiry Date	30/11/2026
Doors	5	Power / Displacement	
Color	SILVER	Paint Finish	TWO COAT UNI
Year Model	2017	Fuel	PETROL
Km Reading	207,264 KM	Transmission	MANUAL
Cab / Body Type	HATCHBACK

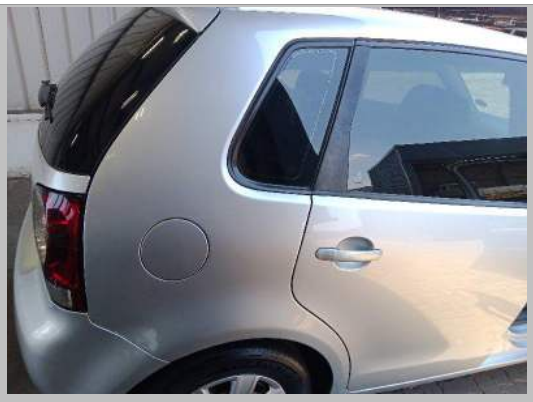
Damage	Repair Way
Radio/CD/USB Defective	Repair
Door Handle Front Left Damaged	Replace
Dash Padding Damaged	Repair
Boot Carpet Damaged	Repair
Side Mirror Left Paintwork • Scratched	Repair
Side Mirror Right Paintwork • Scratched	Repair
Front Bumper Damaged	Replace
Bonnet Paintwork • Chipmarks	Repair
Front Fender Left Paintwork • Scratched	Repair
Rear Fender Left Dented	Repair
Rear Fender Right Residual Traces of Repair	Repair
Door Front Left Paintwork • Scratched	Repair
Door Front Right Dented	Repair
Boot Lid / Hatch door Dented	Repair
Rear bumper Damaged	Repair
Inner Boot Floor Pan and Spare Wheel Well Dented	Repair
Sill Panel Right Paintwork • Scratched	Repair
Windscreen Cracked	Replace
Brake disc 1. Axle left Excessive Wear & Tear	Replace
Brake disc 1. Axle right Excessive Wear & Tear	Replace
Tie Rod End left Cracked	Replace
Tie Rod End right Cracked	Replace
Control Arm Bush(es) Front Axle Left Cracked	Replace
