CONDITION REPORT

Report No:
2017305827
DATE
01/10/2026

Vehicle Type	PASSENGER VEHICLE	Registered Owner	MFC
Manufacturer	VOLKSWAGEN	Registration Number	KWR068NW
Model	POLO VIVO GP 1.4 55KW CONCEPTLINE 5-DR [2016-2018]	Register Number	
		Date Of First Licensing	
VIN	AAVZZZ6SZHU031718	Last COR	
Engine Number		License Expiry Date	30/04/2025
Doors	5	Power / Displacement	
Color	WHITE	Paint Finish	C - COMMON
Year Model	2017	Fuel	PETROL
Km Reading	172,859 KM	Transmission	MANUAL
Cab / Body Type	HATCHBACK

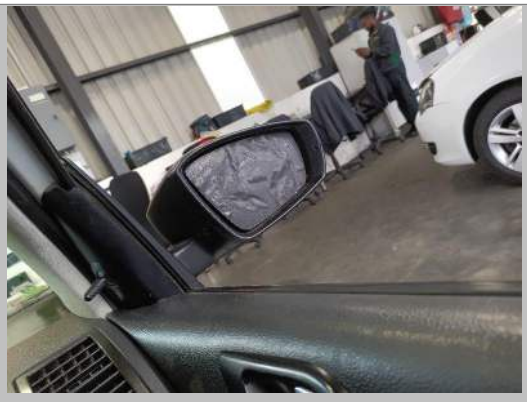
Damage	Repair Way
Engine Oil Leak	Repair
Engine Wiring Defective	Repair
Fog Light Front Left Damaged	Replace
Fog Light Front Right Damaged	Replace
Seat Front Left Torn / Cut	Repair
Seat Front Right Torn / Cut	Repair
Door Panel Front Right Damaged	Replace
Door Handle Front Left Damaged	Replace
Door Handle Front Right Damaged	Replace
Dash Padding Damaged	Replace
Side Mirror Left Damaged	Replace
Side Mirror Right Damaged	Replace
Front Bumper Paintwork • Scratched	Repair
Bonnet Paintwork • Chipmarks	Repair
C • Pillar Right Paintwork • Scratched	Repair
Rear Fender Left Residual Traces of Repair	Repair
Rear Fender Left / Inner Tray Damaged	Replace
Door Front Left Paintwork • Scratched	Repair
Door Rear Left Residual Traces of Repair	Repair
Door Rear Right Paintwork • Scratched	Repair
Boot Lid / Hatch door Residual Traces of Repair	Repair
Rear bumper Residual Traces of Repair	Repair
Brake disc 1. Axle left Excessive Wear & Tear	Replace

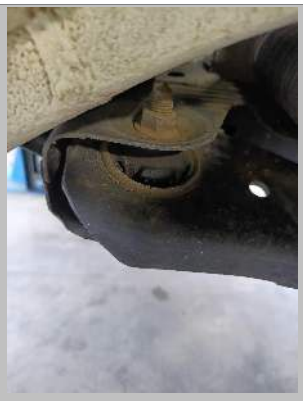
Tie Rod End left Damaged	Replace
Tie Rod End right Cracked	Replace
Spring Front Left Incorrect	Replace
Spring Front Right Incorrect	Replace
Spring Rear Left Incorrect	Replace
Spring Rear Right Incorrect	Replace
Stabilizer Mounting Front Right Damaged	Replace
Control Arm Bush(es) Front Axle Left Cracked	Replace
Control Arm Bush(es) Front Axle Right Cracked	Replace
Tyre Front Left Smooth	Replace
Tyre Front Right Smooth	Replace
Tyre Rear Left Excessive Wear & Tear	Replace
Tyre Rear Right Excessive Wear & Tear	Replace
Spare Tyre Excessive Wear & Tear	Replace
Bolt(s) / Nut(s) Rear Wheel Left Missing	Replace
Bolt(s) / Nut(s) Rear Wheel Right Missing	Replace
Rear tyre size differs	Replace
radiator is loose	Repair
