CONDITION REPORT

Report No:
2017286605
DATE
19/08/2026

Vehicle Type	**PASSENGER VEHICLE**	Registered Owner	**MFC**
Manufacturer	**VOLKSWAGEN**	Registration Number	**LY53VPGP**
Model	**POLO 1.0 TSI 70KW COMFORTLINE 5-DR DSG [2019-2021]**	Register Number	
		Date Of First Licensing	
VIN	**AAVZZZAWZLU014177**	Last COR	
Engine Number		License Expiry Date	**30/09/2026**
Doors	**5**	Power / Displacement	
Color	**WHITE**	Paint Finish	**TWO COAT UNI**
Year Model	**2019**	Fuel	**PETROL**
Km Reading	**195,472 KM**	Transmission	**AUTOMATIC**
Cab / Body Type	**HATCHBACK**

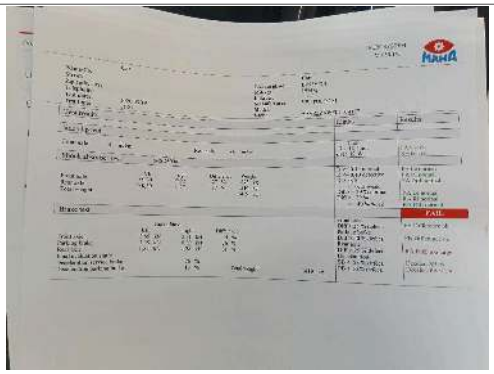
Brake test.

Left	Right		
	Braking Force [KN]	Braking Force [KN]	Axle Weight [KG]	Deceleration [m/s²]
Front	3.65	3.81	-	
Rear	1.84	1.28	-	
Emergency / Parking	1.08	0.8	-

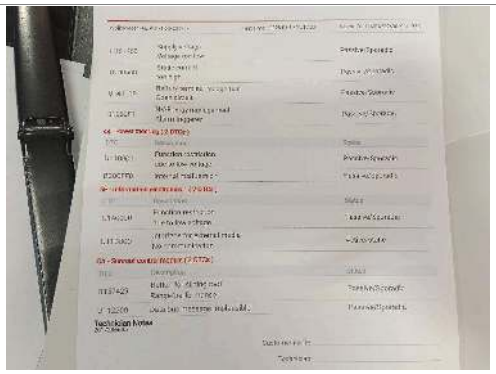
Diagnostic.

No	System	Code	Description	Status
1	01-ENGINE CONTROL MODULE 1	P305400	STARTER DOES NOT TURN MECHANICALLY BLOCKED OR ELECTRICAL MALFUNCTION

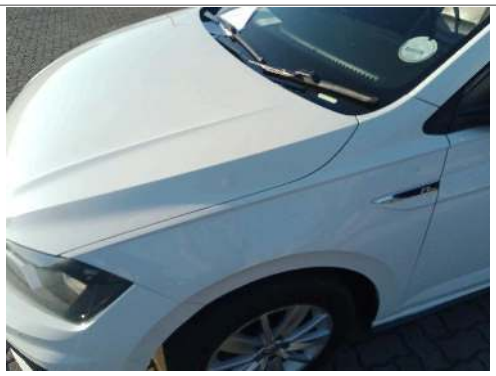
Damage	Repair Way
Engine Management Lights Set	Repair
Side Mirror Right Damaged	Repair
Front Bumper Damaged	Repair
Bonnet Damaged	Repair
Front Fender Left Damaged	Repair
Door Front Left Damaged	Repair
Door Front Right Damaged	Repair
Door Rear Left Damaged	Repair
Boot Lid / Hatch door Damaged	Repair
Rear bumper Damaged	Repair
Windscreen Damaged	Replace
Service Brake Performance Rear Axle Left / Right Difference out of legal range	Repair
Tyre Rear Left Worn	Replace
