CONDITION REPORT

Report No:
2017308858
DATE
07/10/2026

Vehicle Type	PASSENGER VEHICLE	Registered Owner	MFC
Manufacturer	VOLKSWAGEN	Registration Number	LL73CHGP
Model	POLO 1.0 TSI 70KW COMFORTLINE 5-DR DSG [2020-2022]	Register Number	
		Date Of First Licensing	
VIN	AAVZZZAWZMU064954	Last COR	
Engine Number		License Expiry Date	
Doors	5	Power / Displacement	
Color	BLUE	Paint Finish	M - METALLIC
Year Model	2021	Fuel	PETROL
Km Reading	64,818 KM	Transmission	AUTOMATIC
Cab / Body Type	HATCHBACK

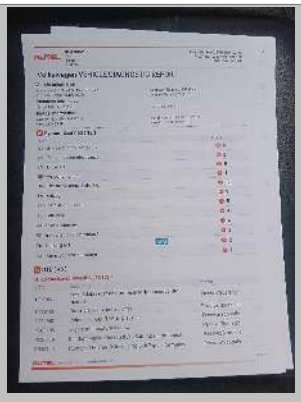
Shock and brake report

Brake test failed	Repair

Left	Right		
	Braking Force [KN]	Braking Force [KN]	Axle Weight [KG]	Deceleration [m/s²]
Front	3.3	3.6	-	
Rear	2.9	2.6	-	
Emergency / Parking	0.8	0.7	-

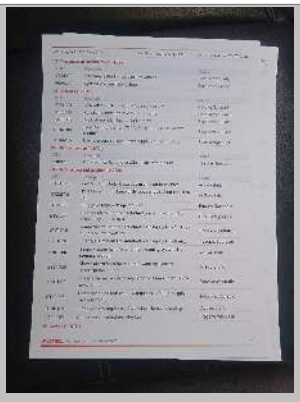
Diagnostic report

No	System	Code	Description	Status
1	ENGINE	P308100	ENGINE TEMPERATURE TOO LOW	PASSIVE SPORADIC

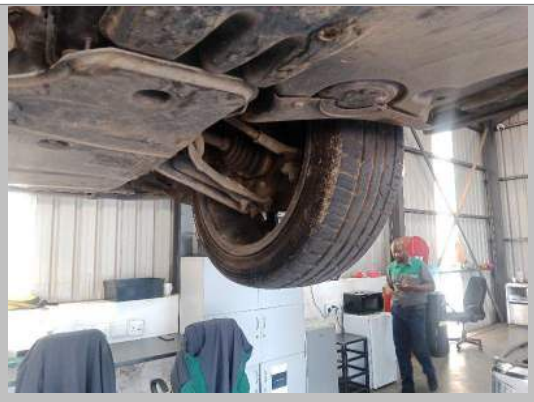
RR TYRE TREAD

Size	Load/Speed Index	Manufacture	Model	Type*	Production Date	Tread Depth (mm)
Front Left	215/45R17	91W	Continental	Contact	V	3722	3 mm
Front Right	215/45R17	91W	Dunlop	Sp sport	V	3621	3 mm
Rear Left	215/45R17	91W	Black hawk	Street -H	V	1421	3 mm
Rear Right	215/45R17	91W	Continental	Contact	V	4820	3 mm

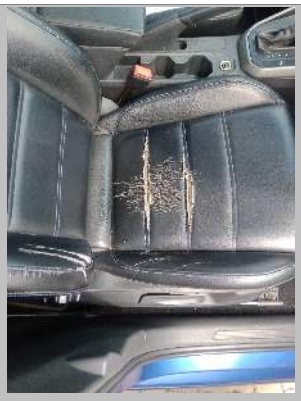
Damage	Repair Way
Fog Light Front Left Malfunction	Repair
Seat Front Right Torn / Cut	Repair
Side Mirror Left Damaged	Repair
Front Bumper Paintwork • Discoloured	Repair
Bonnet Paintwork • Discoloured	Repair
Front Fender Left Paintwork • Discoloured	Repair
Front Fender Right Paintwork • Discoloured	Repair
Rear Fender Left Paintwork • Discoloured	Repair
Rear Fender Right Paintwork • Discoloured	Repair
Door Front Left Paintwork • Scratched	Repair
Door Front Right Paintwork • Chipmarks	Repair
Door Rear Left Dented	Repair
Door Rear Right Paintwork • Scratched	Repair
Boot Lid / Hatch door Paintwork • Discoloured	Repair
Rear bumper Paintwork • Discoloured	Repair
Body exterior	Vehicle got some scratches, stone chips and dents
Body exterior	Discoloring on some body panels
Engine management lights illuminated	Repair
Boot not opening can not see spare wheel	Repair
No license disc	Replace
Two tires deferred name brand	Repair
