CONDITION REPORT

Report No:
2017316347
DATE
23/10/2026

Vehicle Type	PASSENGER VEHICLE	Registered Owner	MFC AUCTION HOUSE
Manufacturer	VOLKSWAGEN	Registration Number	FWT238L
Model	POLO 1.0 TSI 70KW COMFORTLINE 5-DR [2020-2022]	Register Number	
		Date Of First Licensing	
VIN	AAVZZZAWZMU066823	Last COR	
Engine Number		License Expiry Date	30/09/2026
Doors	5	Power / Displacement	
Color	BLUE	Paint Finish	M - METALLIC
Year Model	2021	Fuel	PETROL
Km Reading	152,494 KM	Transmission	MANUAL
Cab / Body Type	HATCHBACK

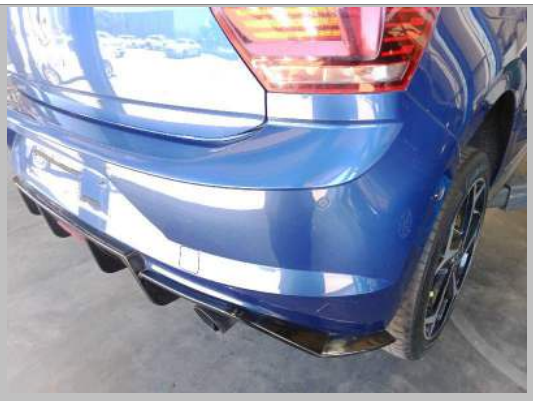
Damage	Repair Way
Seat Front Right Damaged	Repair
Number Plate Rear Missing	Replace
Front Bumper Paintwork • Chipmarks	Repair
Bonnet Paintwork • Chipmarks	Repair
Front Fender Right Dented	Repair
Rear Fender Left Paintwork • Scratched	Repair
Rear Fender Right Dented	Repair
Door Front Left Paintwork • Scratched	Repair
Door Front Right Paintwork • Scratched	Repair
Door Rear Left Paintwork • Scratched	Repair
Door Rear Right Paintwork • Scratched	Repair
Boot Lid / Hatch door Paintwork • Scratched	Repair
Rear bumper Paintwork • Scratched	Repair
Windscreen Cracked	Replace
Tyre Front Right Smooth	Replace
Tyre Rear Right Smooth	Replace
Spare Tyre Smooth	Replace
Engine to silencer pipe Welded	Repair
CV Joint(s) Boot(s) Front Left (inner/outer) Damaged	Replace
Body exterior	Vehicle got minor scratches, stone chips and dents
Engine management lights illuminated	Repair
