CONDITION REPORT

Report No:
2017307088
DATE
03/10/2026

Vehicle Type	PASSENGER VEHICLE	Registered Owner	MFC AUCTION HOUSE
Manufacturer	VOLKSWAGEN	Registration Number	KV36ZZGP
Model	POLO 2.0 TSI 147KW GTI 5-DR DSG [2020-2022]	Register Number	
		Date Of First Licensing	
VIN	AAVZZZAWZMU079518	Last COR	
Engine Number		License Expiry Date	
Doors	5	Power / Displacement	
Color	RED	Paint Finish	M - METALLIC
Year Model	2021	Fuel	PETROL
Km Reading	187,775 KM	Transmission	AUTOMATIC
Cab / Body Type	HATCHBACK

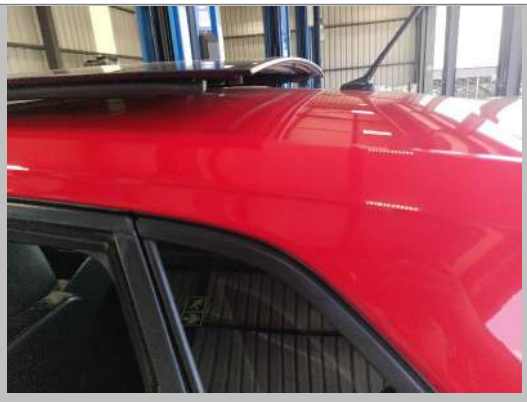
Damage	Repair Way
Switch Electrical Window Winder rear right Defective	Smart Repair
Seat Front Right Torn / Cut	Repair
Front Bumper Residual Traces of Repair	Repair
Bonnet Dented	Repair
A • Pillar Left Dented	Repair
Front Fender Right Residual Traces of Repair	Repair
Door Front Left Residual Traces of Repair	Repair
Door Front Right Dented	Repair
Door Rear Left Paintwork • Scratched	Repair
Door Rear Right Dented	Repair
Boot Lid / Hatch Door Shock Right Defective	Replace
Rear bumper Residual Traces of Repair	Repair
Stabilizer Mounting Front Left Damaged	Replace
Control Arm Bush(es) Front Axle Left Loose / Excessive Play	Replace
Tyre Rear Right Smooth	Replace
Bolt(s) / Nut(s) Rear Wheel Left Missing	Replace
CV Joint(s) Boot(s) Front Left (inner/outer) Damaged	Replace
Body exterior	Signs of spray work done on body panels
Body exterior	Residual traces of repair on body panels

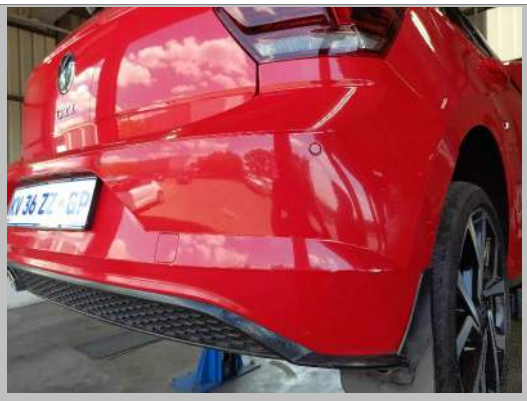
Tyre Rear Right

Size	Load/Speed Index	Manufacture	Model	Type*	Production Date	Tread Depth (mm)
Front Left	225/40R18	92W	Hilo	Vantage	V	3825	5 mm
Front Right	225/40R18	88Y	Goodyear	Eagle	V	2422	2 mm
Rear Left	225/40R18	88Y	Bridgestone	Potenza	V	2119	1 mm
Rear Right	225/40R18	92W	Bridgestone	Potenza	V	4321	0 mm
