CONDITION REPORT

Report No:
2017316406
DATE
23/10/2026

MFC Auction House
M57 Pretoria Rd, Glenmarais, KEMPTON PARK
Gauteng

Vehicle Type	LIGHT LOAD VEHICLE	Registered Owner	MFC
Manufacturer	ISUZU	Registration Number	LHV219NW
Model	D-MAX 250 HO CREWCAB HR D-CAB 4X4 DSL PU [2018-2020]	Register Number	
		Date Of First Licensing	
VIN	ACVNSCHR2J4035570	Last COR	
Engine Number		License Expiry Date	31/10/2026
Doors	4	Power / Displacement	
Color	WHITE	Paint Finish	C - COMMON
Year Model	2019	Fuel	DIESEL
Km Reading	184,719 KM	Transmission	MANUAL
Cab / Body Type	DOUBLE CAB

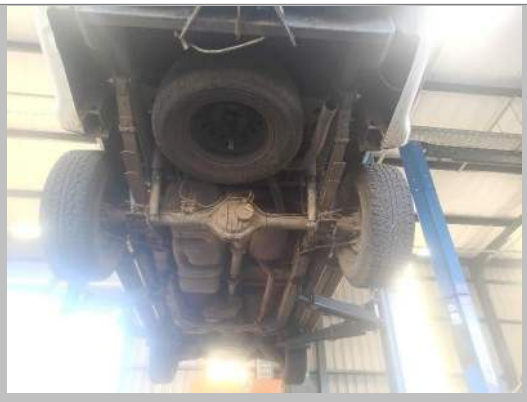
CHASSIS

General Comments: ACCORDING TO THE AGE AND MILEAGE OF THE VEHICLE, NORMAL WEAR AND TEAR MARKS ARE VISIBLE ON THE INTERIOR, EXTERIOR, ELECTRICAL AND MECHANICAL PARTS.Undercarriage: some bolts on Gear box missing

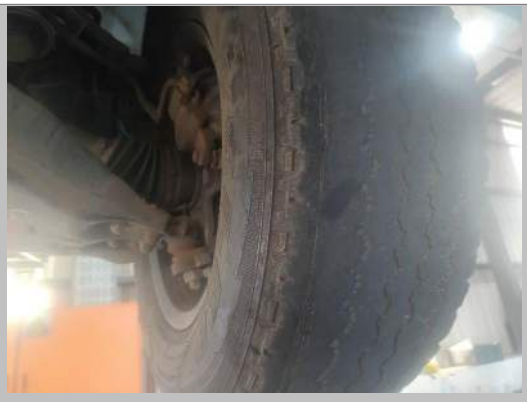
Damage	Repair Way
Engine Oil Sweat	Repair
Air Conditioner Defective	Repair
Number Plate Rear Defective	Repair
Front Bumper Paintwork • Scratched	Repair
Door Front Left Paintwork • Chipmarks	Repair
Windscreen Chipped	Repair
Tyre Front Left Worn	Replace
Tyre Front Right Worn	Replace
Gearbox Oil Sweat	Repair
