CONDITION REPORT

Report No:
2017313361
DATE
16/10/2026

Vehicle Type	LIGHT LOAD VEHICLE	Registered Owner	MFC AUCTION HOUSE
Manufacturer	ISUZU	Registration Number	LX59SMGP
Model	D-MAX 1.9 DDI X-RIDER HR DSL D-CAB PU AT [2023-2026]	Register Number	
		Date Of First Licensing	
VIN	ACVTFR87JPD162724	Last COR	
Engine Number		License Expiry Date	
Doors	4	Power / Displacement	
Color	GREY	Paint Finish	M - METALLIC
Year Model	2024	Fuel	DIESEL
Km Reading	28,171 KM	Transmission	AUTOMATIC
Cab / Body Type	DOUBLE CAB

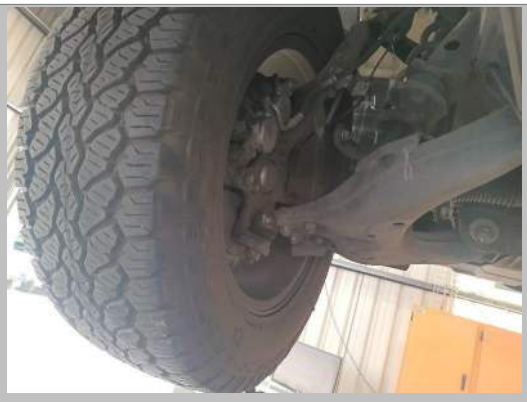
LF TYRE TREAD

Size	Load/Speed Index	Manufacture	Model	Type*	Production Date	Tread Depth (mm)
Front Left	265/60R18	110H	General	Grabber	V	2124	6 mm
Front Right	265/60R18	110H	General	Grabber	V	2124	6 mm
Rear Left	265/60R18	110H	General	Grabber	V	2124	6 mm
Rear Right	265/60R18	110H	General	Grabber	V	2124	6 mm
Spare	265/60R18	110H	General	Grabber	V	0000	6 mm

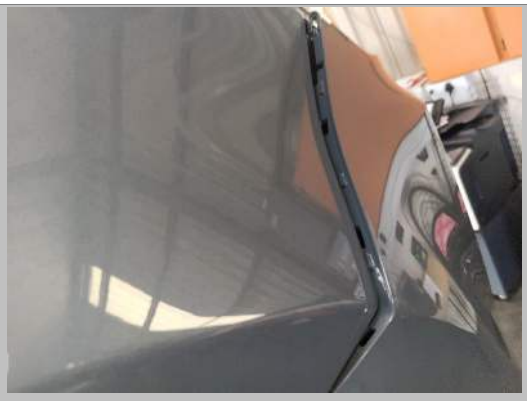
Damage	Repair Way
Side Mirror Left Damaged	Repair
Front Bumper Damaged	Repair
Door Front Left Paintwork • Scratched	Repair
Door Rear Left Dented	Repair
Tailgate Dented	Repair
Rear bumper Damaged	Repair
Load Body Dented	Repair
Body exterior	Signs of spray work done on body panels
