CONDITION REPORT

Report No:
2017315998
DATE
23/10/2026

Vehicle Type	LIGHT LOAD VEHICLE	Registered Owner	MFC AUCTION HOUSE
Manufacturer	ISUZU	Registration Number	LH20LJGP
Model	D-MAX 3.0 DDI LSE 4X4 EX-CAB DSL PU AT [2022-2023]	Register Number	
		Date Of First Licensing	
VIN	ACVTFS40JMD127410	Last COR	
Engine Number		License Expiry Date	30/09/2025
Doors	4	Power / Displacement	
Color	WHITE	Paint Finish	TWO COAT UNI
Year Model	2023	Fuel	DIESEL
Km Reading	81,305 KM	Transmission	AUTOMATIC
Cab / Body Type	SUPER CAB

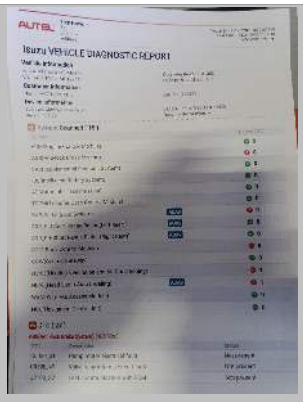
No Brake Test on a brake test machine has been performed.

Brake test.

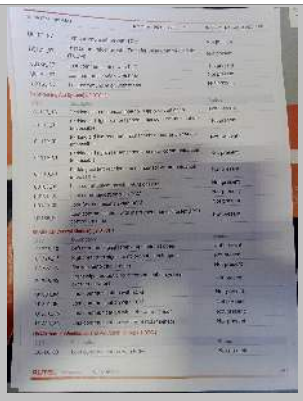
No	System	Code	Description	Status
1	ABS	C0020_01	PUMP MOTOR ELECTRICAL FAULT

Diagnostic.

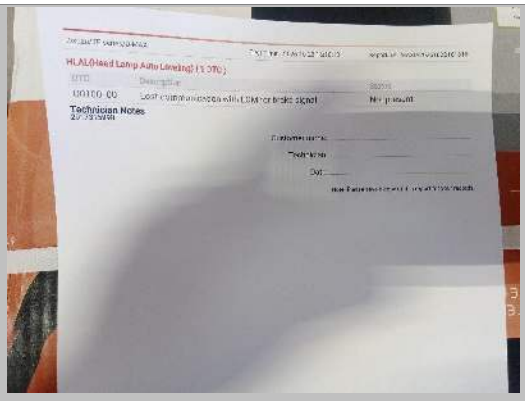
Diagnostic.

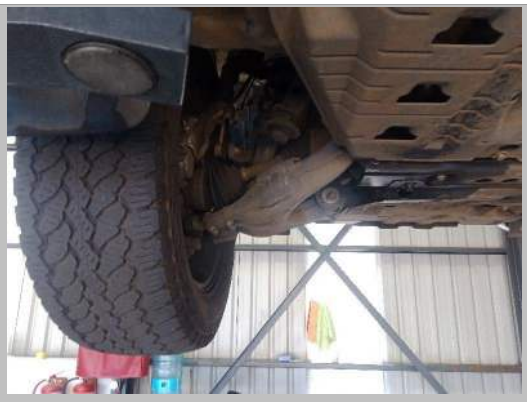
Undercarriage front.

Undercarriage rear.

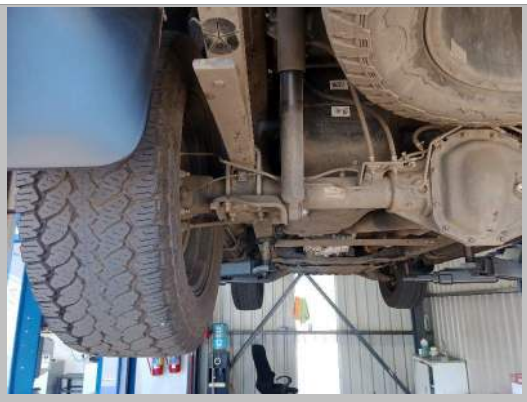
LF TYRE TREAD

Size	Load/Speed Index	Manufacture	Model	Type*	Production Date	Tread Depth (mm)
Front Left	265/60R18	110H	General	Radial	V	1623	3 mm
Front Right	265/60R18	110H	General	Radial	V	1623	3 mm
Rear Left	265/60R18	110H	General	Radial	V	1623	3 mm
Rear Right	265/60R18	110H	General	Radial	V	1623	3 mm
Spare	265/60R18	110H	General	Radial	V	////	4 mm
