CONDITION REPORT

Report No:
2017314581
DATE
20/10/2026

Vehicle Type	PASSENGER VEHICLE	Registered Owner	MFC AUCTION HOUSE
Manufacturer	NISSAN	Registration Number	KH40GRGP
Model	TIIDA 1.6 VISIA+ 5-DR [2006-2014]	Register Number	
VIN	ADNFCAC11Z2030162	Date Of First Licensing	
Engine Number		Last COR	
Doors	5	License Expiry Date	
Color	WHITE	Power / Displacement	
Year Model	2011	Paint Finish	TWO COAT UNI
Km Reading	133,595 KM	Fuel	PETROL
Cab / Body Type	HATCHBACK	Transmission	MANUAL

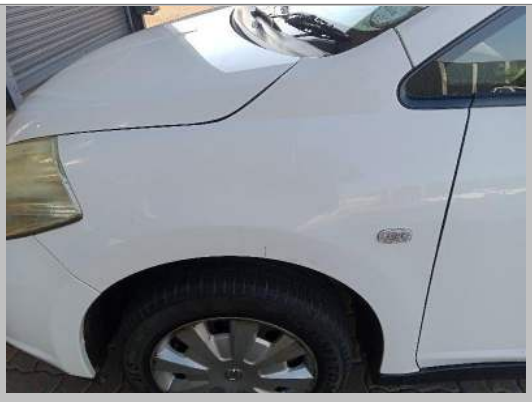
Damage	Repair Way
Battery box Damaged	Replace
Under bonnet insulation cover Damaged	Repair
Hooter Defective	Repair
Heater control Damaged	Replace
Windscreen Wiper Damaged	Replace
Headlight Left Defective	Repair
Headlight Right Defective	Repair
Hood Lining Damaged	Repair
Door Panel Front Left Damaged	Repair
Door Panel Front Right Damaged	Repair
Door Panel Rear Left Damaged	Repair
Dash Padding Damaged	Repair
Side Mirror Left Paintwork • Scratched	Repair
Side Mirror Right Damaged	Replace
Front Bumper Damaged	Repair
Bonnet Damaged	Repair
Front Fender Left Paintwork • Scratched	Repair
Front Fender Right Paintwork • Scratched	Repair
Rear Fender Left Paintwork • Scratched	Repair
Door Front Left Paintwork • Scratched	Repair
Door Front Right Paintwork • Scratched	Repair
Boot Lid / Hatch door Damaged	Repair
Rear bumper Paintwork • Scratched	Repair
Fuel Flap Defective	Repair
Roof Dented	Repair
Control Arm Bush(es) Front Axle Left Cracked	Replace
