# CONDITION REPORT

**Report No:**
**2017310484**
**DATE**
**12/10/2026**

| Manufacturer | NISSAN | Registration Number | BP96HSGP |
| Model | NP200 1.6 8V BASE PU [2009-2019] | Register Number | |

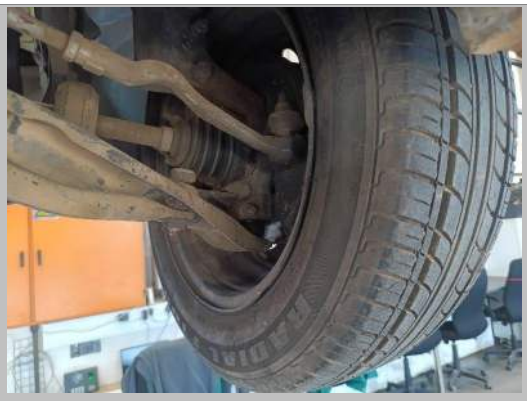
LF TYRE TREAD

LR TYRE TREAD

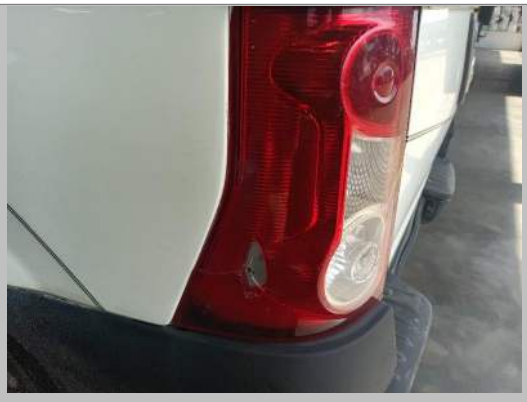
| Damage | Repair Way |
|---|---|
| Load Body Residual Traces of Repair | Repair |

Load Body

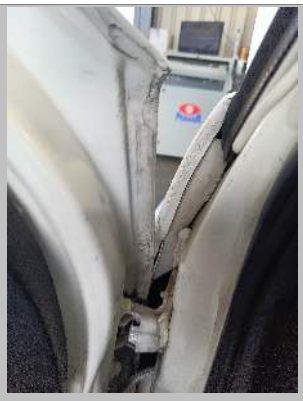
| Damage | Repair Way |
|---|---|
| Door Front Left Residual Traces of Repair | Repair |

Door Front Left
